# Arboricultural Consultancy for Lloyds Bank

| Insured | Mr and Mrs Darryl and Jacqueline Burchell | Address | 47 Western Park, London, N8 9SY | | |
| Client | Subsidence Management Services | Contact | Ian Domigan | Claim No. | IFS-LBG-SUB-22-0105179 |

The insured structure is a 3 storey end-terrace house. It has been extended with a single-storey extension to the rear. The property occupies a level site with no adverse topographical features.

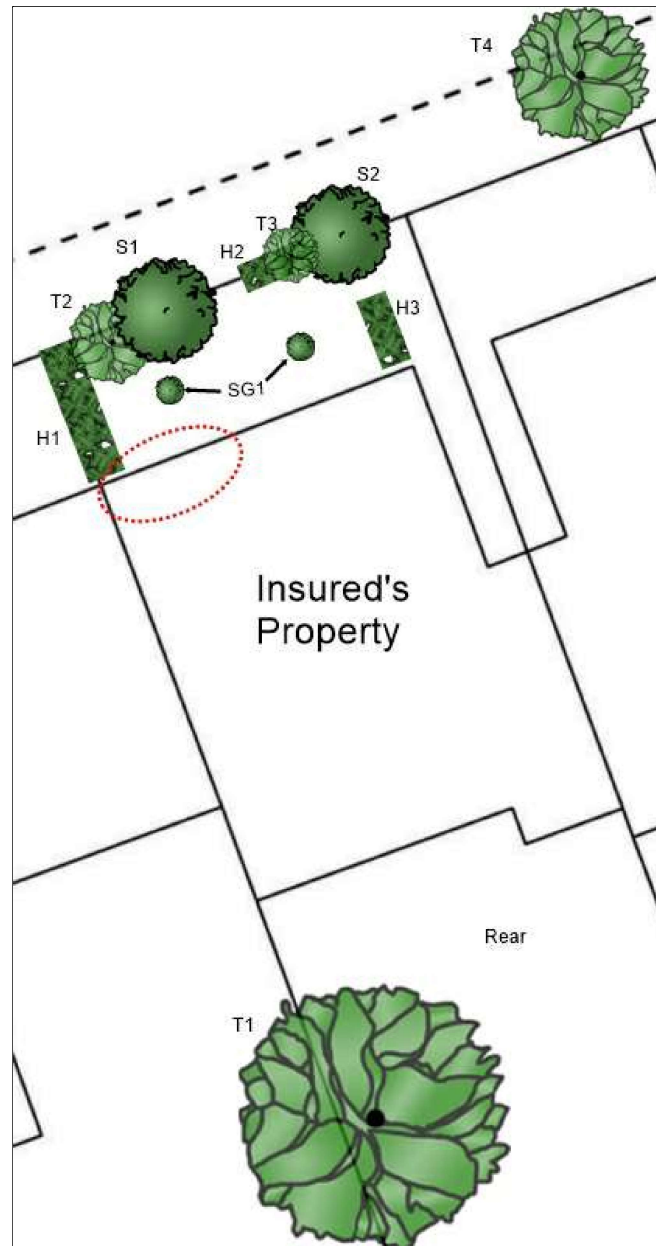
## 7. Site Plan

We understand that the current damage relates to the front bay window of the insured dwelling, where cracking indicates downwards movement.

Following tree surgery we recommended that the building be monitored to establish the effectiveness of the works in restoring stability.

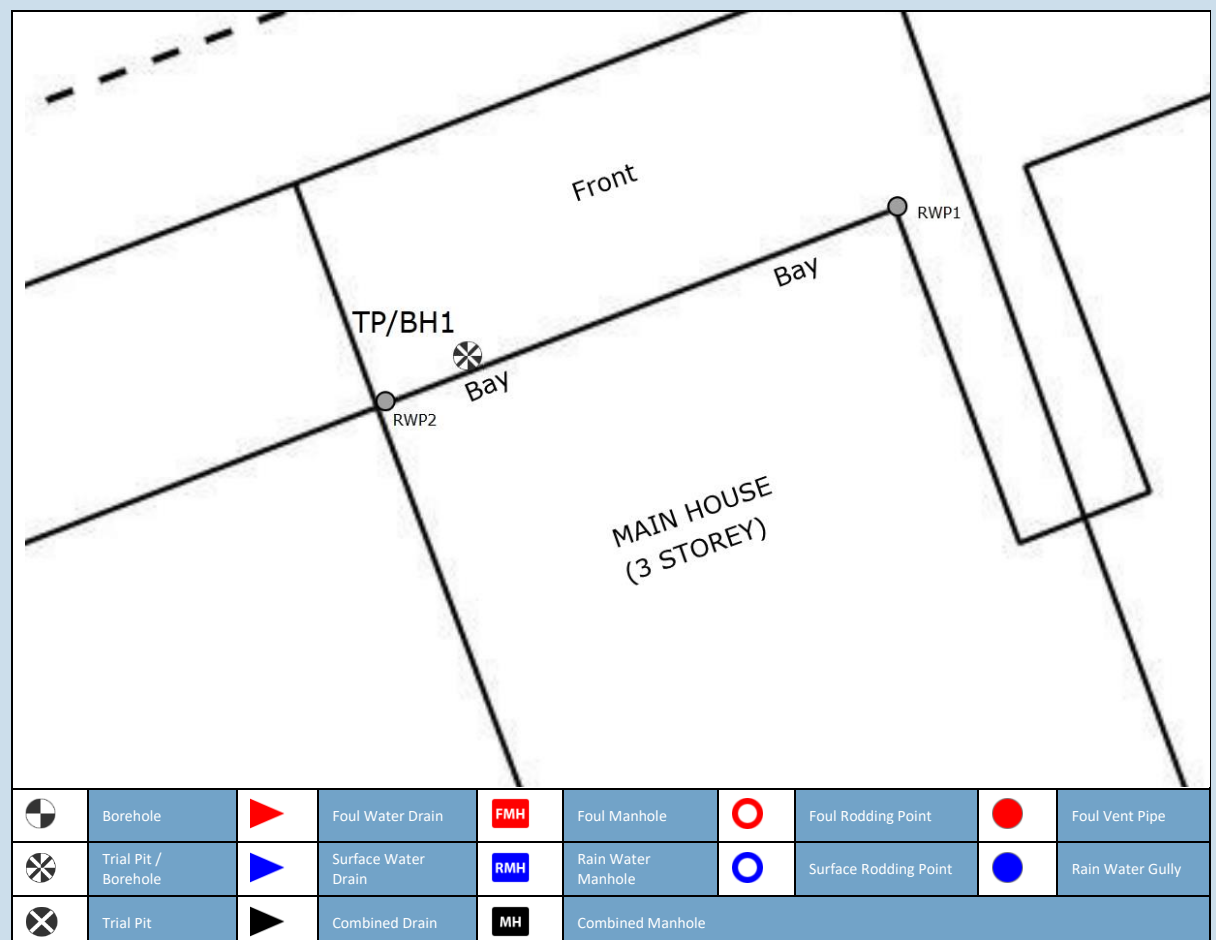
### Site Plan

Bay foundation comprised of brick wall to 300mm bgl, bearing on stepped brickwork to 400mm bgl with a total projection of 150mm from the elevation. In turn, bearing on concrete to 700mm bgl with a total projection of 150mm from the elevation. Underside of foundation (USF) was exposed to 100mm back from the face of the foundation and probed 200mm back from the face of the foundation.

At 0.70m bgl UNDERSIDE OF BAY FOUNDATION in TP/BH1.
