# GEOSHIELD Verification Report

Phase 3:Clarendon Road, GR DPC installation.

AREA SURVEYED: Threshold Detail - Block D2

DATE: 03/07/2023

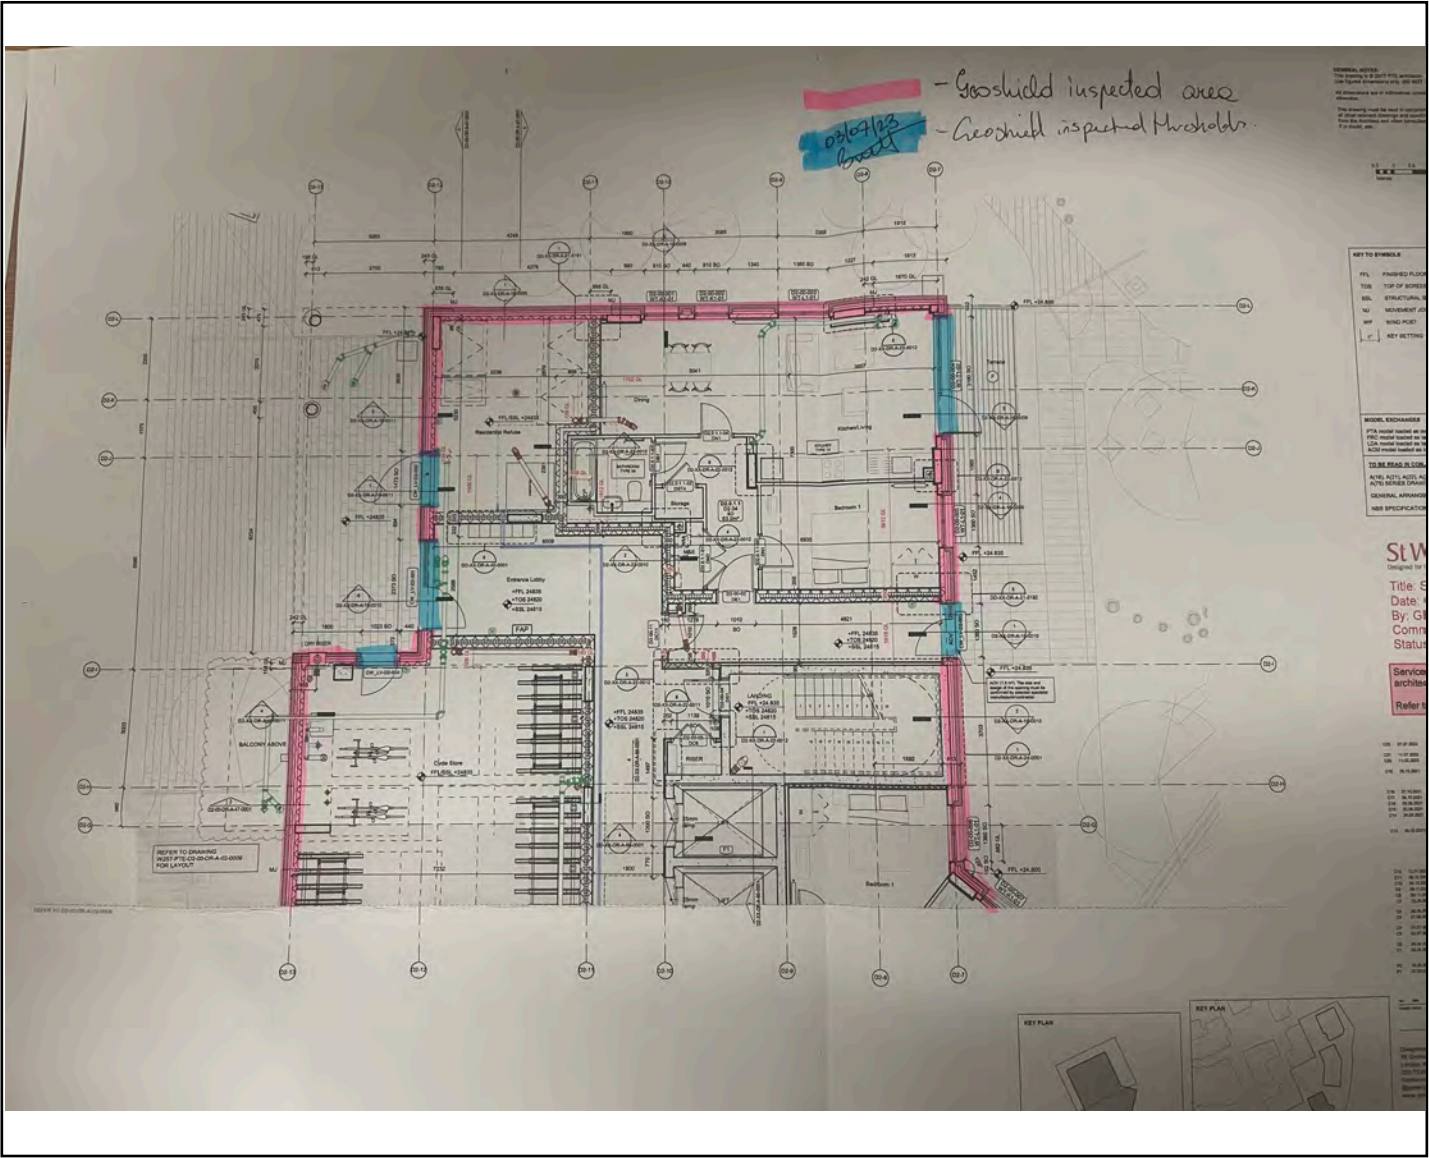
The areas highlighted in blue shows where the verification inspection took place

on site today. Threshold Detail - Block D2

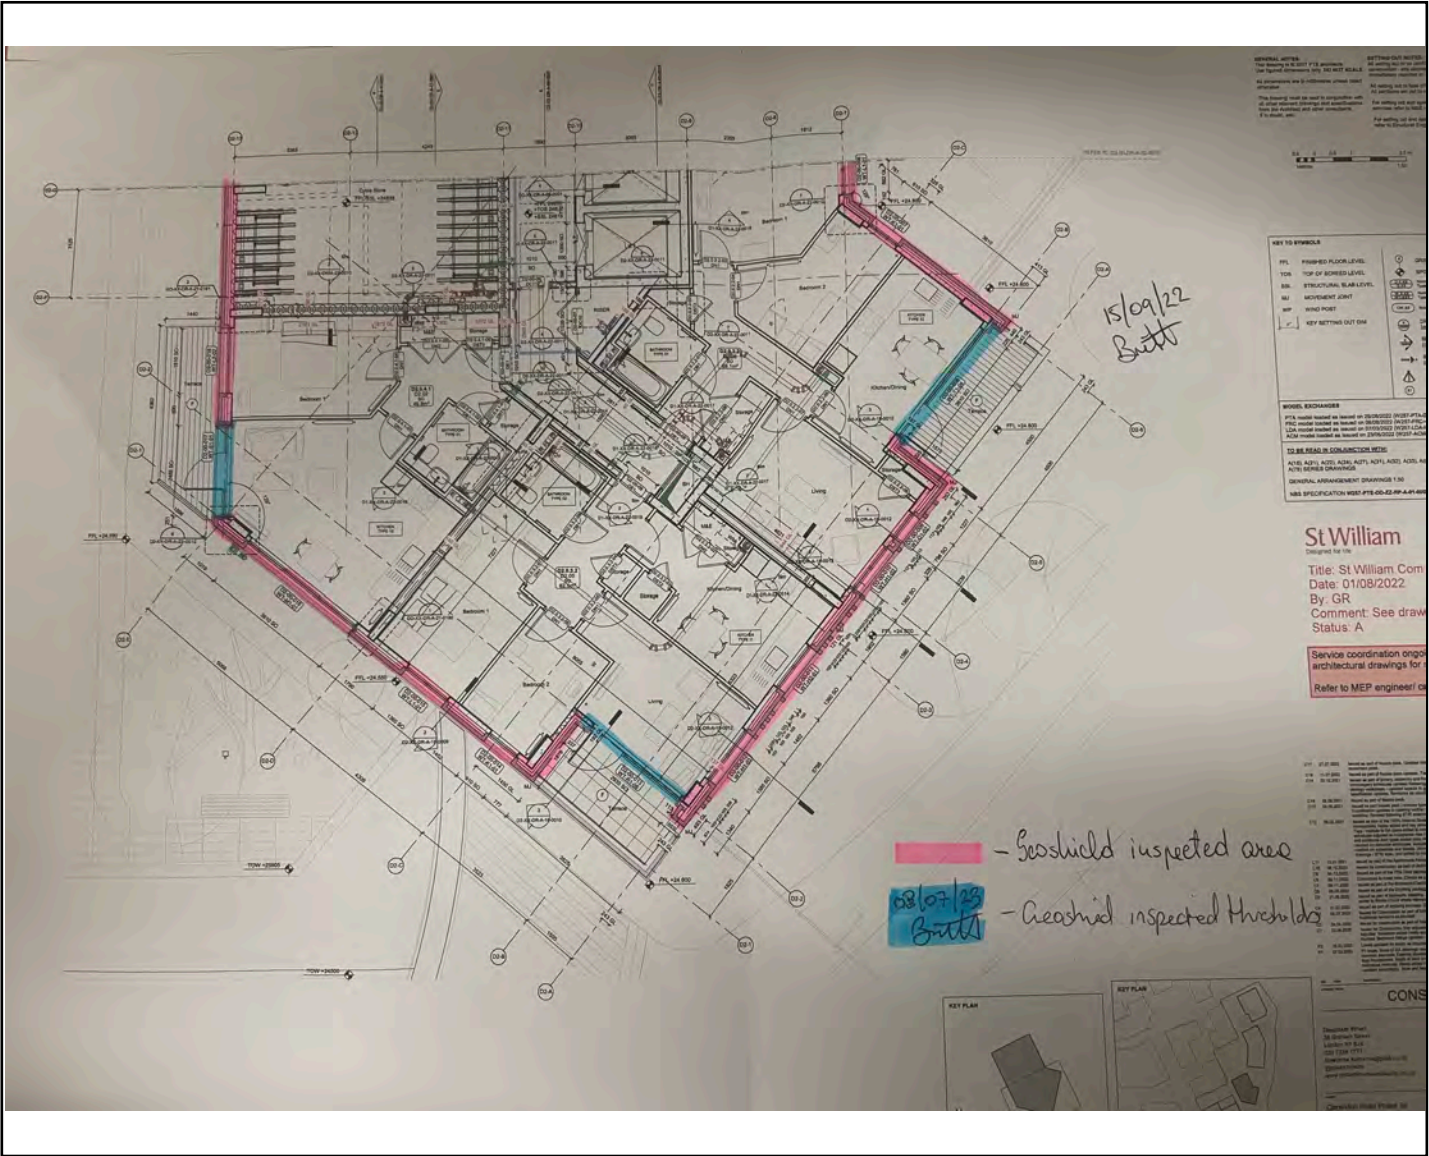
The areas highlighted in blue shows where the verification inspection took place

on site today. Threshold Detail - Block D2

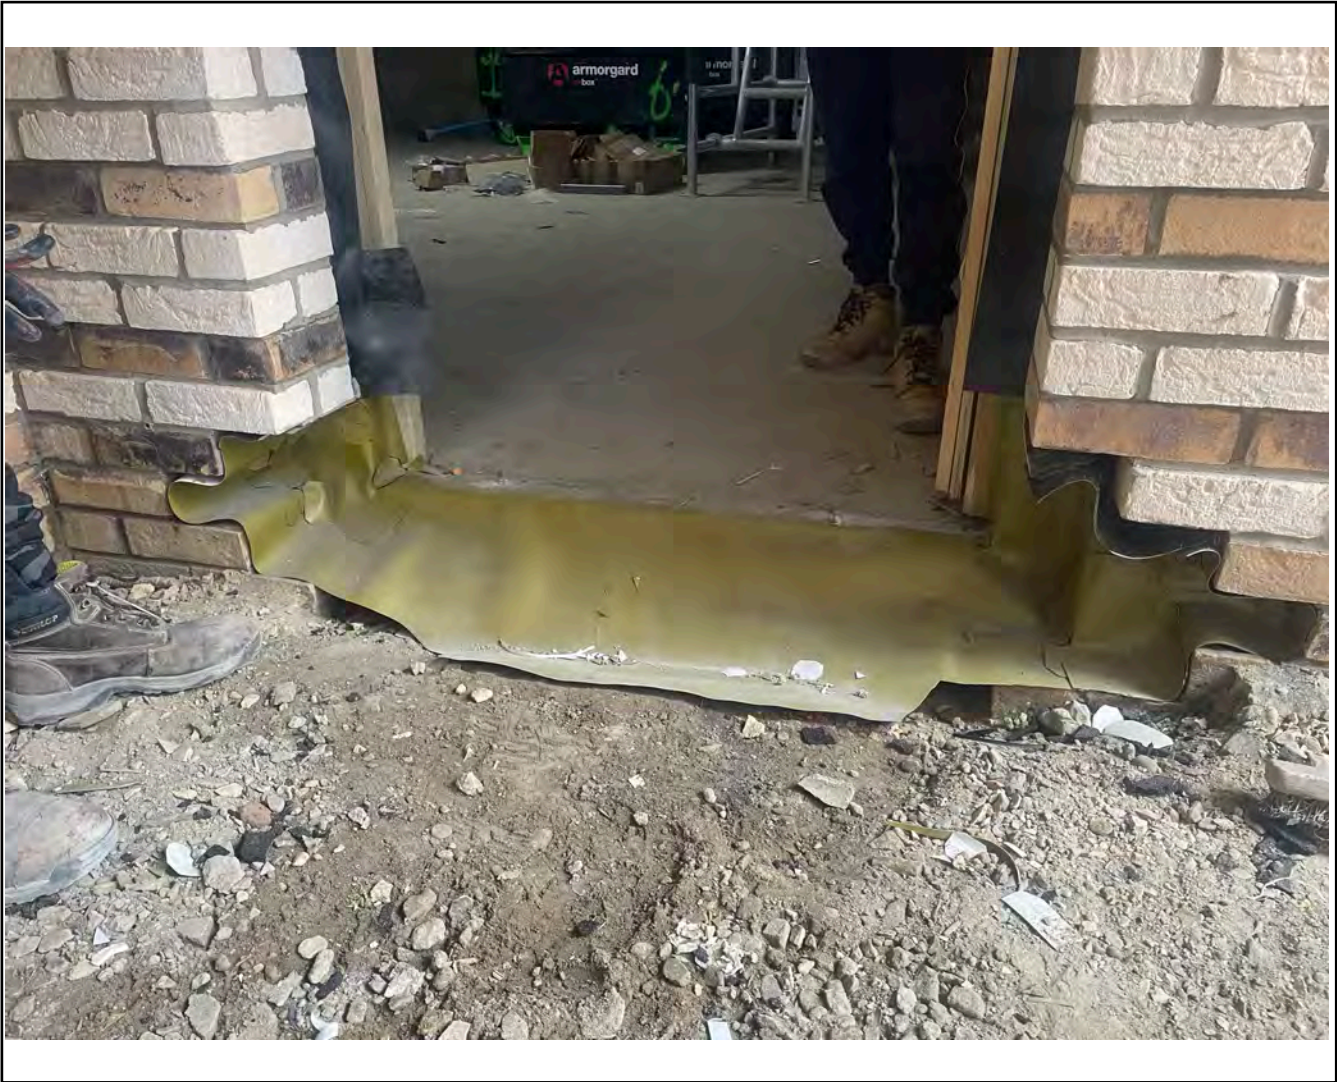
Threshold Detail - Block D2

The photograph above displays an overview of where today's

verification inspection took place on site.

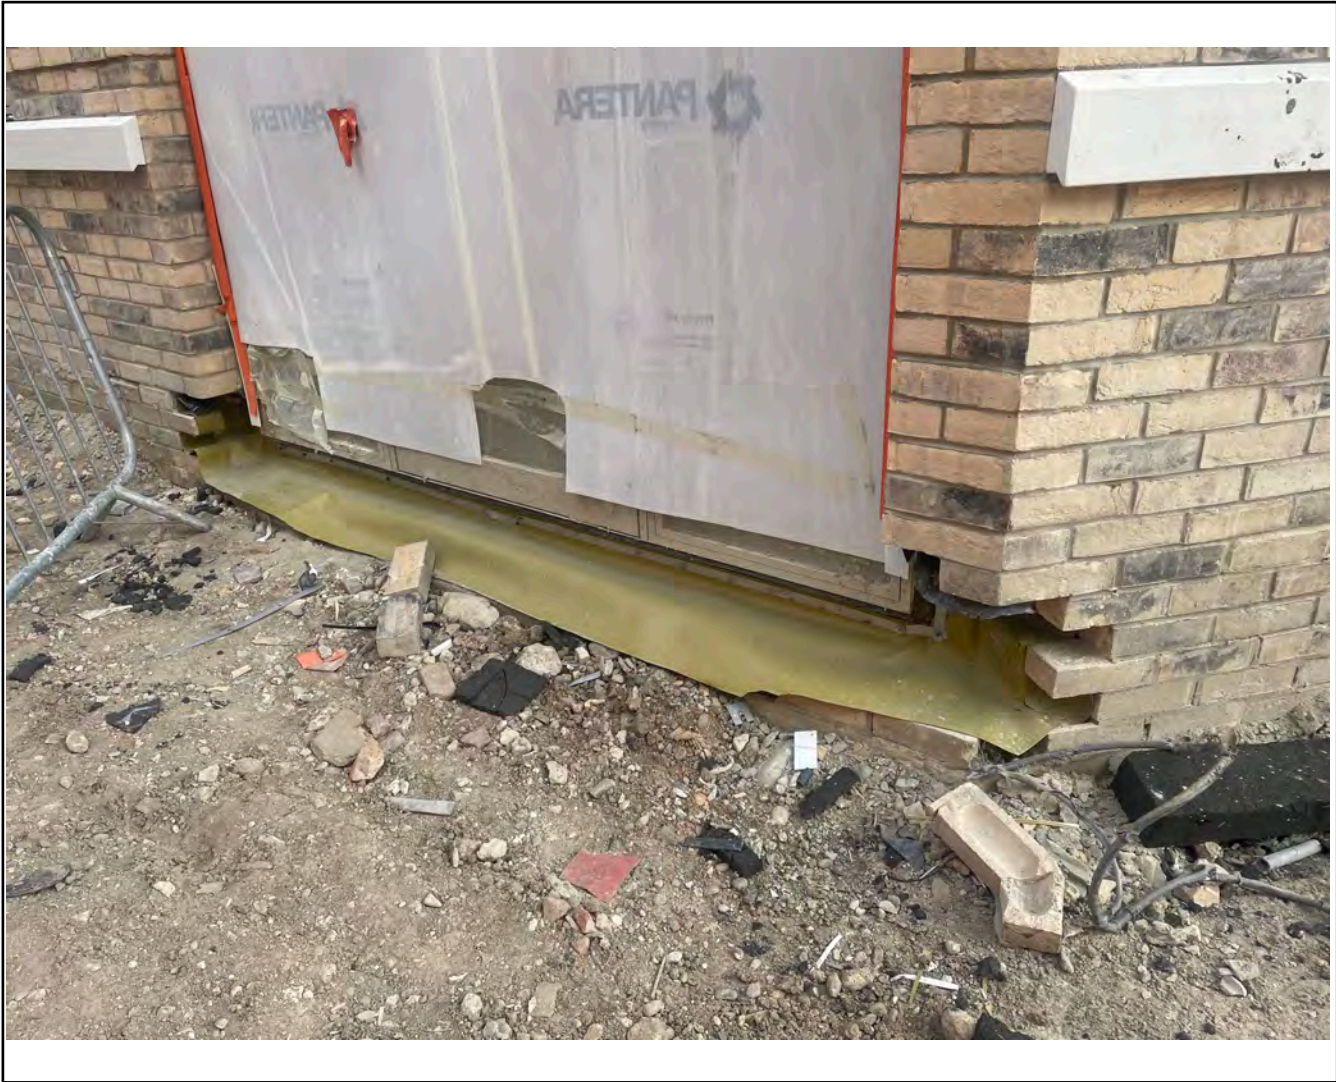
Threshold Detail - Block D2

The photograph above displays an overview of where today's

verification inspection took place on site.

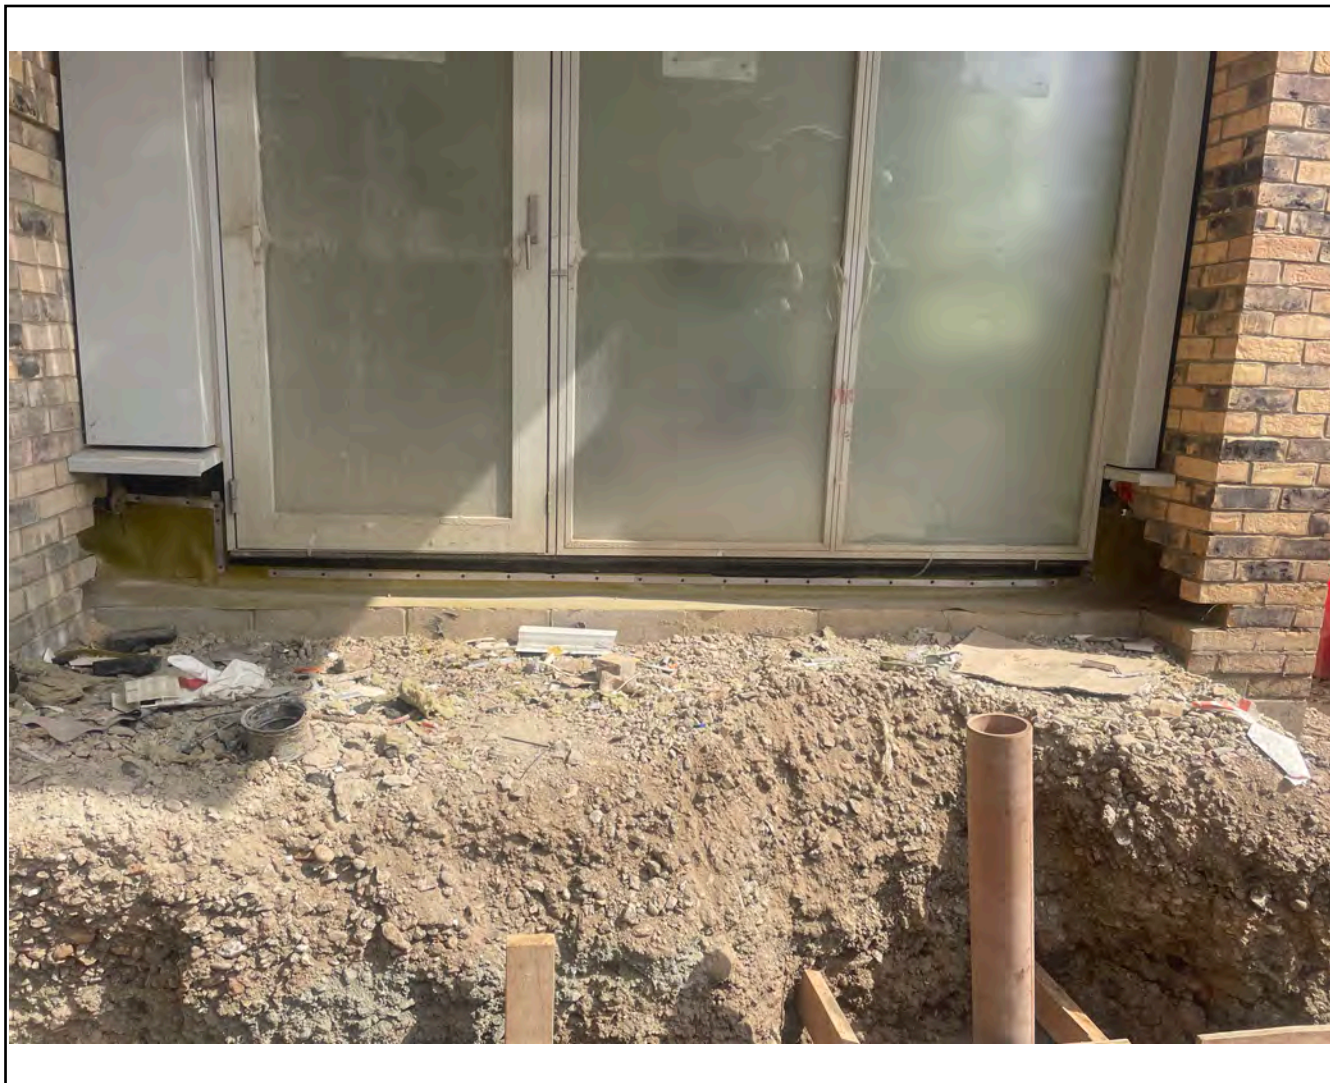
An alternate overview photograph of where the verification

inspection took place on site today.
