Civic Centre

Repair and restoration of the civic centre

Curtain Walling and Windows

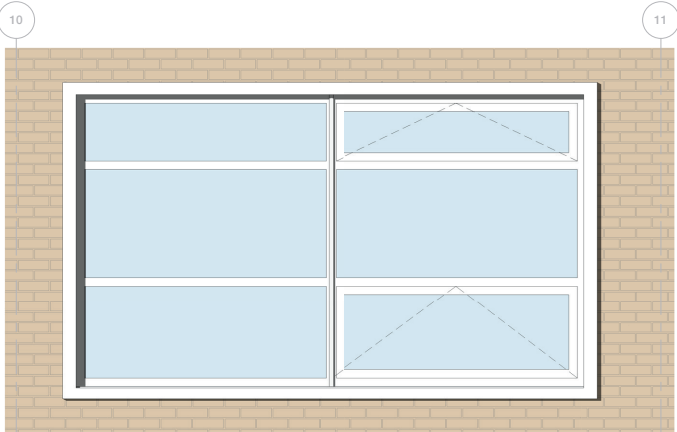
L10/331 - Typical Bay - Refer to 310313 & 310314  
1:20

- Aluminium stick system
- Generally Single glazed
- Inconsistent positioning of top-hung opening lights,
- Internally solar control film in places - in some locations this is degrading/peeling
- Sealant/beading has degraded and contains asbestos

The emerging preferred approach for the replacement of the existing aluminium windows is a steel system with a bespoke cover cap. Which will be coated in a finish to mimic the current anodised aluminium

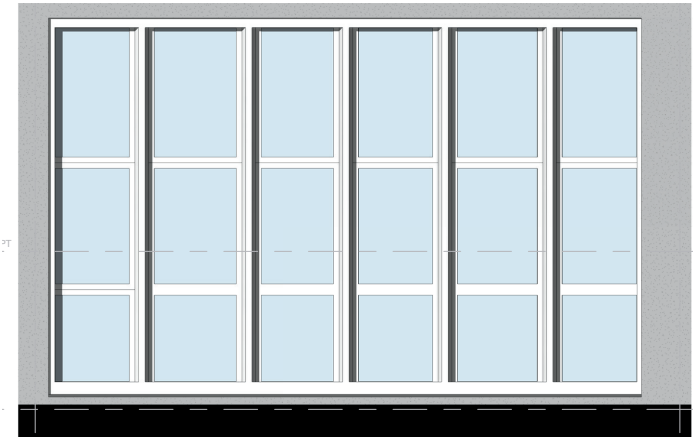
L10/332 - Typical Bay - Refer to 310313 & 310314  
1:20

- Steel window system
- Precast concrete surrounds in need of urgent repair (Repaired in places previously unsympathetically), not thermally broken and signs of water ingress.
- Generally Single glazed
- Inconsistent positioning of top-hung opening lights,
- Internally solar control film in places - in some locations this is degrading/peeling
- Sealant/beading has degraded
- Paint added to frames has degraded

The emerging approach for the replacement of the windows on the Third floor is a steel system with a bespoke cover cap. Which will be coated in a finish to mimic the current
