Existing Building

Key Internal Spaces - Council Chamber

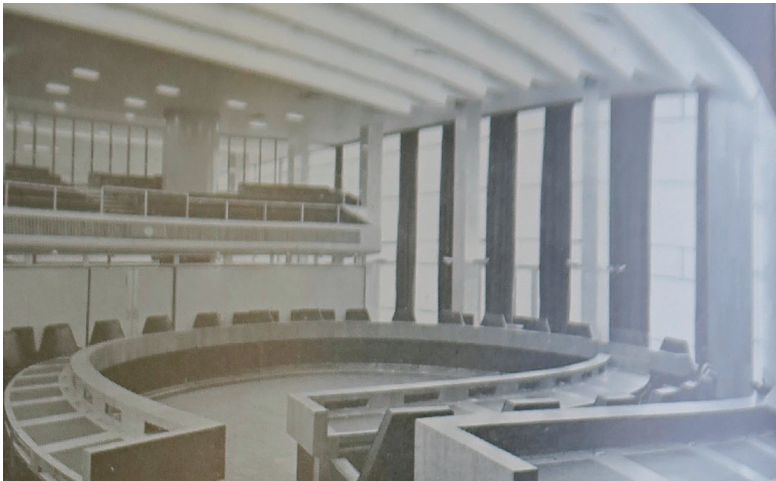
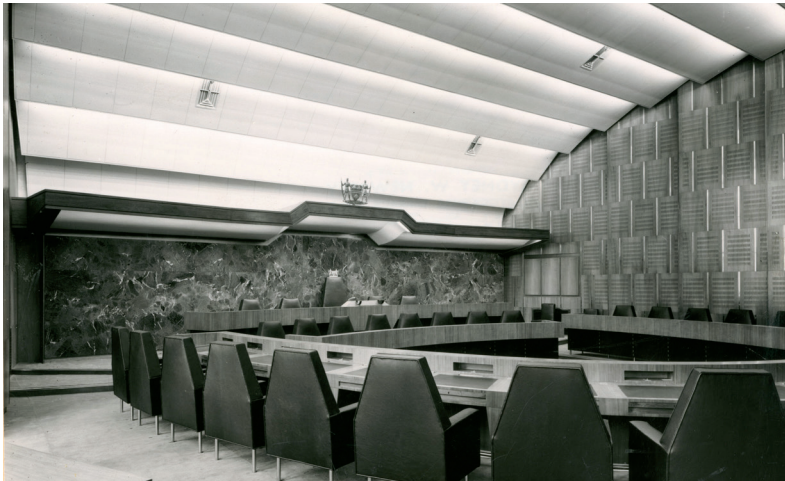
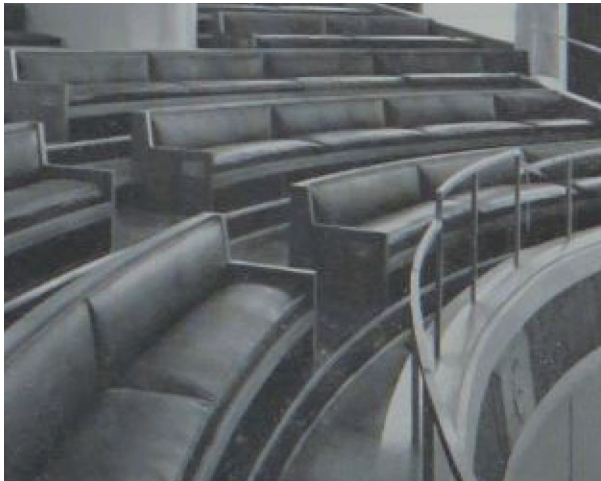
- Asbestos ceiling
- Timber panelling with brass inlays - brass tarnished
- Non-Original carpet
- Vertical Blinds
- Original brass clock removed

- Asbestos ceiling removed
- Carpet Removed & Blinds Removed (Curtain track retained)

Middle  
Pre-Enabling Works

Bottom  
Post-Enabling Works
