# **The Printworks, High Road West**

## **Structural Survey (Existing Buildings)**

**HRW-BHE-PW-XX-RP-S-0001**

28 July 2023

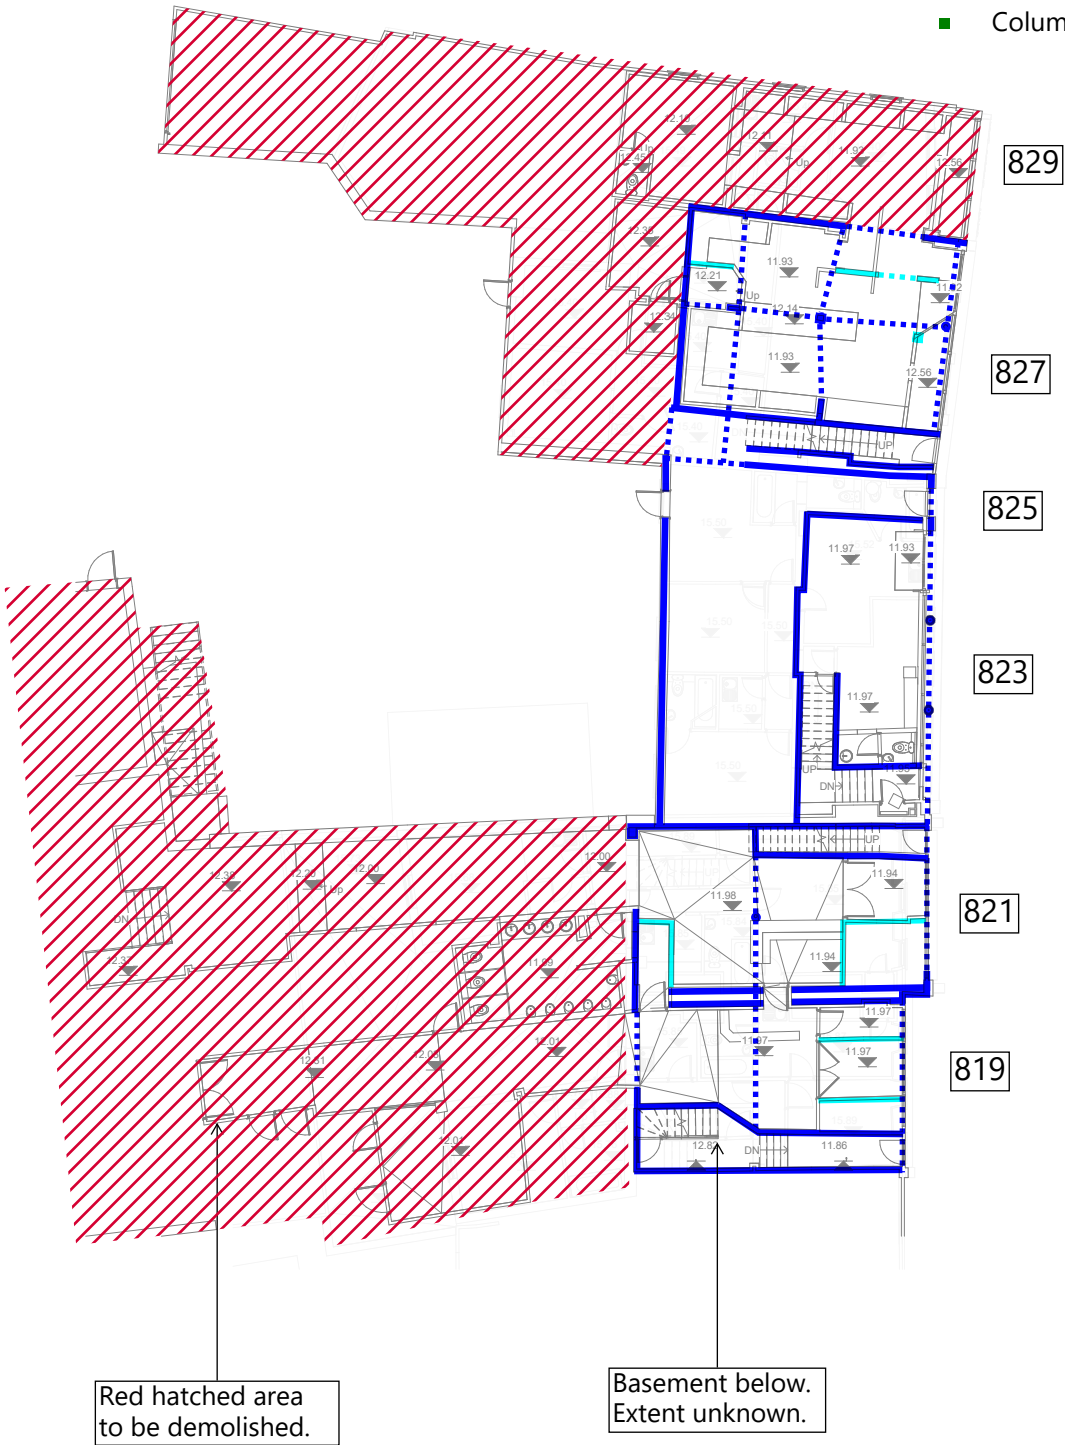
Mark up of existing layout

The layout of existing load bearing walls is working assumption based on typical floor plans and likely structure identified on site visit. Not to scale.
