THE  
CHOCOLATE  
FACTORY

## Arboricultural Impact Assessment Report

ARBORICULTURAL IMPACT ASSESSMENT REPORT  
BS 5837:2012 'Trees in relation to design, demolition and construction.  
Recommendations'

5 Clarendon Rd, London N22 6XJ

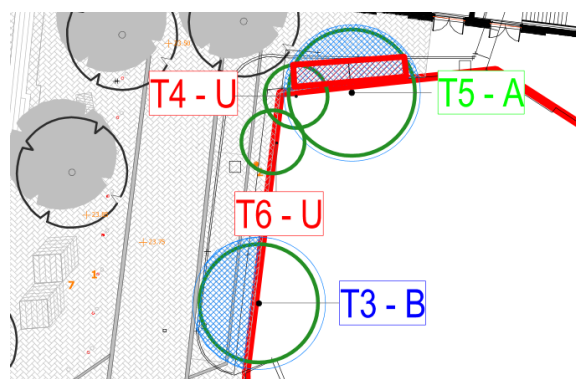
Plan 2 – extract from *SHA 261 TPP*. Do not scale. North

The silver birch trees' root protection areas extend under the pavement and bike shed. It is proposed that the surface will change, and that the bike stand will be removed.

Therefore, this report includes method statements at appendix 5 to ensure that root integrity and function remain. The proposed change to block paving is an improvement as it will allow gaseous exchange and water infiltration to the roots. The areas to which these method statements apply is shown on the plan *SHA 260 TPP* by blue cross hatching.
