# Haringey Civic Centre

Additional Architectural Information  
following LBH Carbon Management  
Response

HCC-HBA-XX-XX-RP-A-081001

## **Facade System Condition Survey**

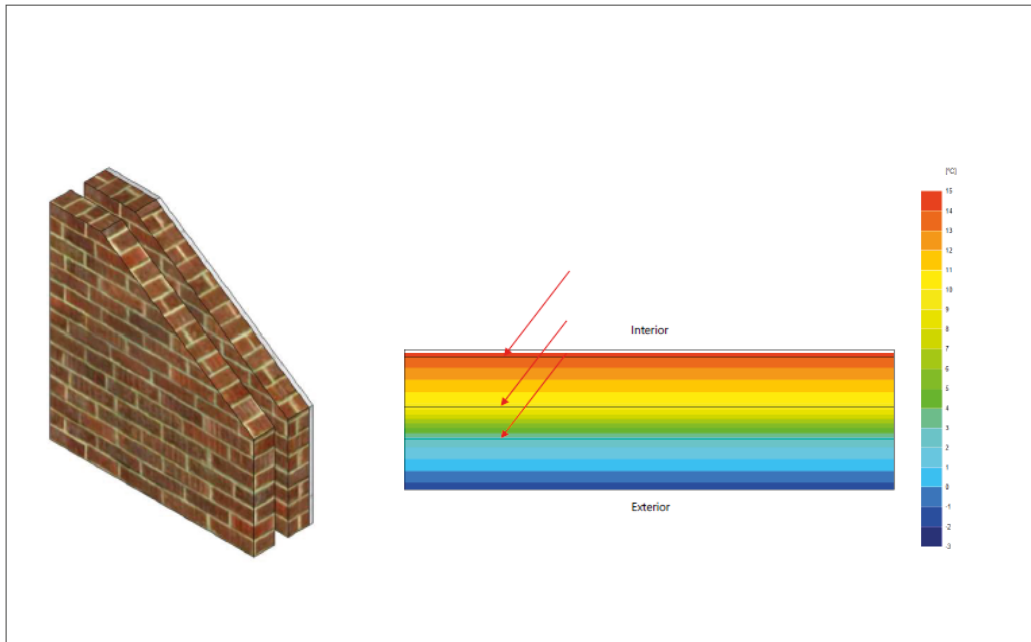
### Existing Uninsulated Cavity Wall

- Achieves U-Value c. 1.845 W/m<sup>2</sup>K
- Red arrows show the condensation risk

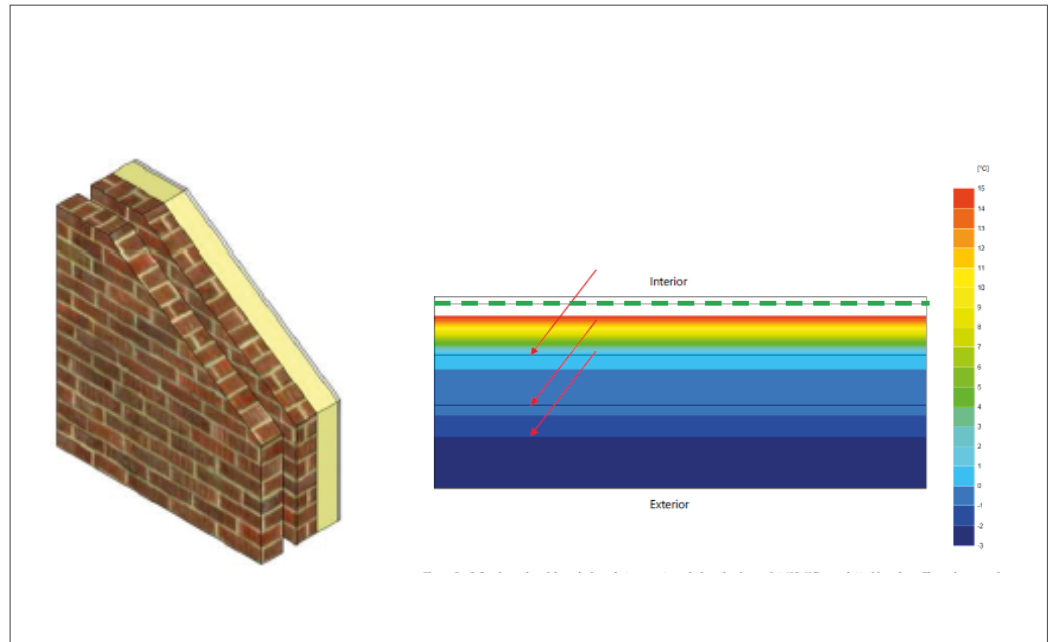
### Proposed Internal Insulation

- Achieves U-Value c. 0.3 W/m<sup>2</sup>K
- Red arrows show the condensation risk
- VCL (green dashed line) implemented to mitigate condensation risk

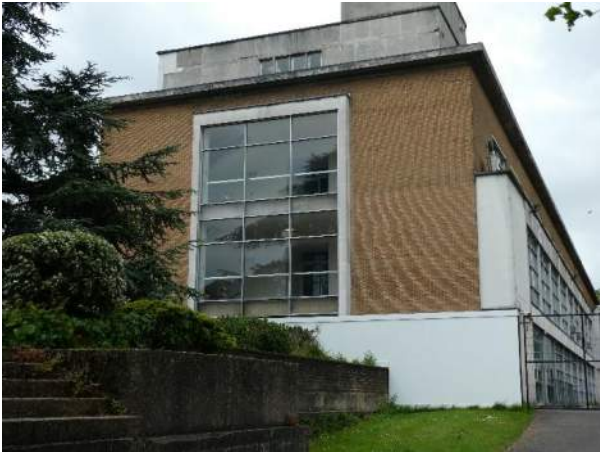
| Selected Photos from Site Inspections<br>Façade Type: Brickwork (1 of 3) | |
|---|---|
| <p><b>Photo 1:</b> East elevation brickwork façade</p> | <p><b>Photo 2:</b> South elevation brickwork façade</p> |

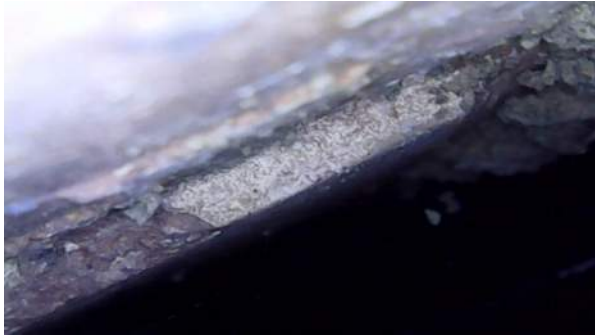
| Selected Photos from Site Inspections<br>Façade Type: Brickwork (1 of 3) | |
|---|---|
| <p><b>Photo 3:</b> Intrusive investigation at location B1, internal, exposing ties and rear face of external brickwork leaf</p> | <p><b>Photo 4:</b> Intrusive investigation at location B2, internal, endoscope imaging, possible corroded metal shelf angle supporting external brickwork leaf</p> |

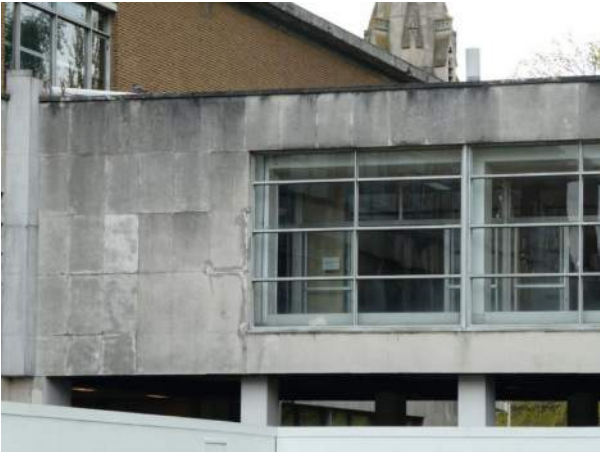
| Selected Photos from Site Inspections<br>Façade Type: Precast Concrete Cladding (1 of 3) | |
|---|---|
| <p><b>Photo 13:</b> Precast concrete cladding at Level 1 on North elevation of 'Western wing'</p> | <p><b>Photo 14:</b> Precast concrete cladding at Level 2 on West elevation</p> |

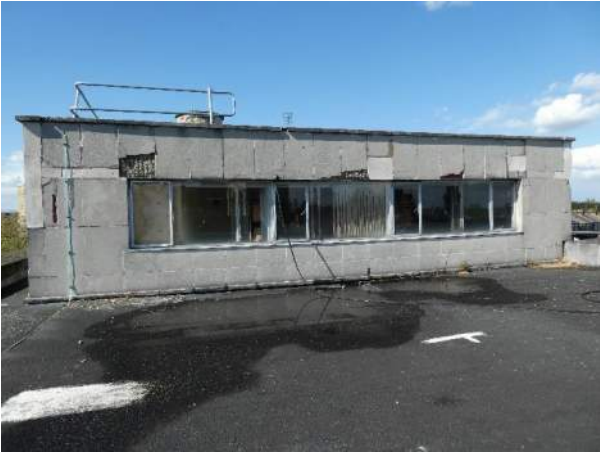
- Panels at level 3 in much worse condition with concrete spalling and extensive reinforcement corrosion generally, replacement of a large number of panels at this level may be needed.

| Selected Photos from Site Inspections<br>Façade Type: Precast Concrete Cladding (1 of 3) | |
|---|---|
| <p><b>Photo 15:</b> Precast concrete cladding at Level 3 on South elevation</p> | <p><b>Photo 16:</b> Precast concrete cladding at Level 3 on West elevation</p> |

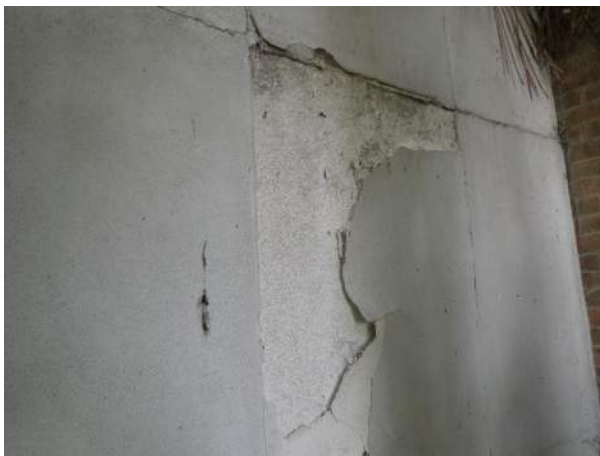
**Photo 19:** Patchy/peeling render on precast concrete panels adjacent to entrance

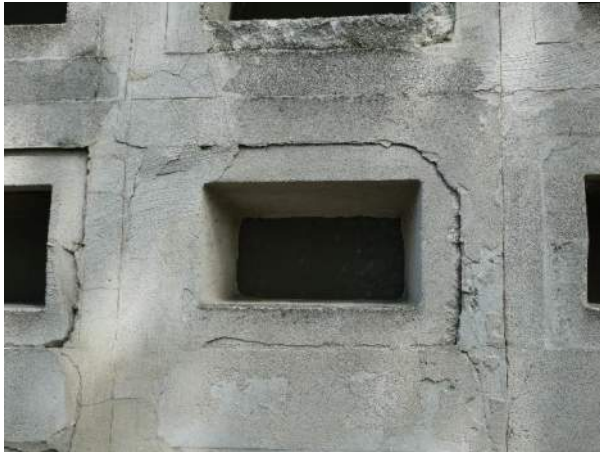
**Photo 21:** Punched windows in precast concrete panels on West elevation (with some glazing replaced with wooden sheets)

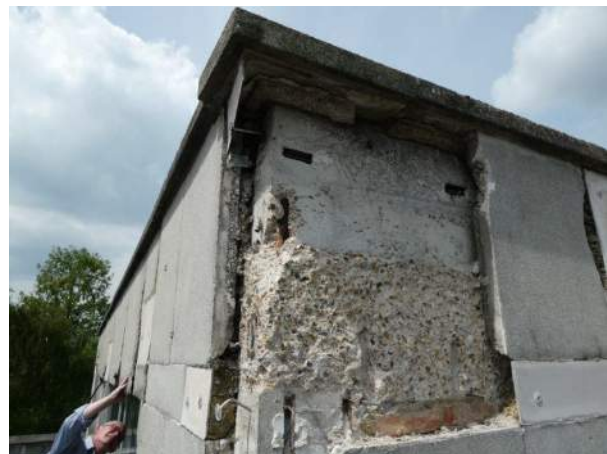
**Photo 24:** Intrusive investigation location P2, concrete behind with cast-in channels and concrete fill in cavity

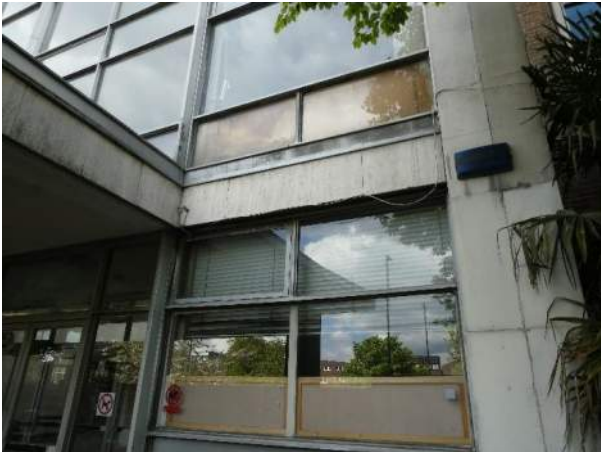
| Selected Photos from Site Inspections<br>Façade Type: Stone Cladding (1 of 1) | |
|---|---|
| <p><b>Photo 25:</b> Stone cladding strip around entrance on East elevation</p> | <p><b>Photo 26:</b> Stone cladding on 'canopy' columns</p> |

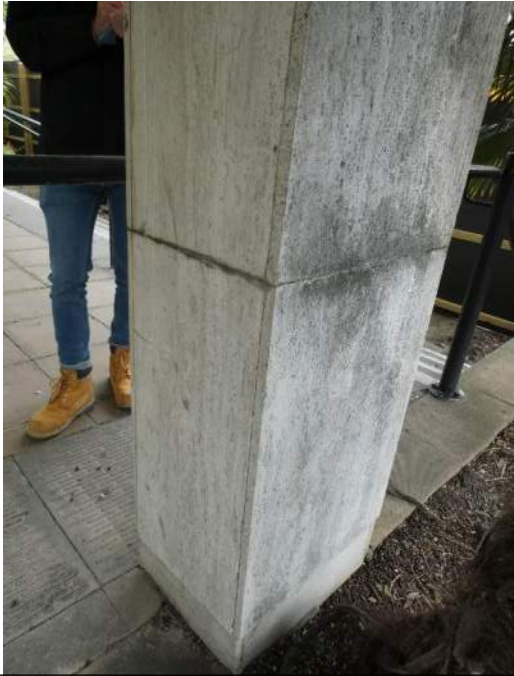
- Further check of integrity of fixings is recommended.
- Stone cladding
  - Stone cladding in fair condition, appears to be soundly supported apart from the larger panels around the canopy columns which appear dislodged and will require refixing.

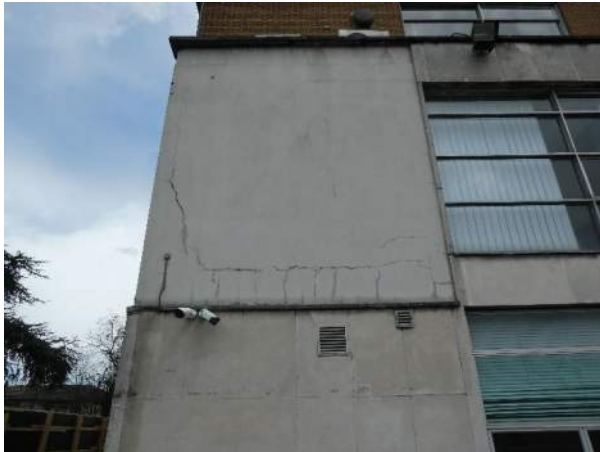
- Some cracked tiles will require repair or replacement, cleaning is recommended.
- Render system
  - Render system appears to be at end of service life and extensive cracking is visible, will require removal and new render being applied.

**Photo 29:** Render on North-West corner, with extensive cracking

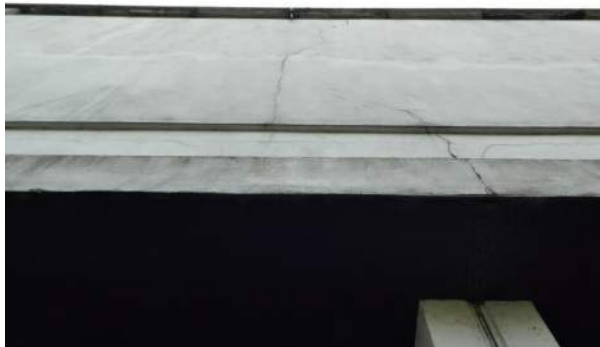
**Photo 31:** Cracking on North elevation of 'West Wing', at movement joint location

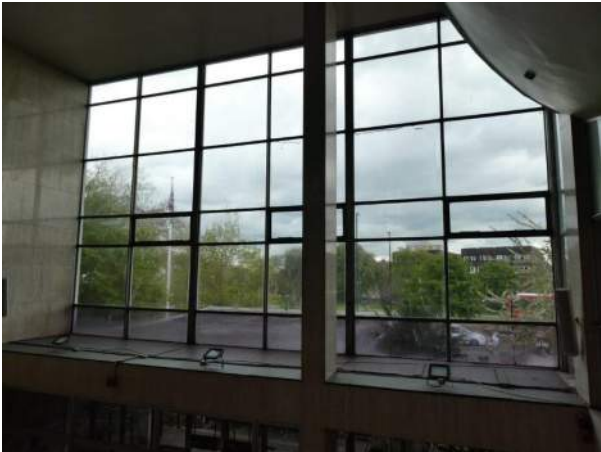
| Selected Photos from Site Inspections | |
|---|---|
| Photo 33: Aluminium curtain walling above entrance, East elevation | Photo 34: Aluminium window system, West elevation, Level 2 |

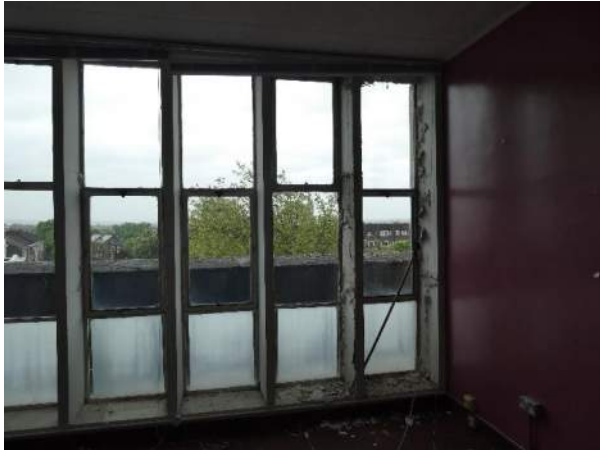
**Photo 41:** Steel window system, East elevation, level 3, showing significant moisture ingress

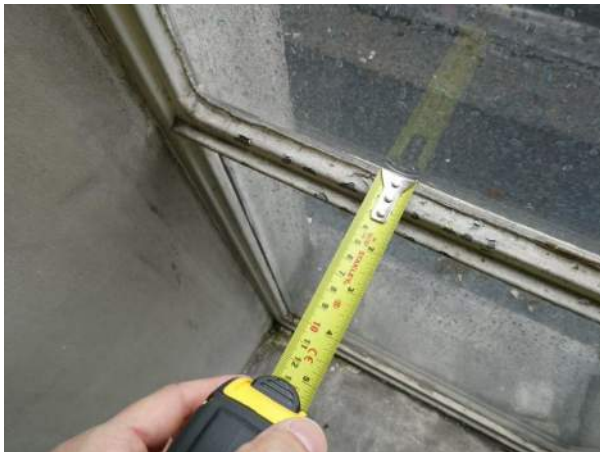
**Photo 43:** Peeling paint/coating on steel window system internally

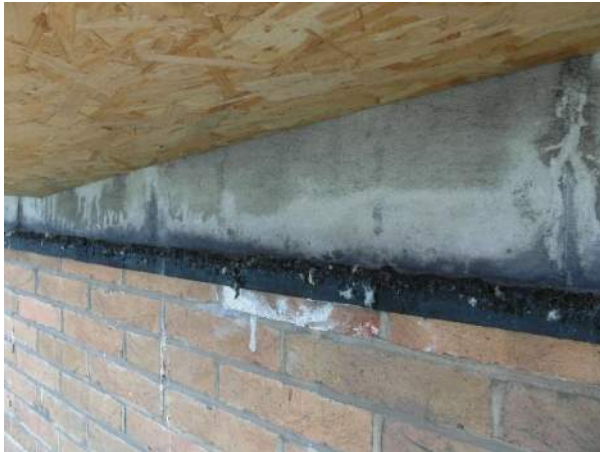
**Photo 45:** Cornice at third floor showing exposed vertical concrete face, and lead flashing above brickwork (1)

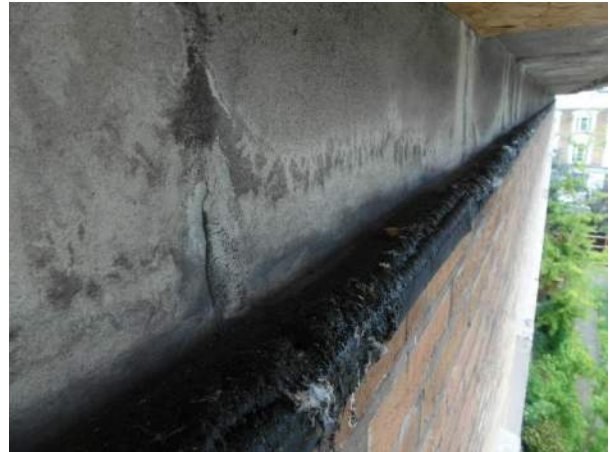
**Photo 46:** Cornice at third floor showing exposed vertical concrete face, and lead flashing above brickwork (2)

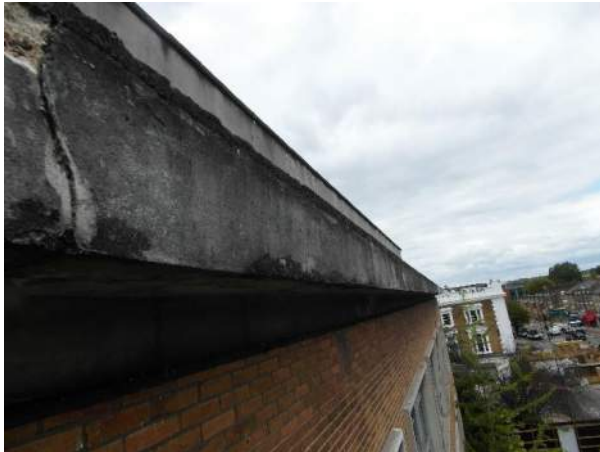
**Photo 49:** Degradation of concrete cornice above brickwork

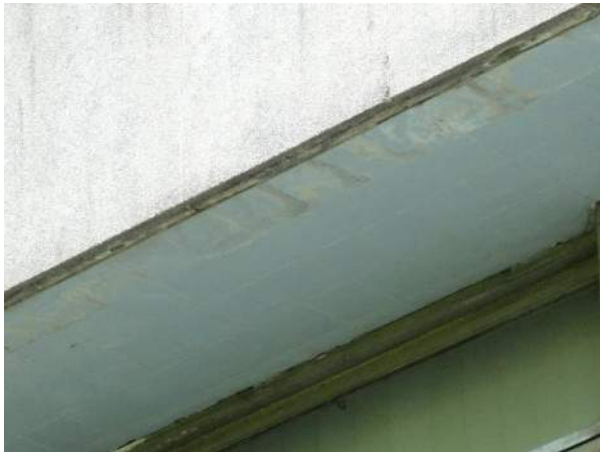
**Photo 53:** Tiled area at West wing building – not accessible for close inspection

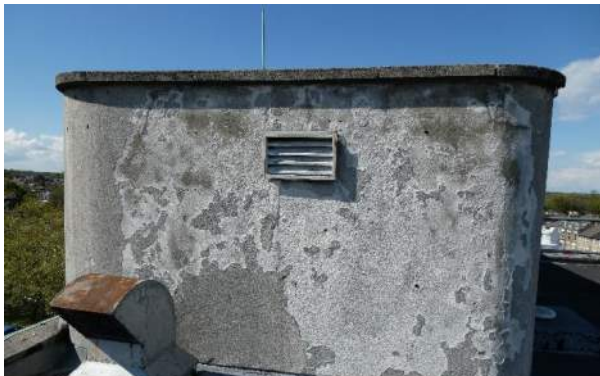
**Photo 55:** Render layer peeling off concrete wall

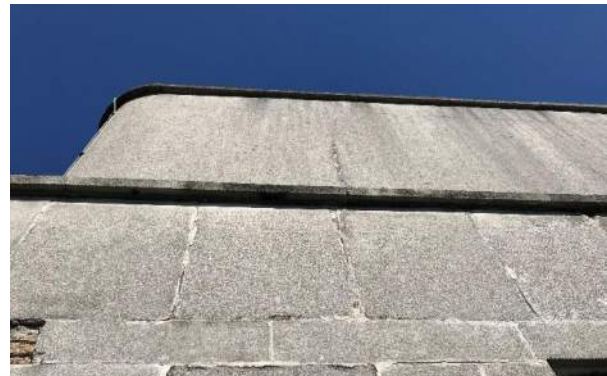
**Photo 56:** Crack in render on roof outbuilding

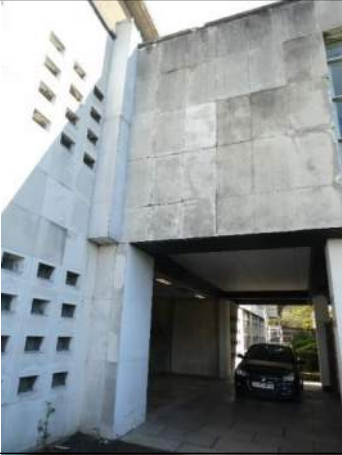
| Selected Photos from Site Inspections<br>Façade Type: Other Items (2 of 7) | |
|---|---|
| Photo 57: Concrete skim patchy | Photo 58: Spalling of concrete around opening |

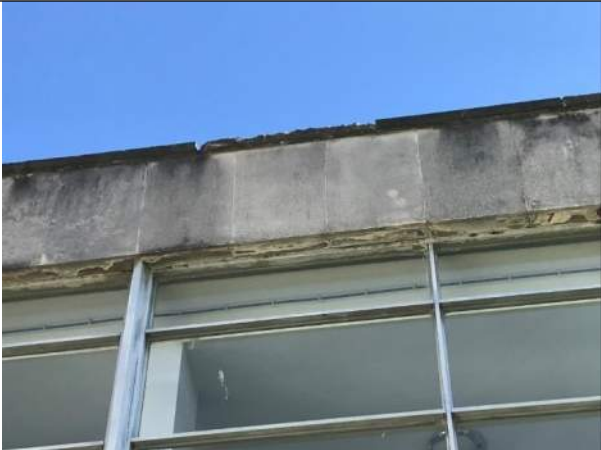
| Selected Photos from Site Inspections<br>Façade Type: Other Items (2 of 7) | |
|---|---|
| Photo 59: Decayed coping stones | Photo 60: Concrete decayed above windows, reinforcement exposed |

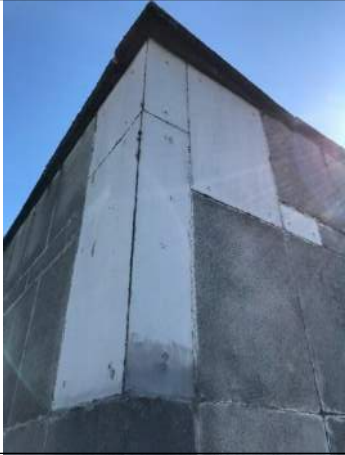
| Selected Photos from Site Inspections<br>Façade Type: Other Items (3 of 7) | |
|---|---|
| Photo 63: Wood panels replacing missing precast concrete cladding elements | Photo 64: Glazing in punched concrete panels replaced with wood |

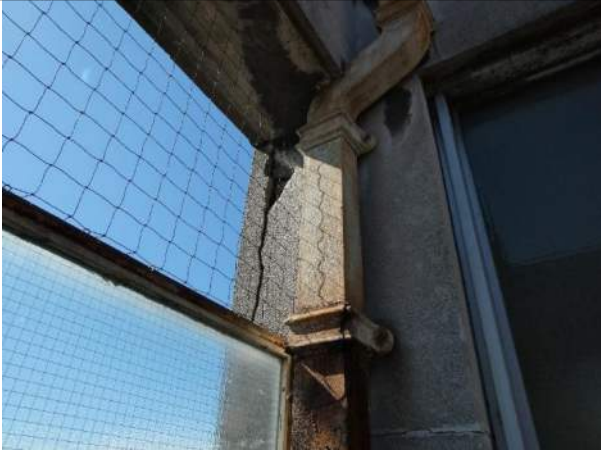
| Selected Photos from Site Inspections<br>Façade Type: Other Items (4 of 7) | |
|---|---|
| Photo 69: Cracks in concrete | Photo 70: Movement joint in brickwork façade |

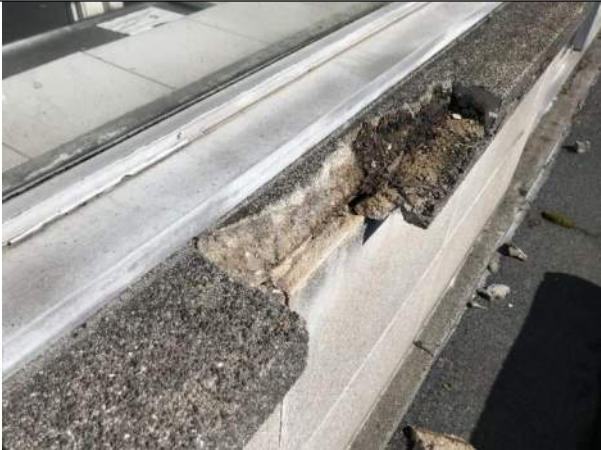
| Selected Photos from Site Inspections<br>Façade Type: Other Items (4 of 7) | |
|---|---|
| Photo 71: Decayed concrete at window details | Photo 72: Water run-off at window cill |

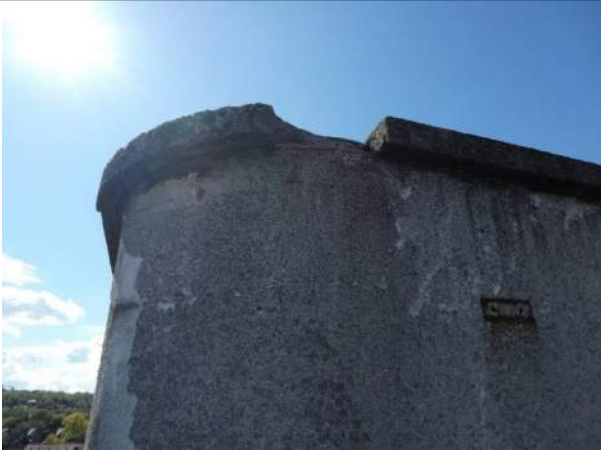
| Selected Photos from Site Inspections<br>Façade Type: Other Items (5 of 7) | |
|---|---|
| Photo 75: Broken coping | Photo 76: Cracks in concrete fins |

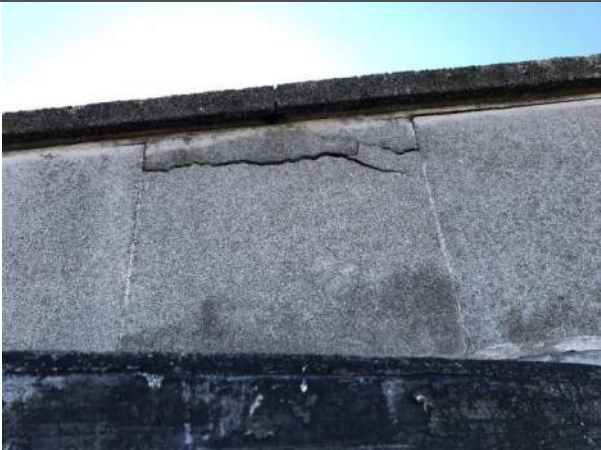
| Selected Photos from Site Inspections<br>Façade Type: Other Items (5 of 7) | |
|---|---|
| Photo 77: Cracks in concrete panels | Photo 78: Stone coping dislodged |

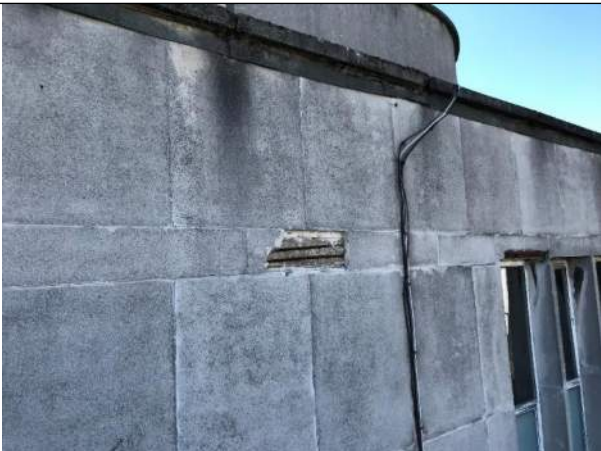
| Selected Photos from Site Inspections<br>Façade Type: Other Items (5 of 7) | |
|---|---|
| Photo 79: spalled concrete, exposed reinforcement (note: no evidence of red oxide paint / possible recent event) | Photo 80: Vertical mortar joints misaligned in brickwork |

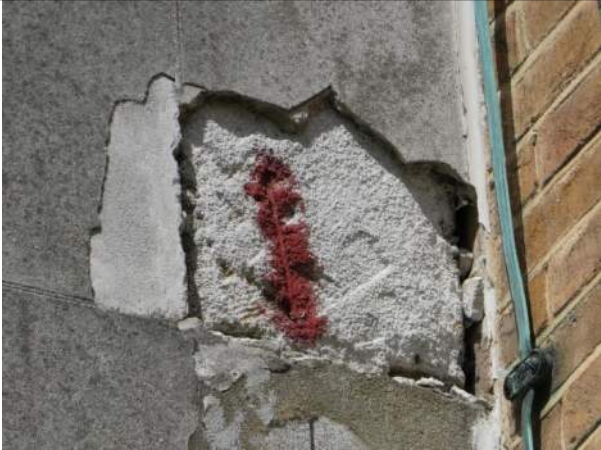
| Selected Photos from Site Inspections<br>Façade Type: Other Items (6 of 7) | |
|---|---|
| Photo 81: spalled concrete and exposed reinforcement | Photo 82: Aluminium flashing above travertine panels |

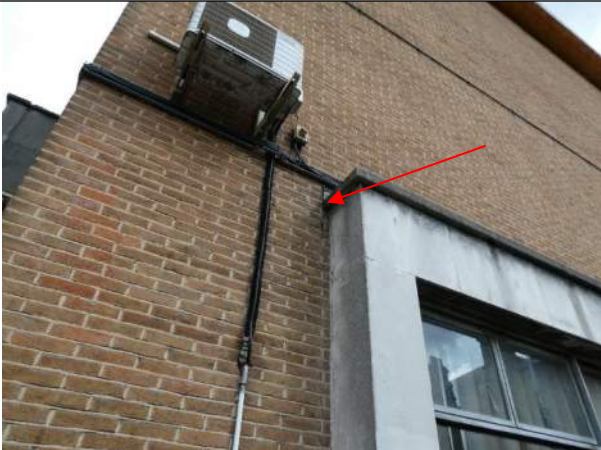
| Selected Photos from Site Inspections<br>Façade Type: Other Items (6 of 7) | |
|---|---|
| Photo 83: Crack in brickwork | Photo 84: Stained concrete panels |

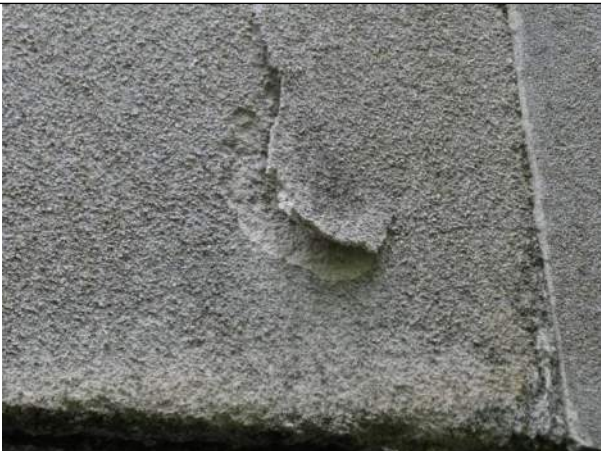
| Selected Photos from Site Inspections<br>Façade Type: Other Items (6 of 7) | |
|---|---|
| Photo 85: Start of spalling in concrete | Photo 86: Decayed/broken coping stones |

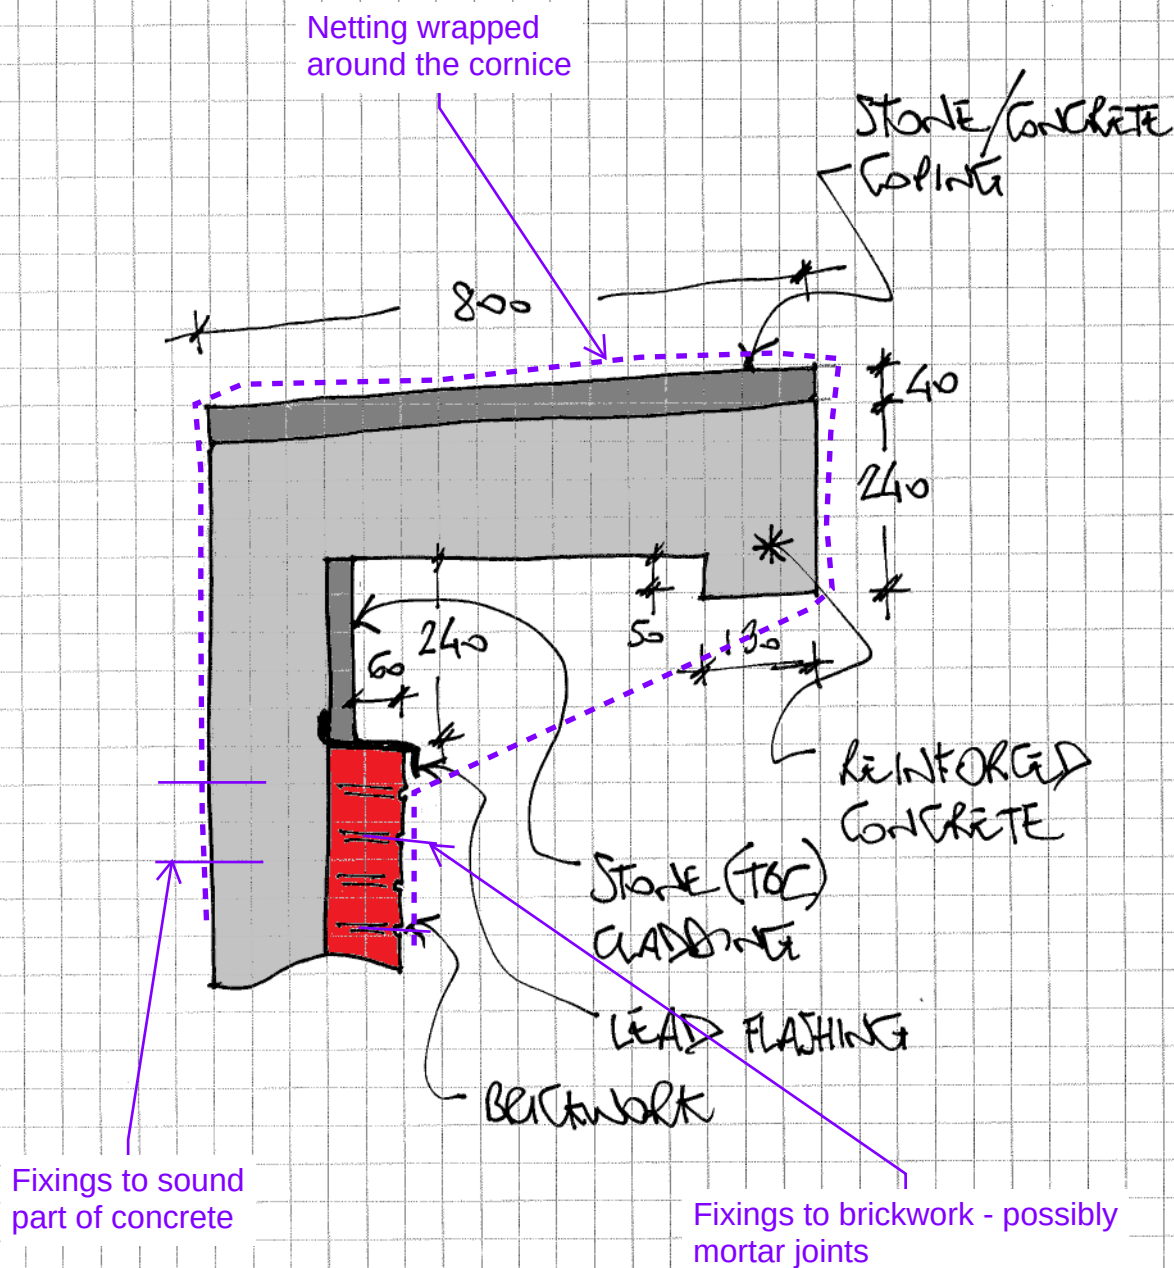
THIRD FLOOR TOP CORNICE

- a. There is evidence of portions of concrete spalling and falling off the cornice due to corrosion of the reinforcement. This is more likely in extreme weather conditions.

- b. This process is progressive and will continue until a thorough refurbishment of the feature is completed including refacing of the concrete.
  - c. Temporary protection to part of the East elevation cornice has been fitted to avoid detaching parts of material falling down to the pavement: in our opinion this form of protection is not the most effective: the Sterling board panels are not durable if exposed to the weather, and in fact evidence of deterioration is visible especially on the panels fitted to the outermost vertical face of the concrete. Also, the panels are fixed to concrete with shallow screws which are prone to failure especially in highly carbonated and cracked concrete – a panel is already detaching from the bottom face of the cornice (Photo 10c). Furthermore, the boards do not allow the water to run-off the concrete surface thus aggravating the whole corrosion issue. Finally, there is the added risk of detached material accumulating behind the boards and falling all at once.

- d. For the reasons listed above, it is our opinion that a different system should be used to protect the people accessing the building: we are not able to provide a design for it as this is outside our scope, but in principle our recommendation would be to provide a safety mesh fixed to sound parts of concrete to the inside of the building and to the brickwork on the outside. The mesh should be able to retain the larger pieces of concrete which should detach from the main structure and at the same time allow water to run-off the concrete surface. Please see sketch SK-003.

- h. There will remain a risk of smaller portion of concrete falling through the mesh, therefore our recommendation is to enforce obligation to wear PPEs including hard hat to all visitors and contractors accessing the building – including the guardians when they walk around the perimeter.

POSSIBLE TEMPORARY PROTECTION  
NOTE: TO BE DESIGNED BY OTHERS

NOTE:  
WEARING PPEs INCLUDING HARD HAT TO BE  
MADE MANDATORY TO ACCESS THE BUILDING

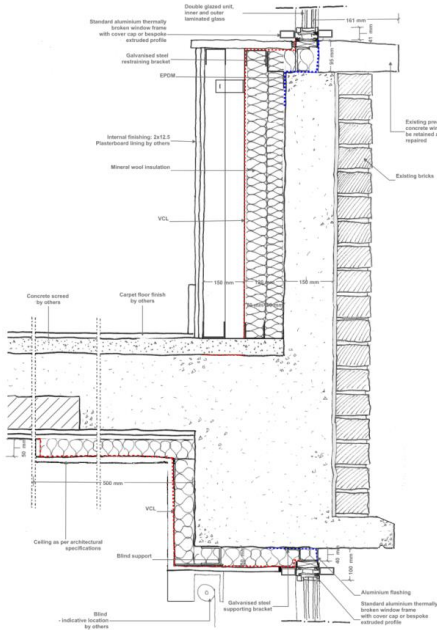
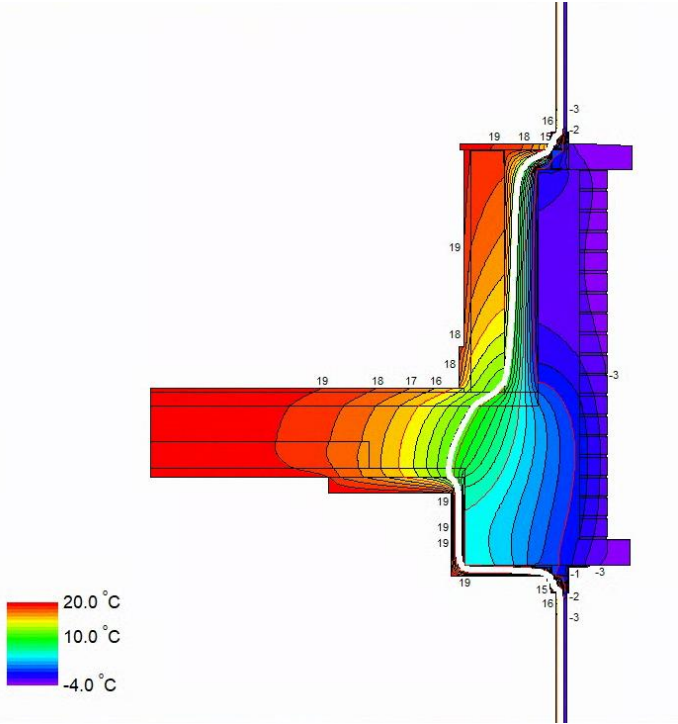
| Boundary conditions | | Detail | Condensation analysis results | Comments |
|---|---|---|---|---|
| <ul style="list-style-type: none"><li><b>Internal Temperature:</b><br/>21° as per MEP Engineer report.</li><li><b>External Temperature:</b><br/>-4° as CWCT standard for condensation analysis</li><li><b>Relative humidity (RH):</b><br/>RH=55%, considered as a conservative assumption for office buildings. The value indicated in the MEP report is 70% / uncontrolled which is not applicable for an office building.</li><li><b>Dew point:</b><br/>11.6°C, calculated considering the RH and the Internal temperature indicated.</li></ul> | D01 | | <p>Dew point line in white.</p> | <p>All the section parts analysed were considered 1000mm wide as the standard suggests and to show a better distribution of the thermal lines.</p> <p>Insulation is positioned to the inner face of the existing wall, to achieve the required thermal performance and leave the outer finishing layer visible.</p> <p>Additional ceiling insulation was considered to avoid thermal bridges.</p> <p>VCL is required between the insulation and plasterboard layer to prevent possible condensation phenomena.</p> |

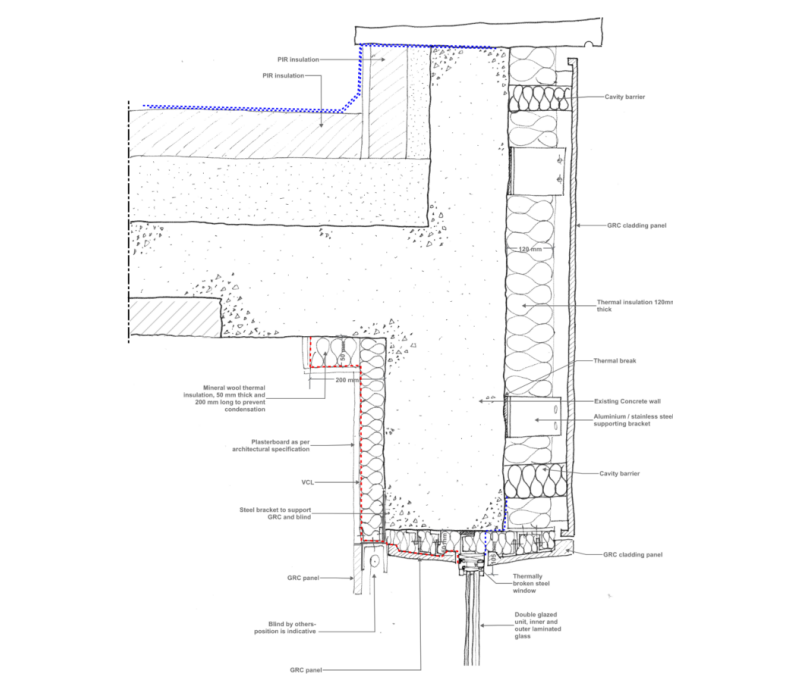
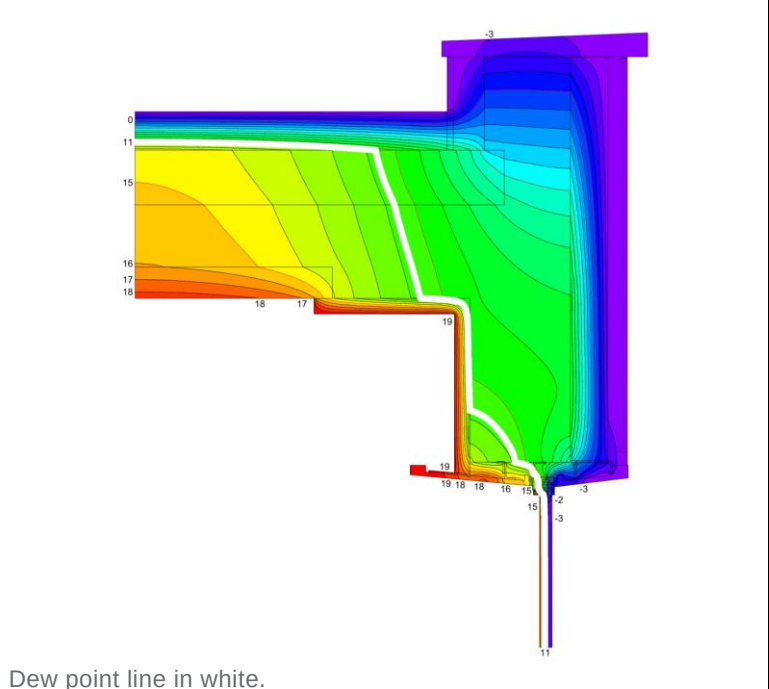
| Boundary conditions | | Detail | Condensation analysis results | Comments |
|---|---|---|---|---|
| <ul style="list-style-type: none"><li><b>Internal Temperature:</b><br/>21° as per MEP Engineer report.</li><li><b>External Temperature:</b><br/>-4° as CWCT standard for condensation analysis</li><li><b>Relative humidity (RH):</b><br/>RH=55%, considered as a conservative assumption for office buildings. The value indicated in the MEP report is 70% / uncontrolled which is not applicable for an office building.</li><li><b>Dew point:</b><br/>11.6°C, calculated considering the RH and the Internal temperature indicated.</li></ul> | D08 | | <p>Dew point line in white.</p> | <p>Insulation is placed outside the structural wall to achieve the required façade thermal performances. Brackets and cavity barrier are placed between the wall and GRC rainscreen.</p> <p>Additional internal soffit insulation was required to avoid thermal bridges.</p> <p>VCL is required between the insulation and plasterboard layer to prevent possible condensation phenomena.</p> |
