# **Hutton + Rostron Environmental Investigations Limited**

## **Hornsey Town Hall: Façade masonry condition investigation**

**Site note 1 for 3 and 8 August 2018, job no. 405.73**

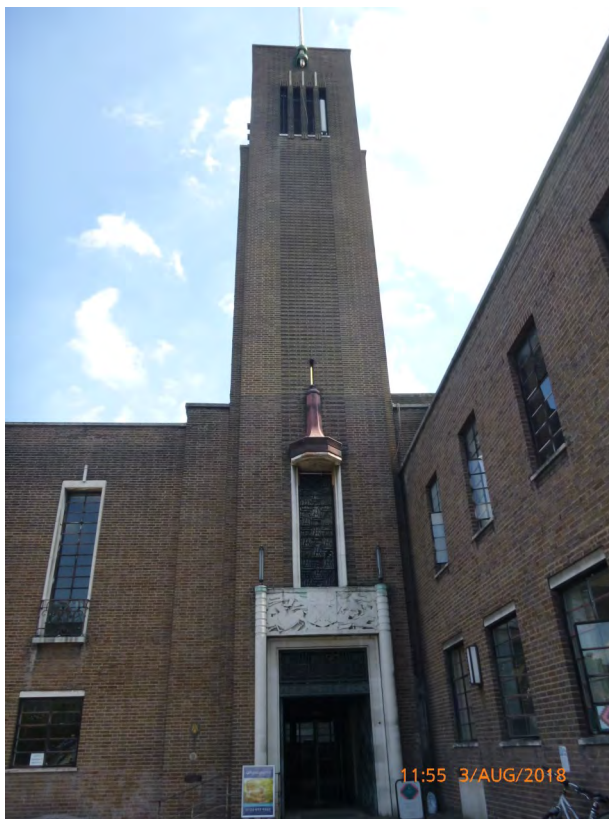
**Fig 1:**

Elevation 1; showing general view.  
Note previous re-point to parapet

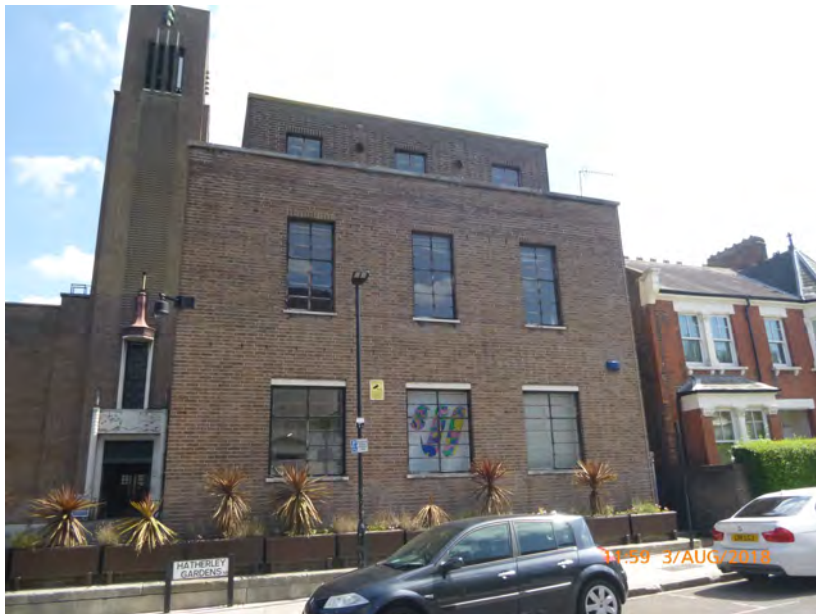
**Fig 13:**

Elevation 1; showing general view of south part

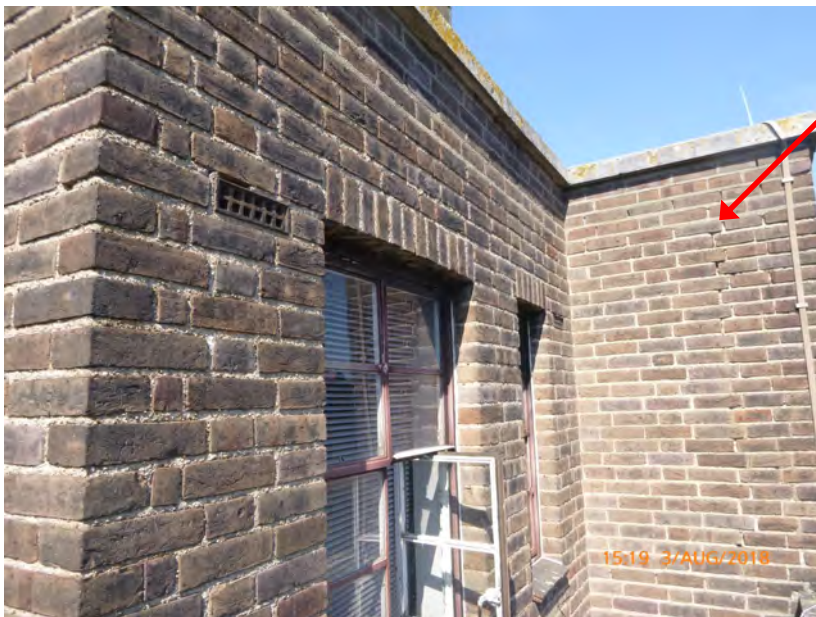
**Fig 16:**

Elevation 1, south side; showing high level view

Note vertical crack in brickwork appeared to follow a line of weak bond pattern

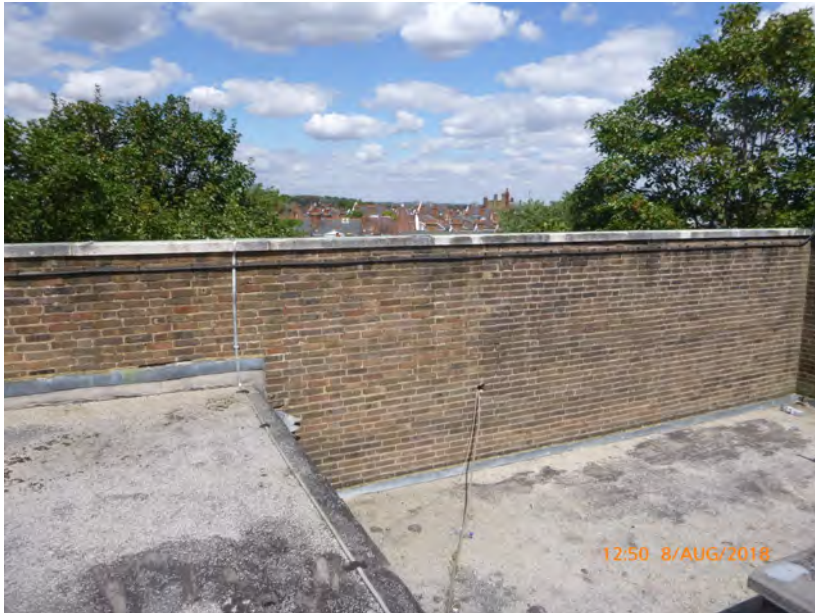
**Fig 29:**

Elevation 2, high level; showing relatively tall parapet comprising a single brick solid wall

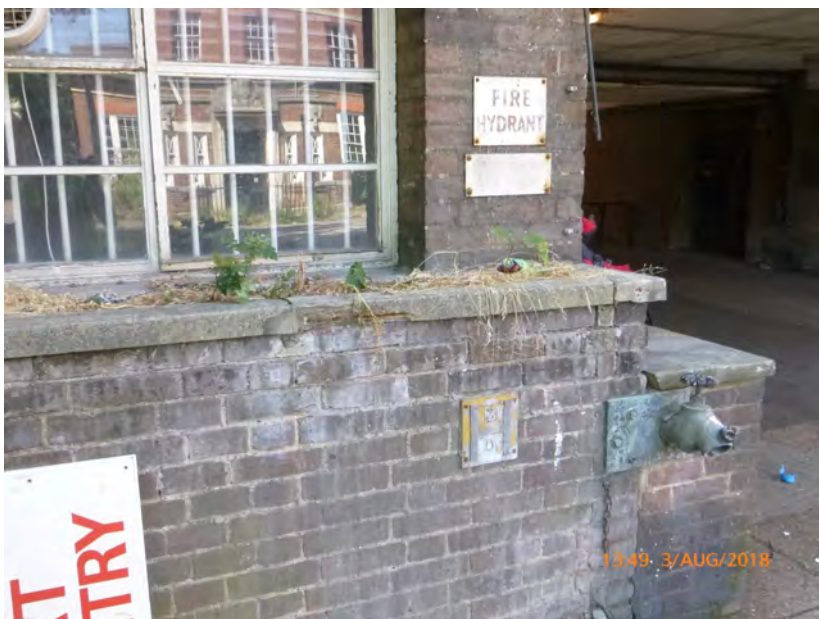
**Fig 34:**

Elevation 3; showing typical brick planter

Note staining and RC sill failure

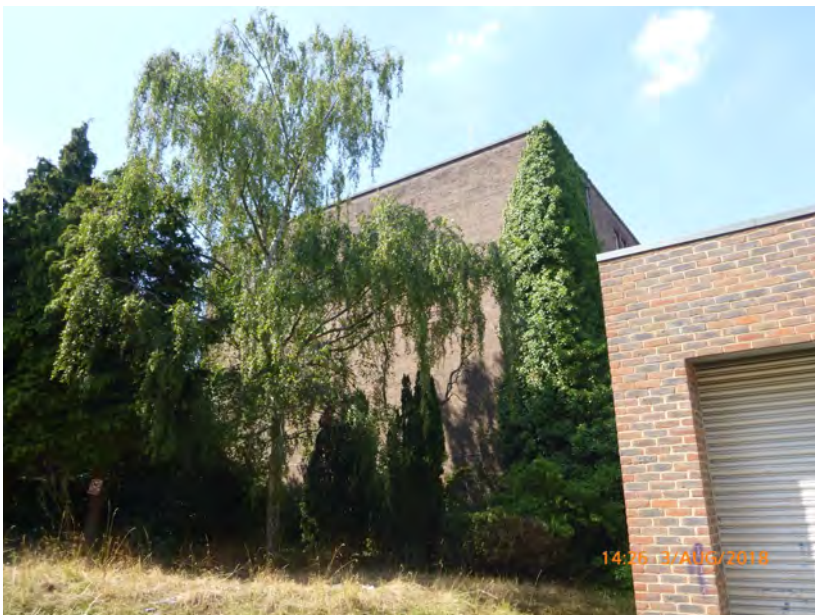
**Fig 40:**

Elevation 4; showing west side

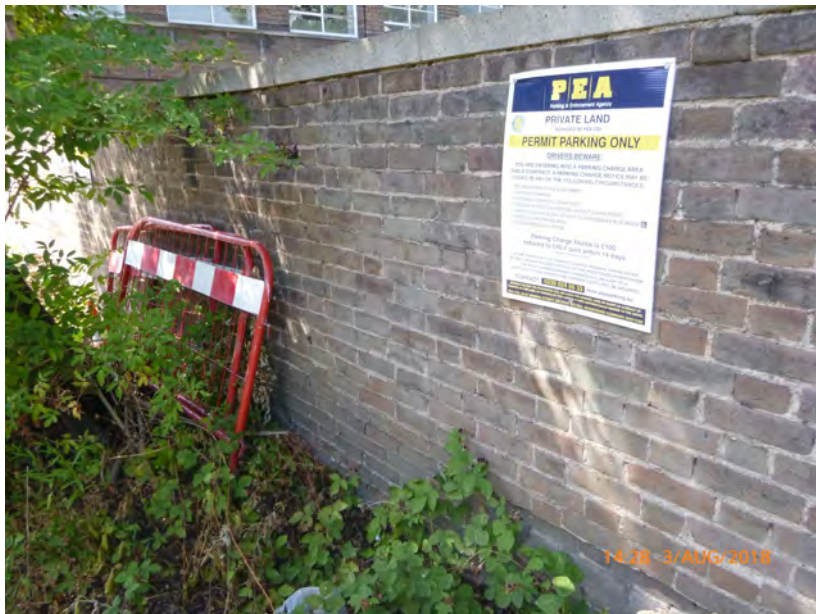
**Fig 41:**

Elevation 4; showing associated boundary wall

Typically, these were in a poor state due to cracking and movement

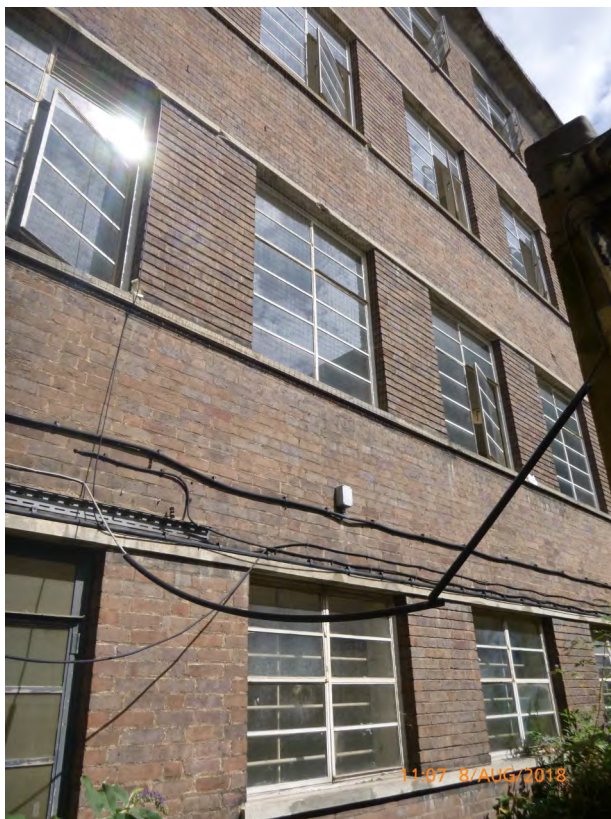
**Fig 46:**

Elevation 4; showing general view.

Also note widespread RC failure and patch repair

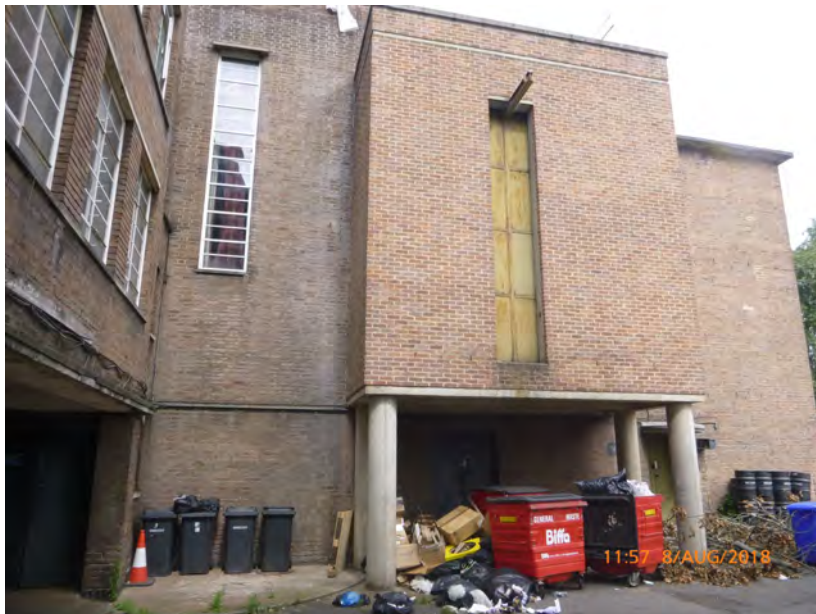
**Fig 51:**

Elevation 5; showing later addition at east side

Significant vertical cracking was noted at the interface

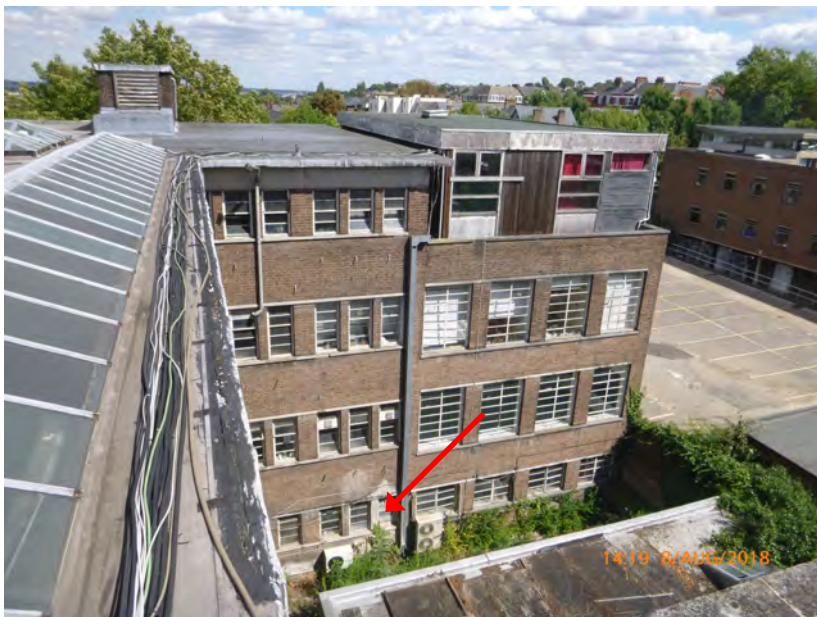
**Fig 58:**

Section CC; showing general view

Note plumbing leak staining and overgrowth at low level

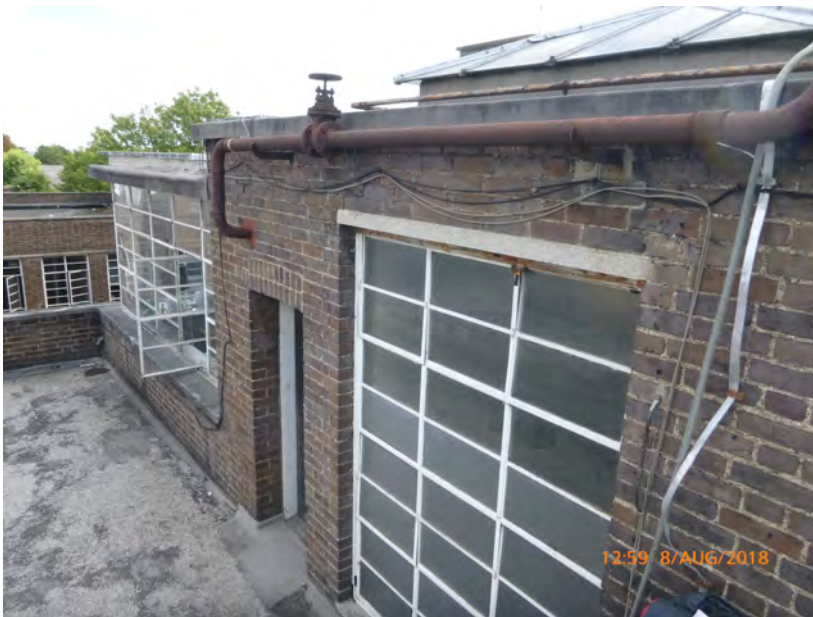
**Fig 60:**

Section EE; showing roof level façade

RC damage/repairs were noted to the roof soffit and sill of the glazed room

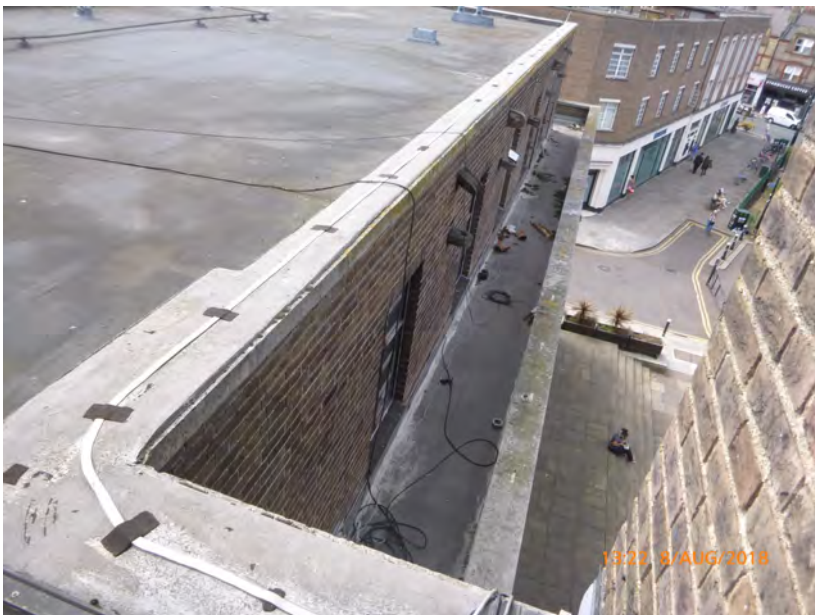
**Fig 62:**

Section FF; showing west wing wall heads

The lower roof copings were exposed and were damaged at their cramp fixings in a number of areas

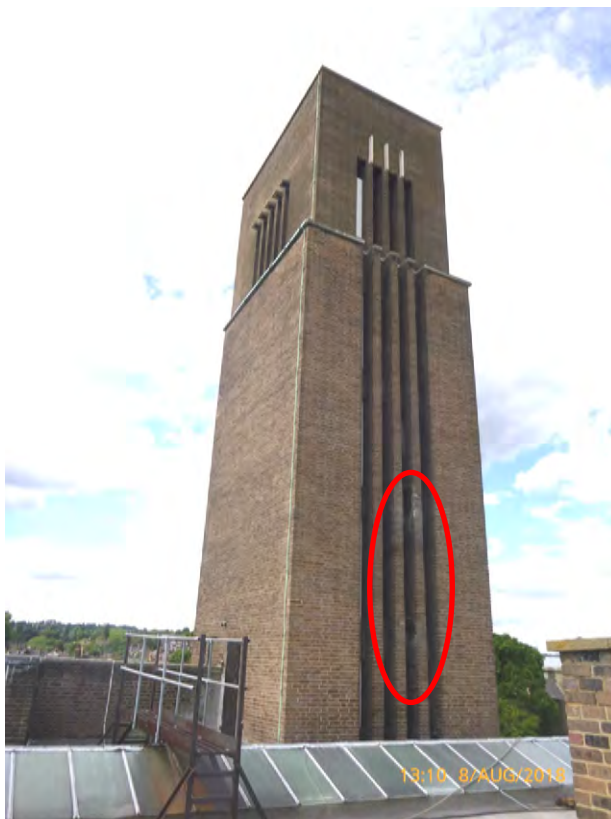
**Fig 64:**

Section HH; showing tower

A plumbing overflow pipe had caused saturation and staining of the brickwork as well as rooted plant growth

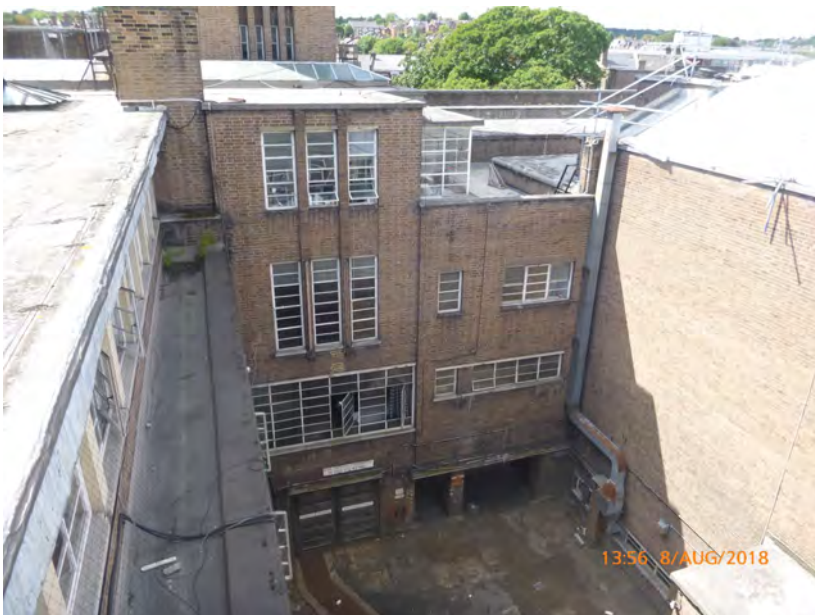
**Fig 66:**

Section HH; showing general view

This area showed very significant diagonal cracking at the interface with the auditorium. This may indicate differential foundations and lack of provision for movement

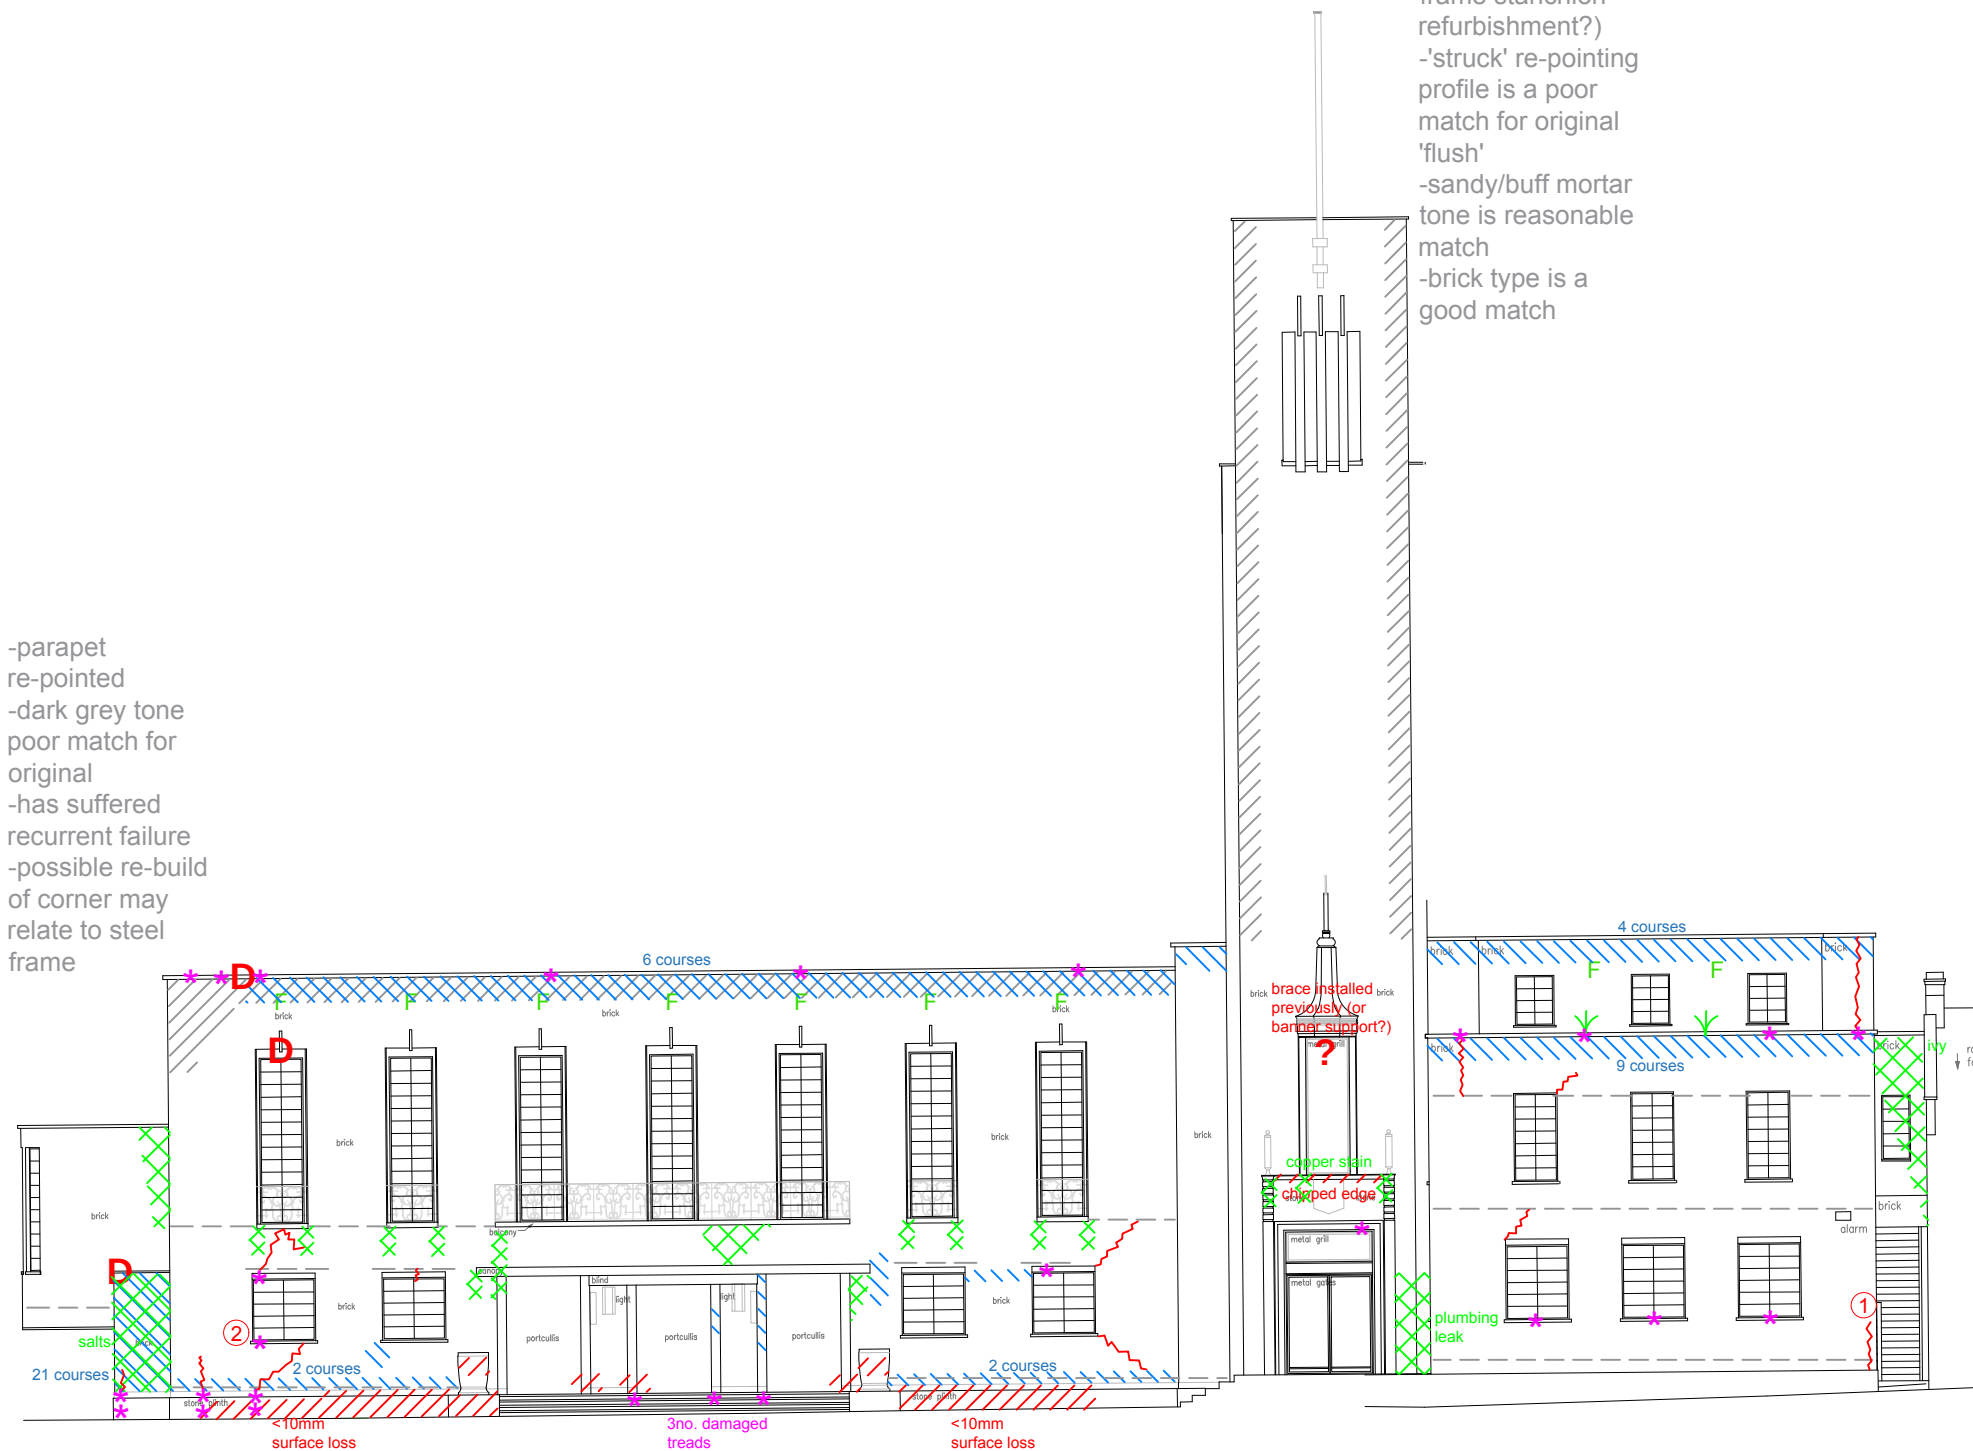
**Hornsey Town Hall, Elevation 1**  
Façade masonry condition investigation  
August 2018

-parapet  
re-pointed  
-dark grey tone  
poor match for  
original  
-has suffered  
recurrent failure  
-possible re-build  
of corner may  
relate to steel  
frame

-corners partially  
re-built previously  
(related to steel  
frame stanchion  
refurbishment?)  
-'struck' re-pointing  
profile is a poor  
match for original  
'flush'  
-sandy/buff mortar  
tone is reasonable  
match  
-brick type is a  
good match

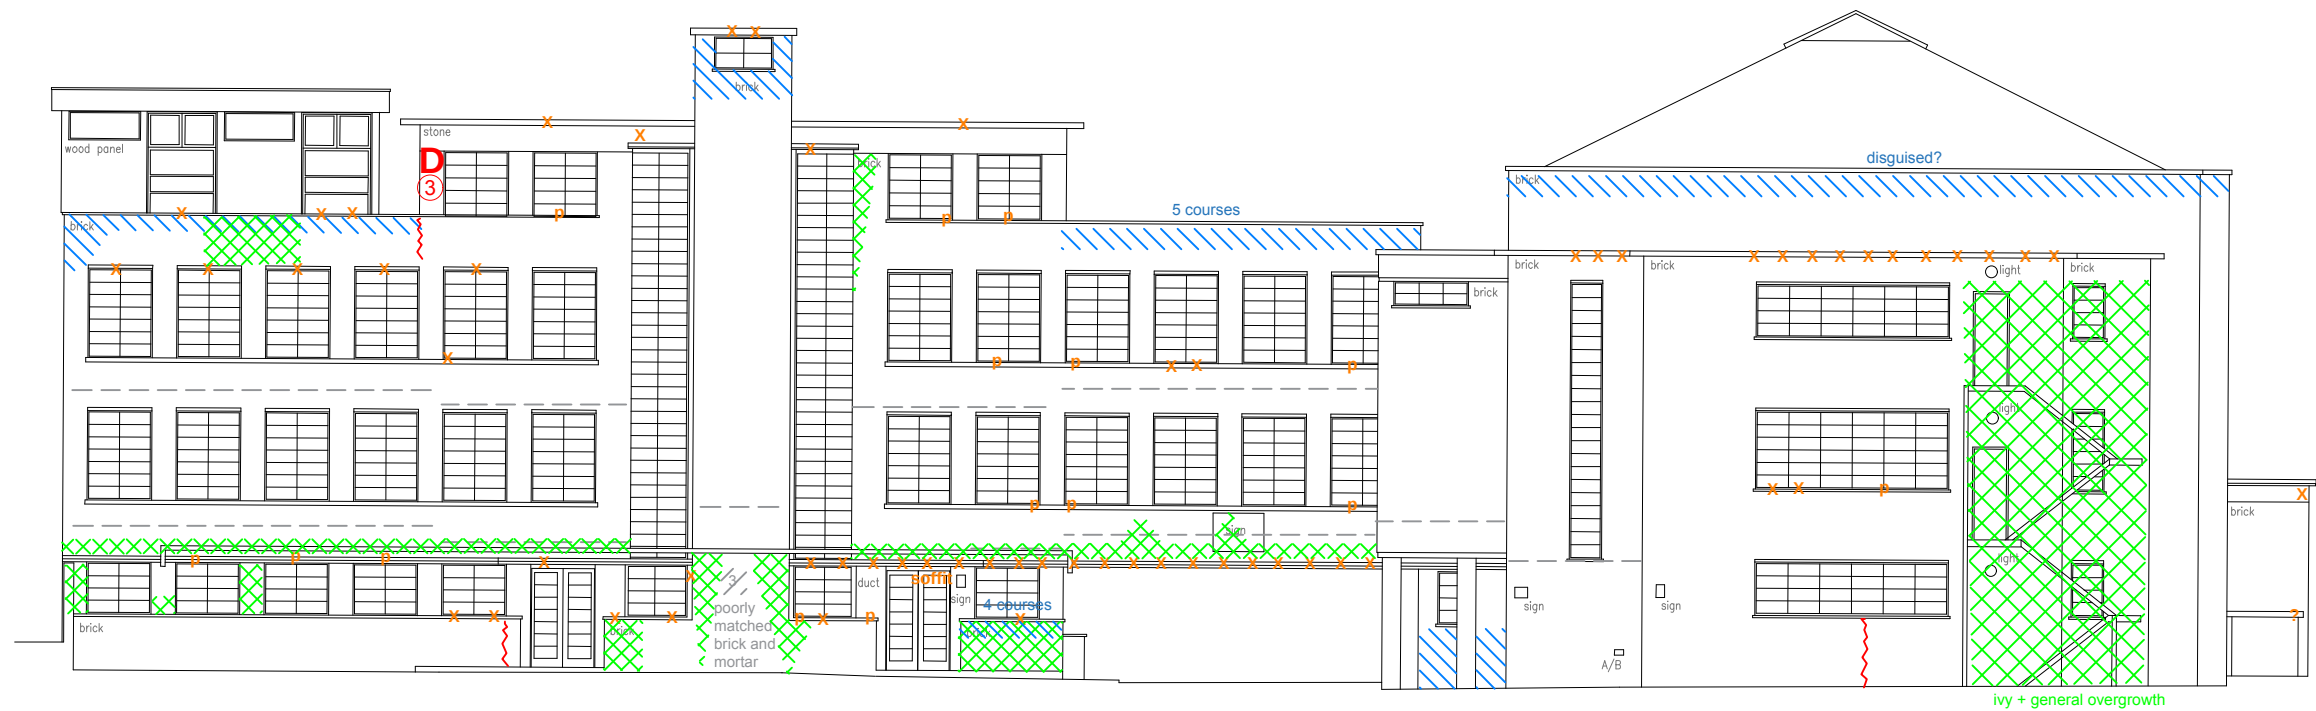
**Hornsey Town Hall, Elevation 3**  
**Façade masonry condition investigation**  
**August 2018**

-parapet  
re-pointed  
-dark grey tone  
poor match for  
original  
-has suffered  
recurrent failure

evidence of at  
least two  
re-pointing  
schemes at head

localised perp.  
joint loss
