## E: Council Chamber

Council Chamber

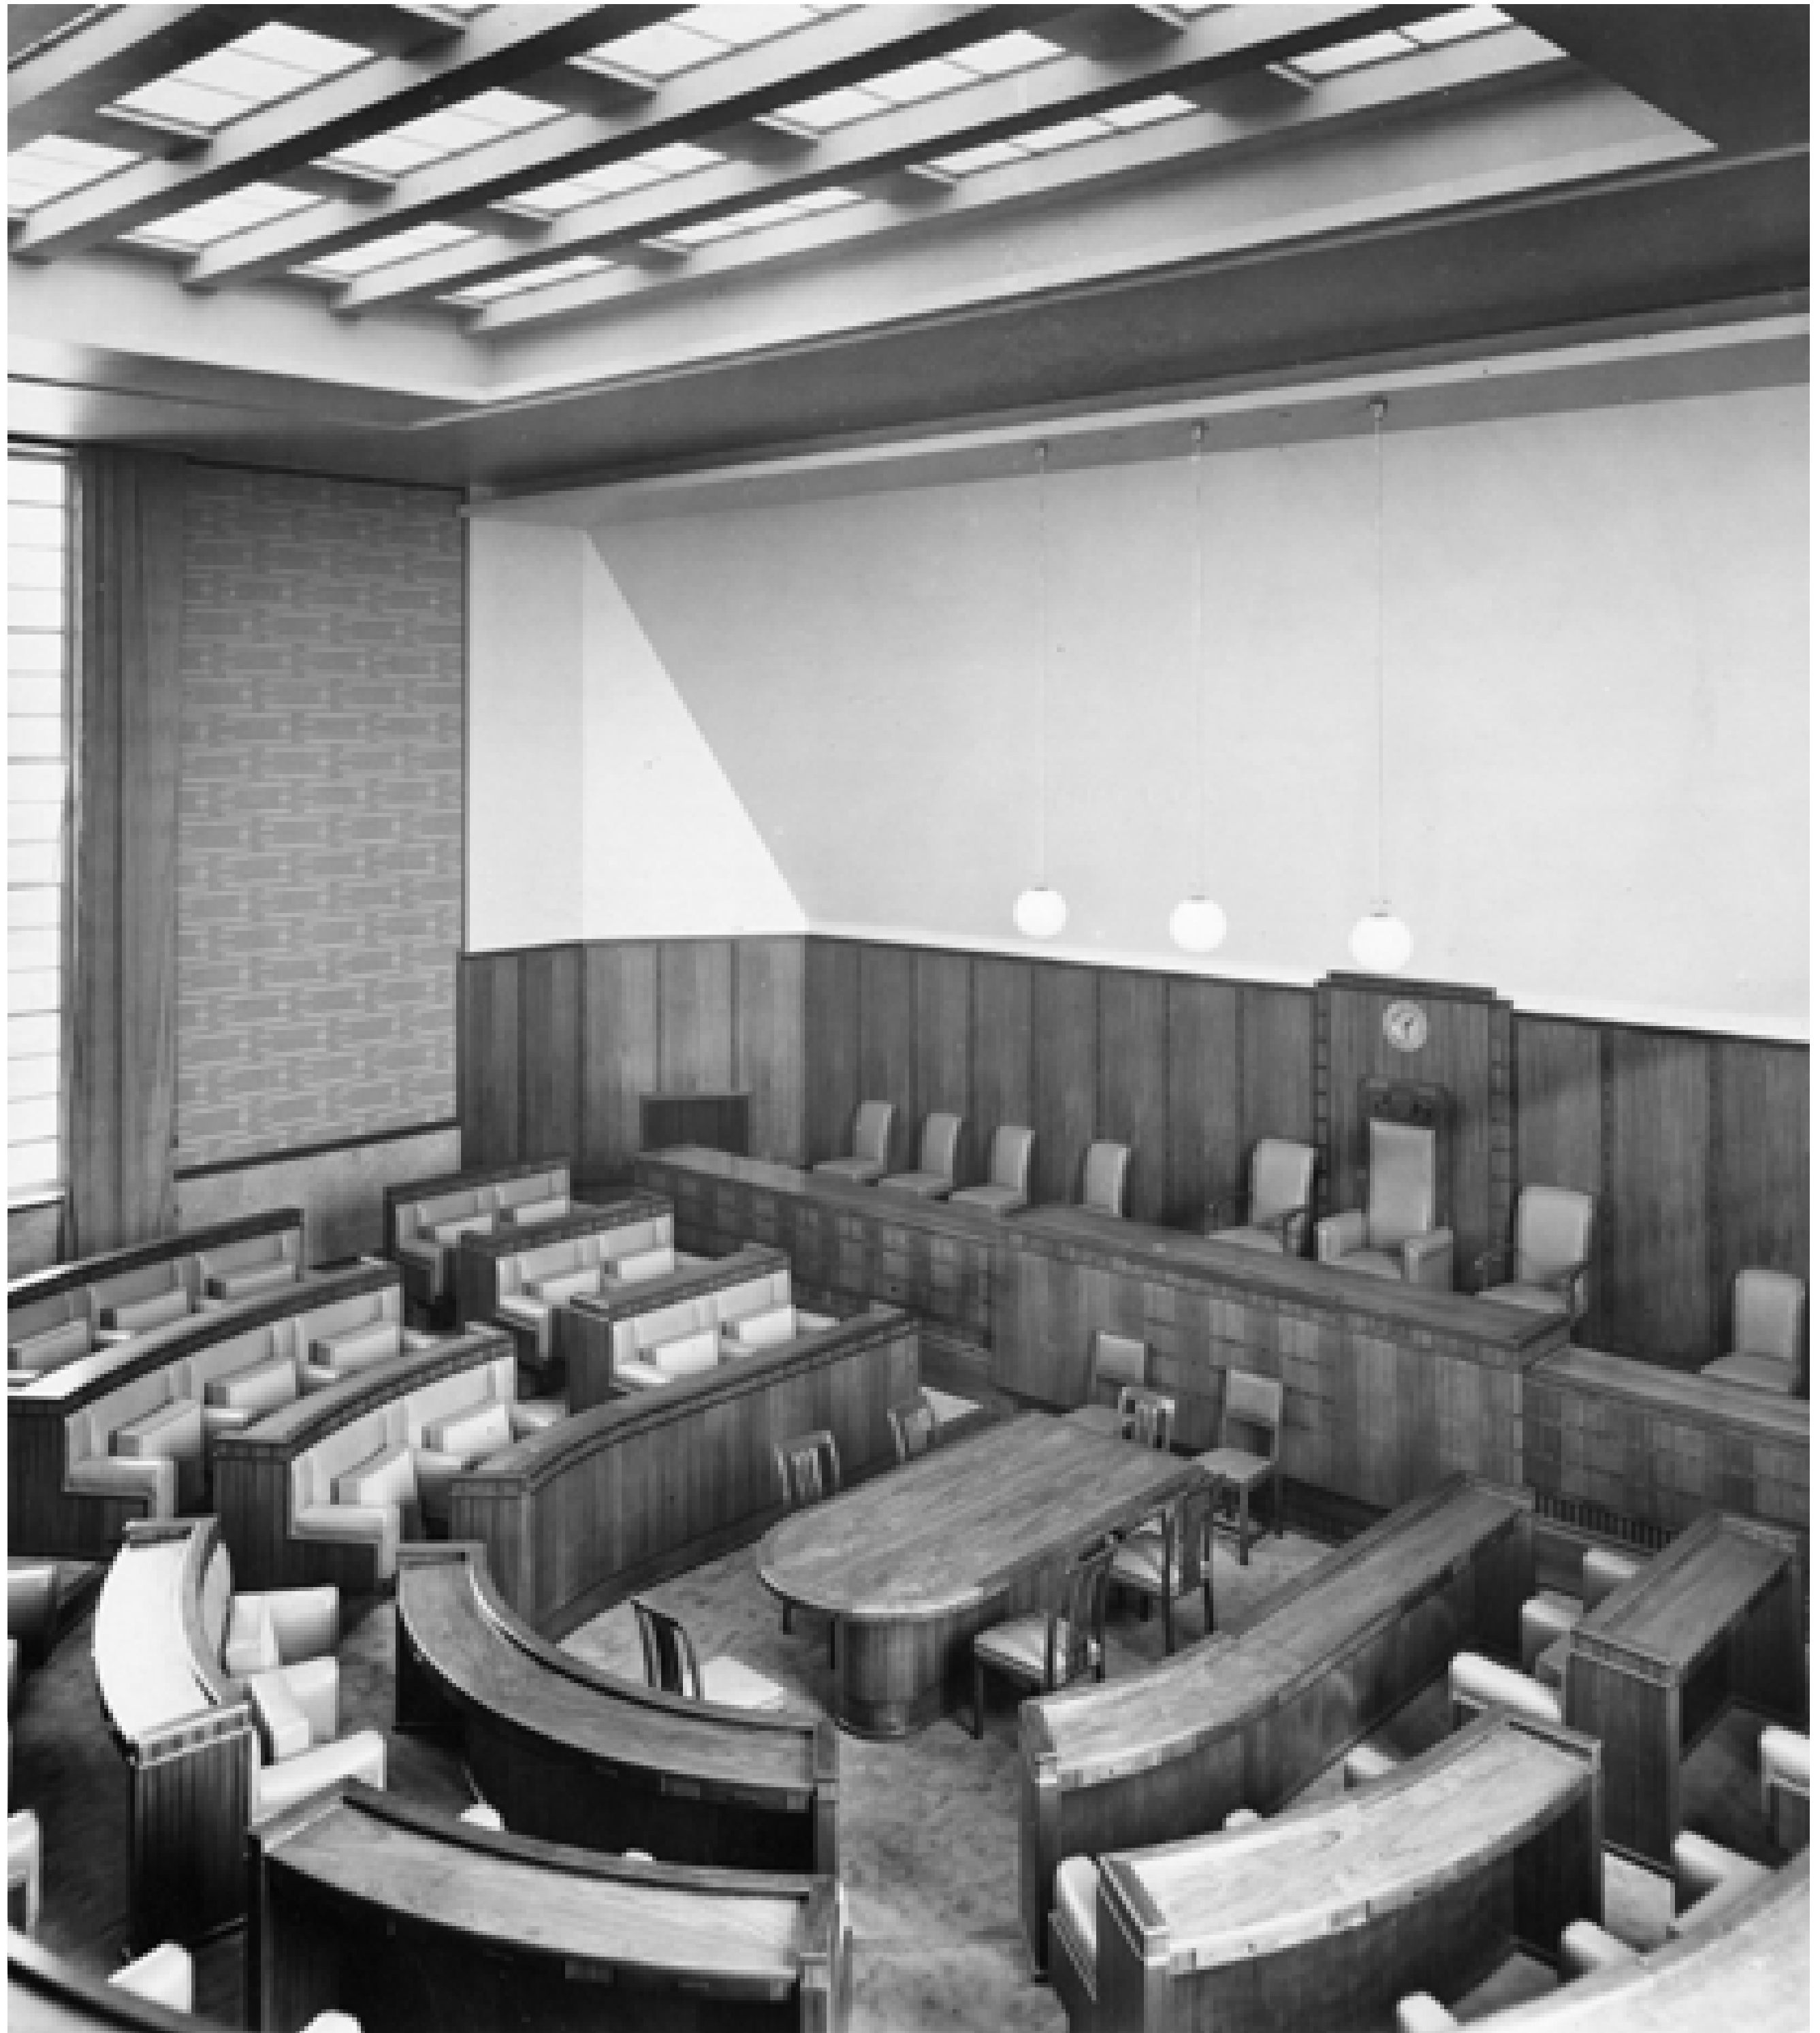
The lobbies to Council Chamber have Veneered doors with decorative banding and small vision panels, with Georgian wired glass. On the landing side, these two doors framed by stone and mosaic. Veneered panelled walls up to frieze height and painted plaster above. Small steel casements with timber reveals. Other features include radiator dials and switch plates.

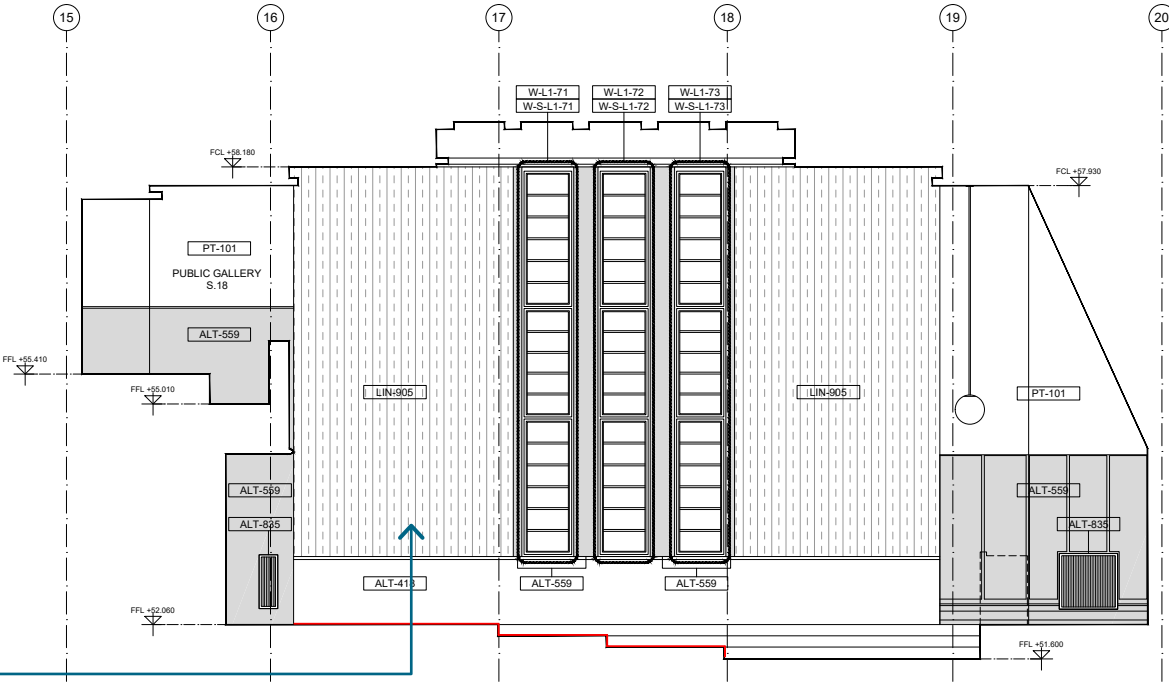
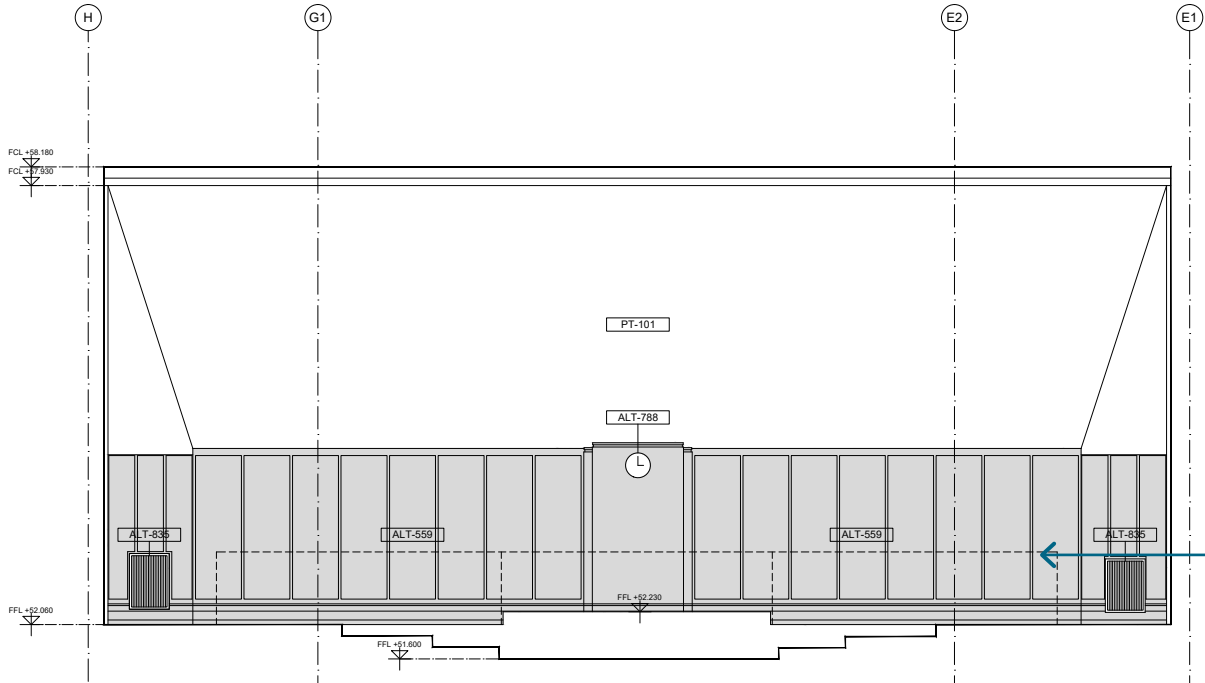
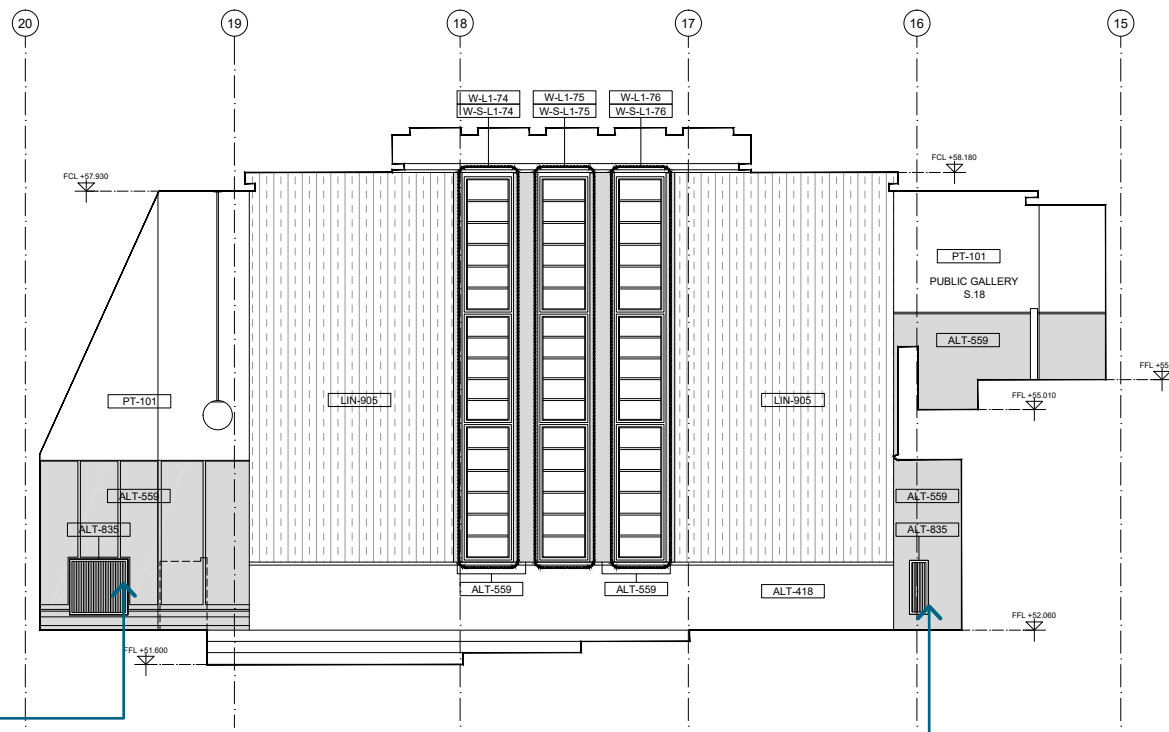
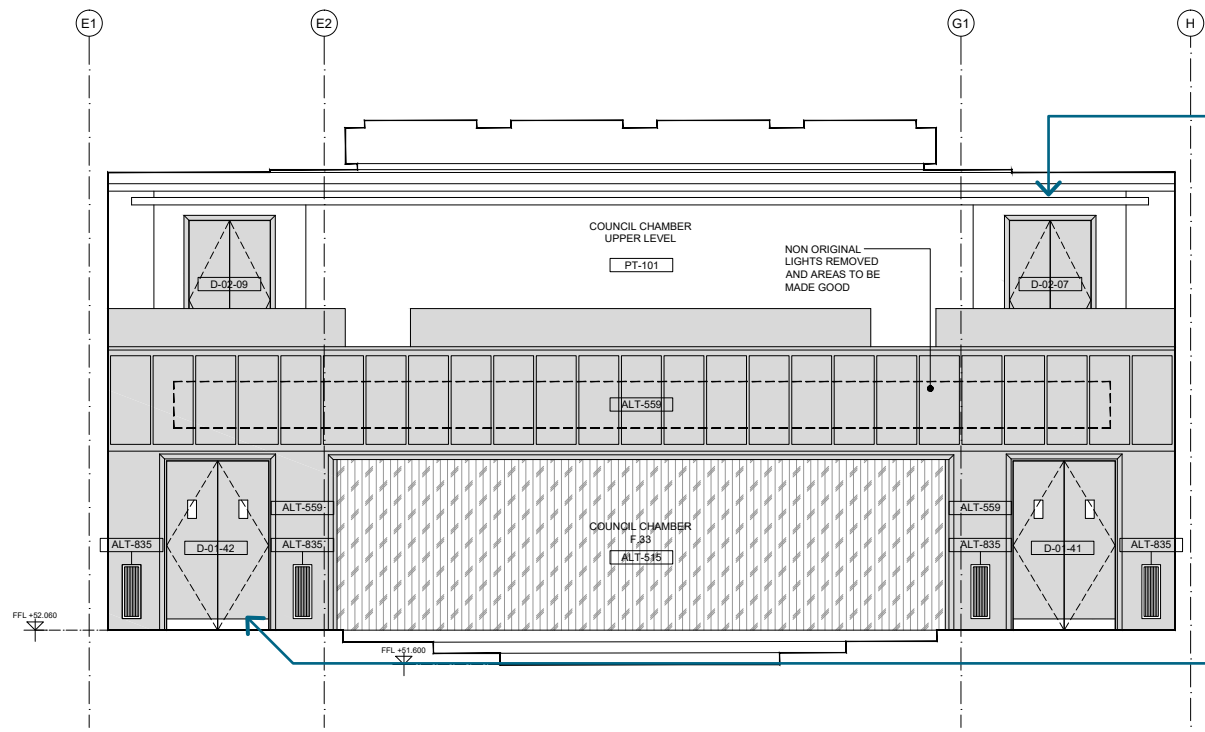
Exiting walnut veneer panelling is in good condition and is to be lightly refurbished to keep aged look as the approved sample on site with HE and LBH.

Existing tapestry shown left - replaced with new tapestry by Hines of Oxford as approved on site with LBH and EH

ALT-559 Refurbishment of veneered wall lining

LIN-905 Replacement replica tapestries with acoustic absorption

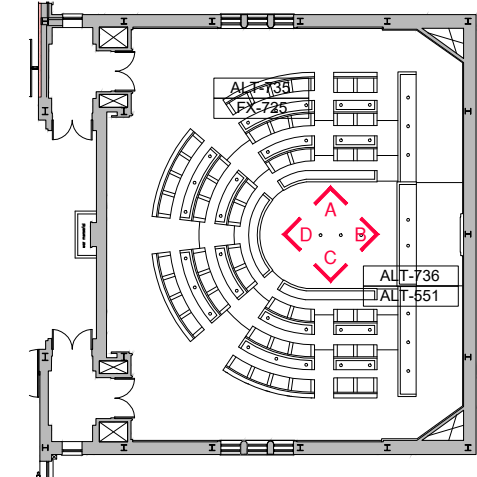
Existing top floor council chamber door has been painted on the corridor side, as part of the refurbishment of the door, the paint is to be removed and door refurbished back to original finish as visible on the chamber side.

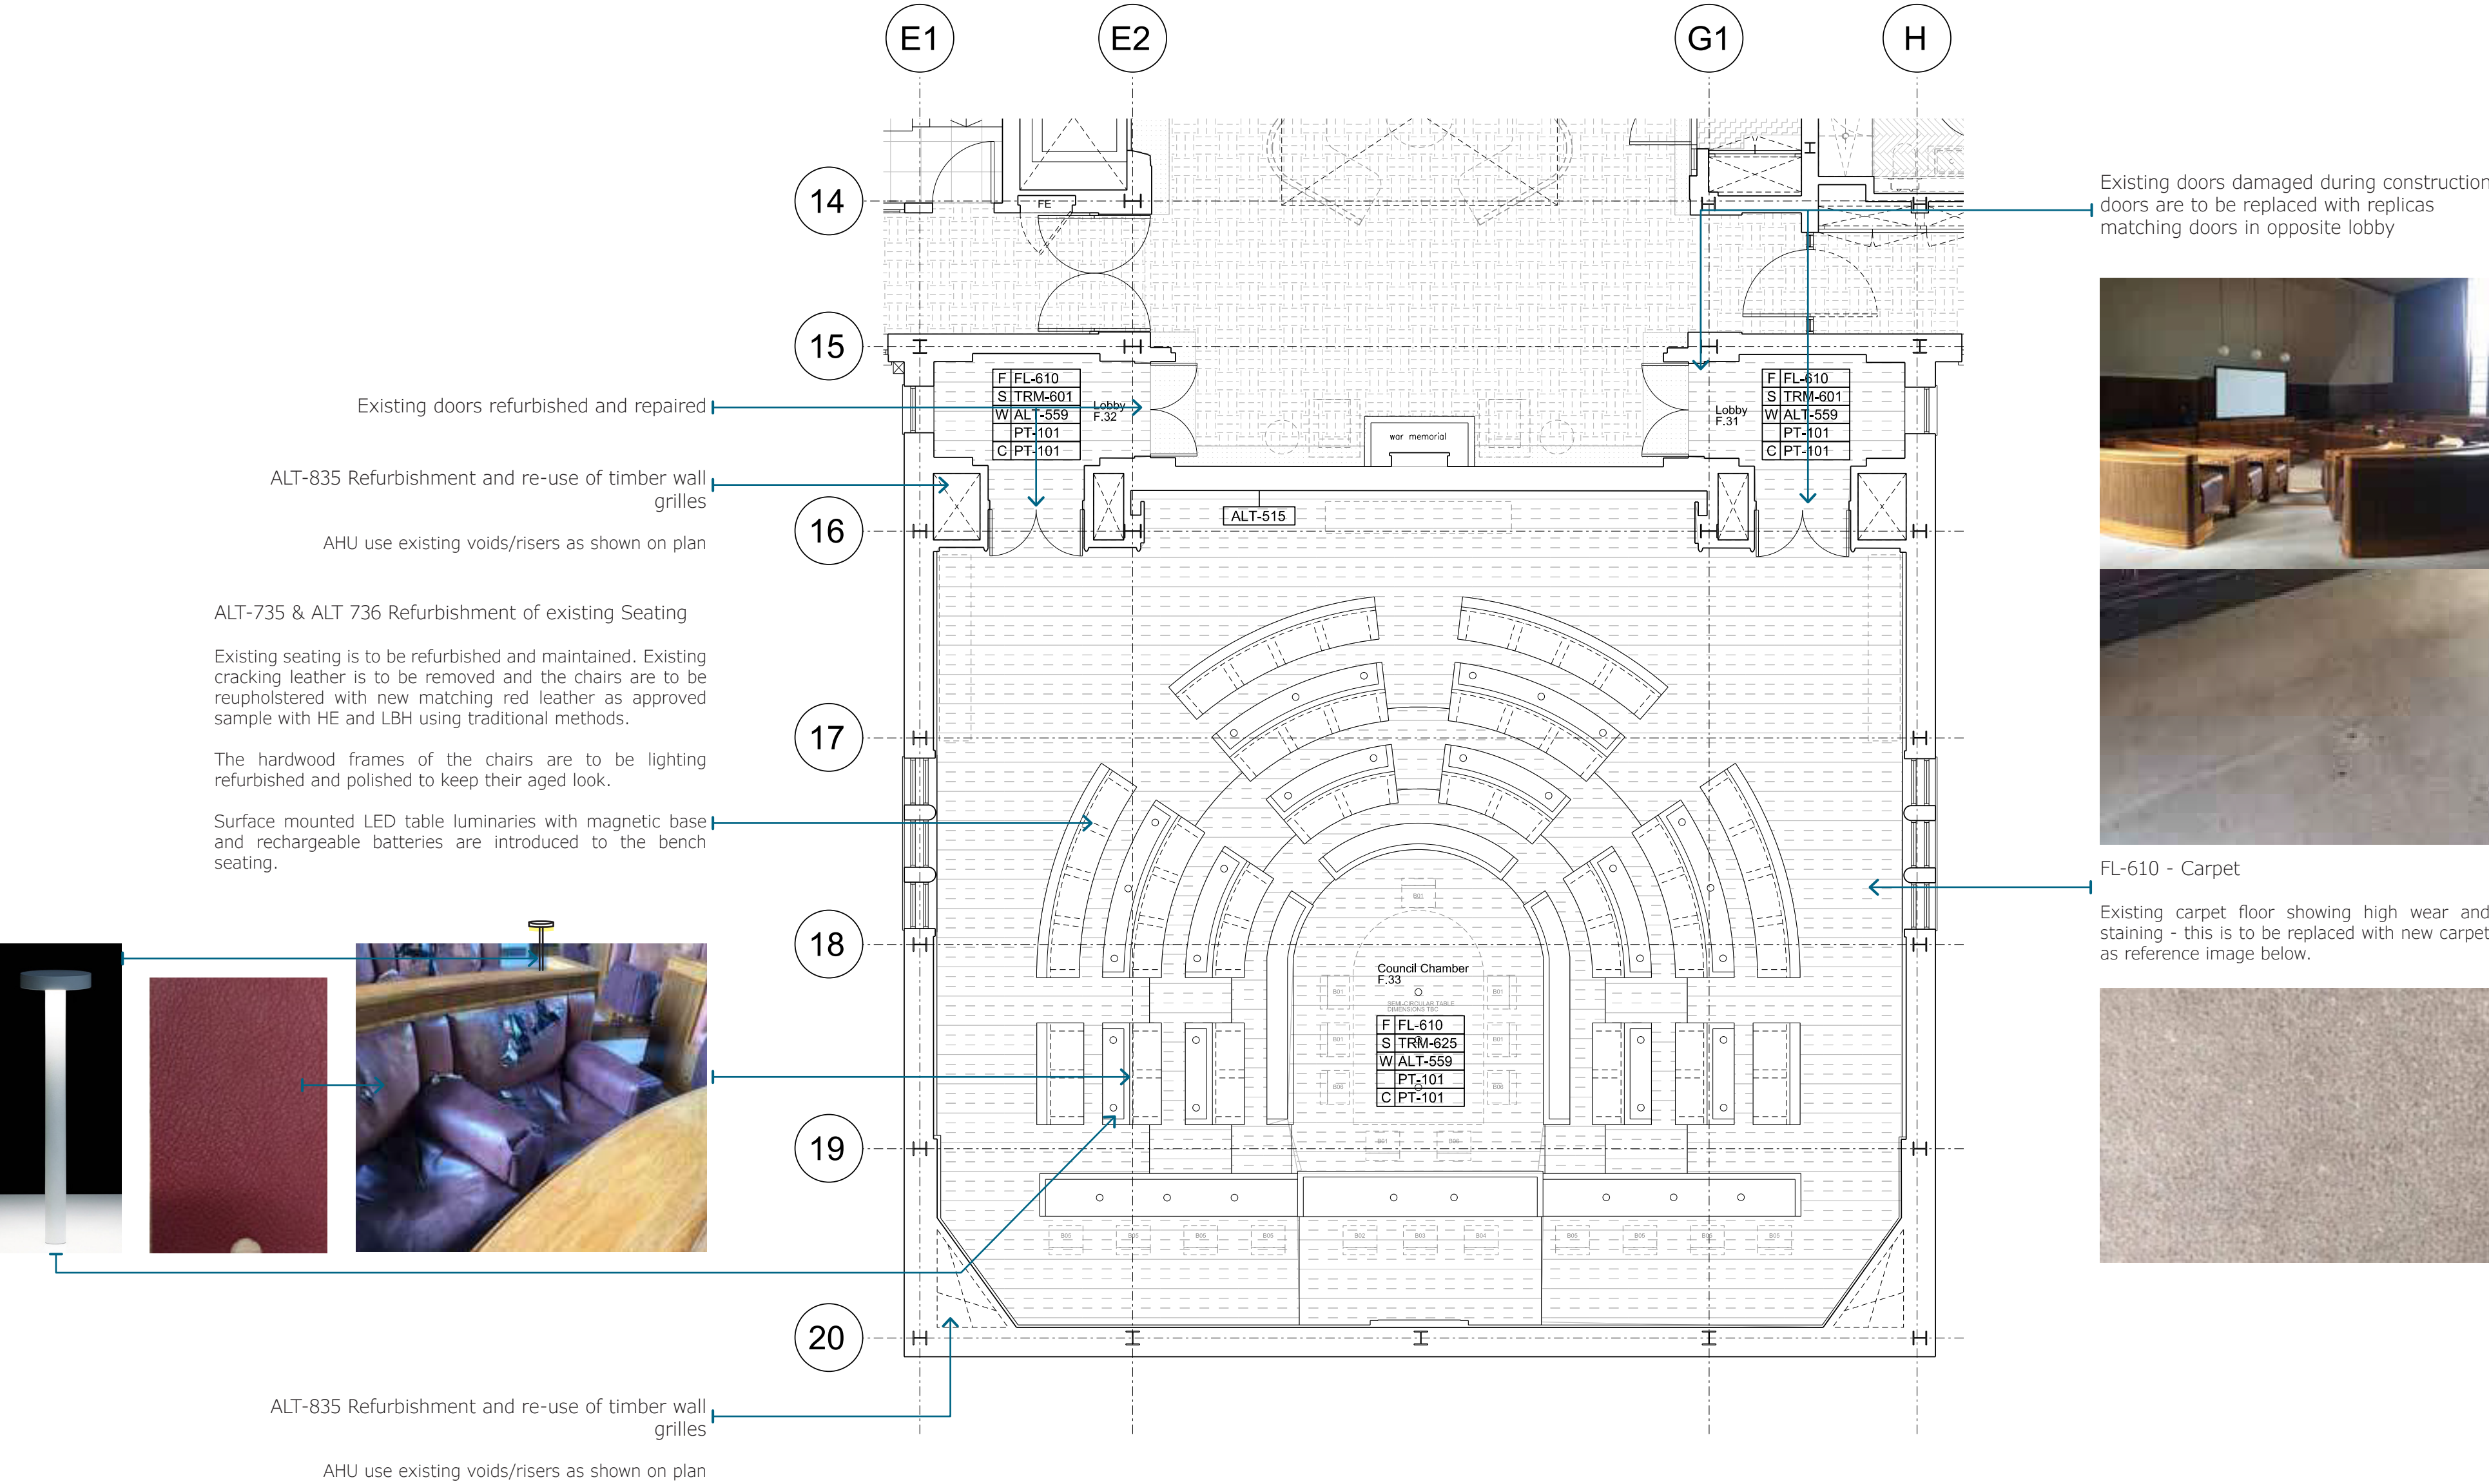
Summary; The general arrangement plan of the Council Chamber is set around the positioning of its furniture. With the central Mayors Rosturm the focal point and a curved stepped flooring to form a stepped gallery towards the centre focal point. All of which is to be retained and existing setting out matched.

Floor Finishes; Existing flooring within the Council Chamber is carpet throughout, which shows sign of long term ware and staining. New carpet is to be introduced as a replacement matching the existing colour and style of the existing carpet.

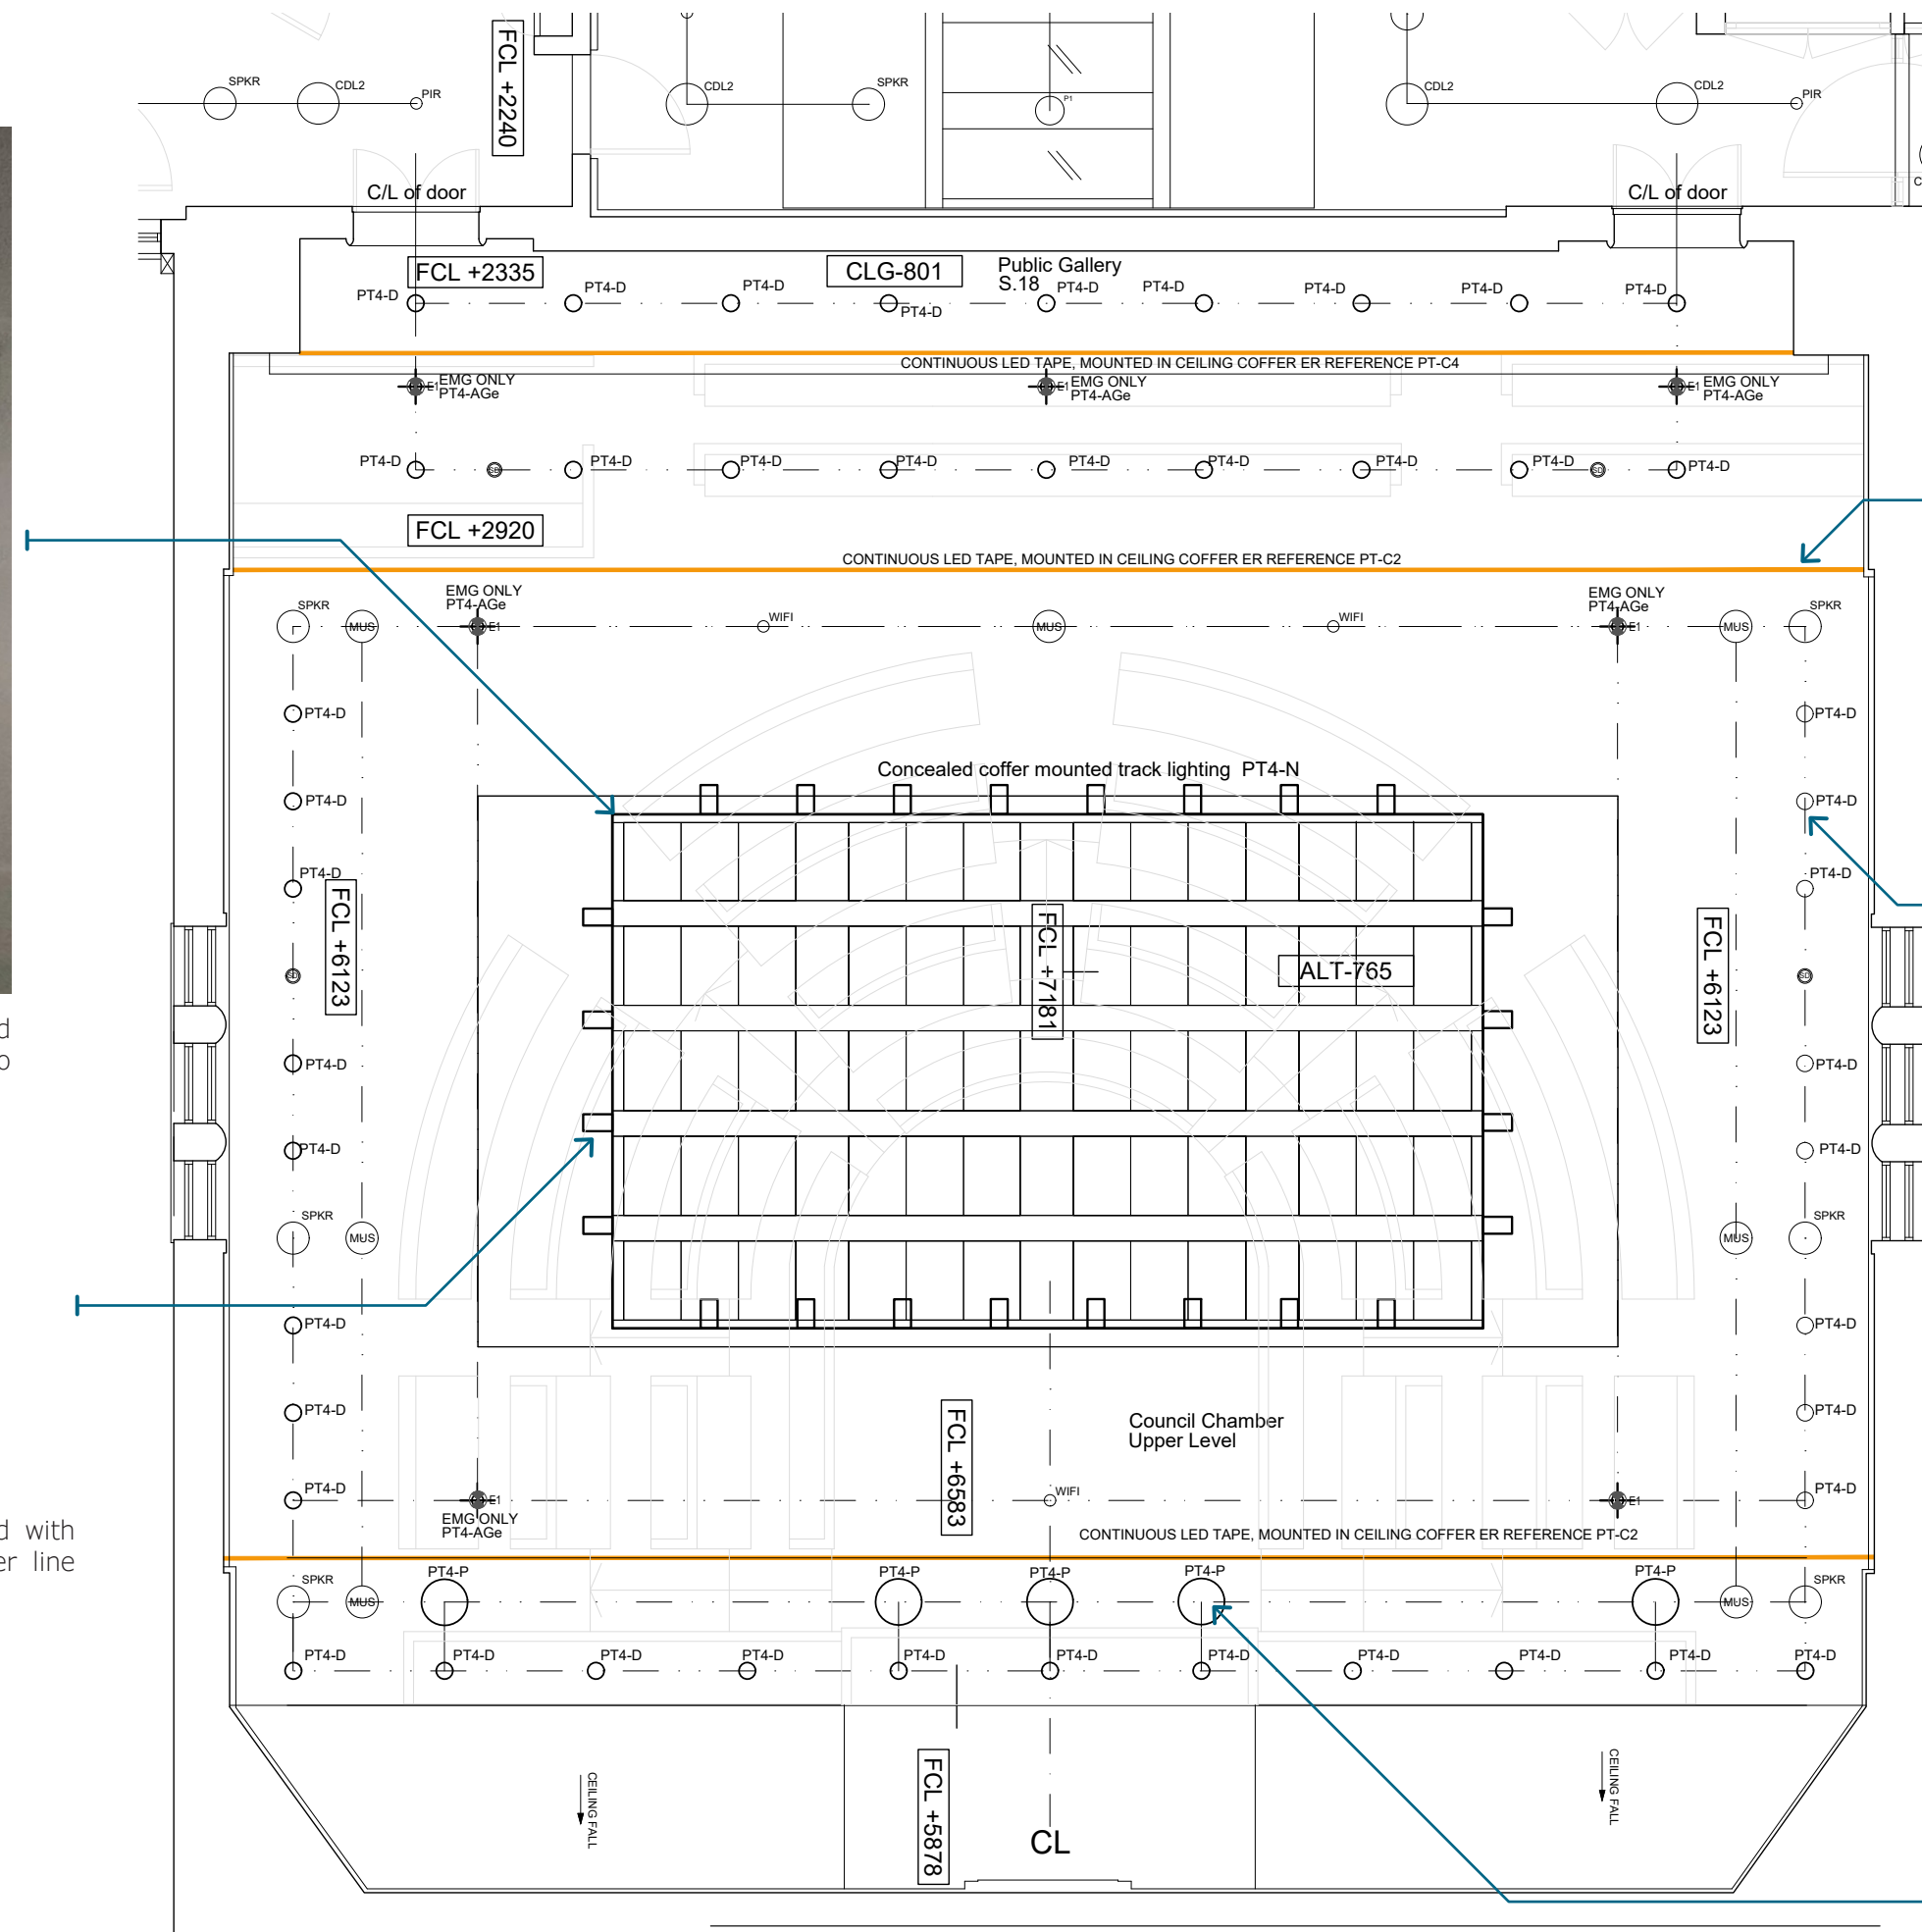
Ceilings; The ceiling finish in the main area is in good condition, and is to be lightly refurbished as required and a new layer of paint. With existing coffer details and setting out to be retained.

Lighting; An existing roof light sits above the centre of the space, a key feature of the ceiling with a surrounding coffer detail. Roof lights are to be refurbished, with new LED lights above to create LED light panels, discrete spot lights are to be installed within the coffer around the edge of the light panels. Additional coffers are to have a hidden installed LED strip lighting. Existing globe long drop pendants are to be refurbished and relamped with LED fittings.

LED strip lighting is to be included within existing coffers.
