## F: Committee Room

Committee Rooms

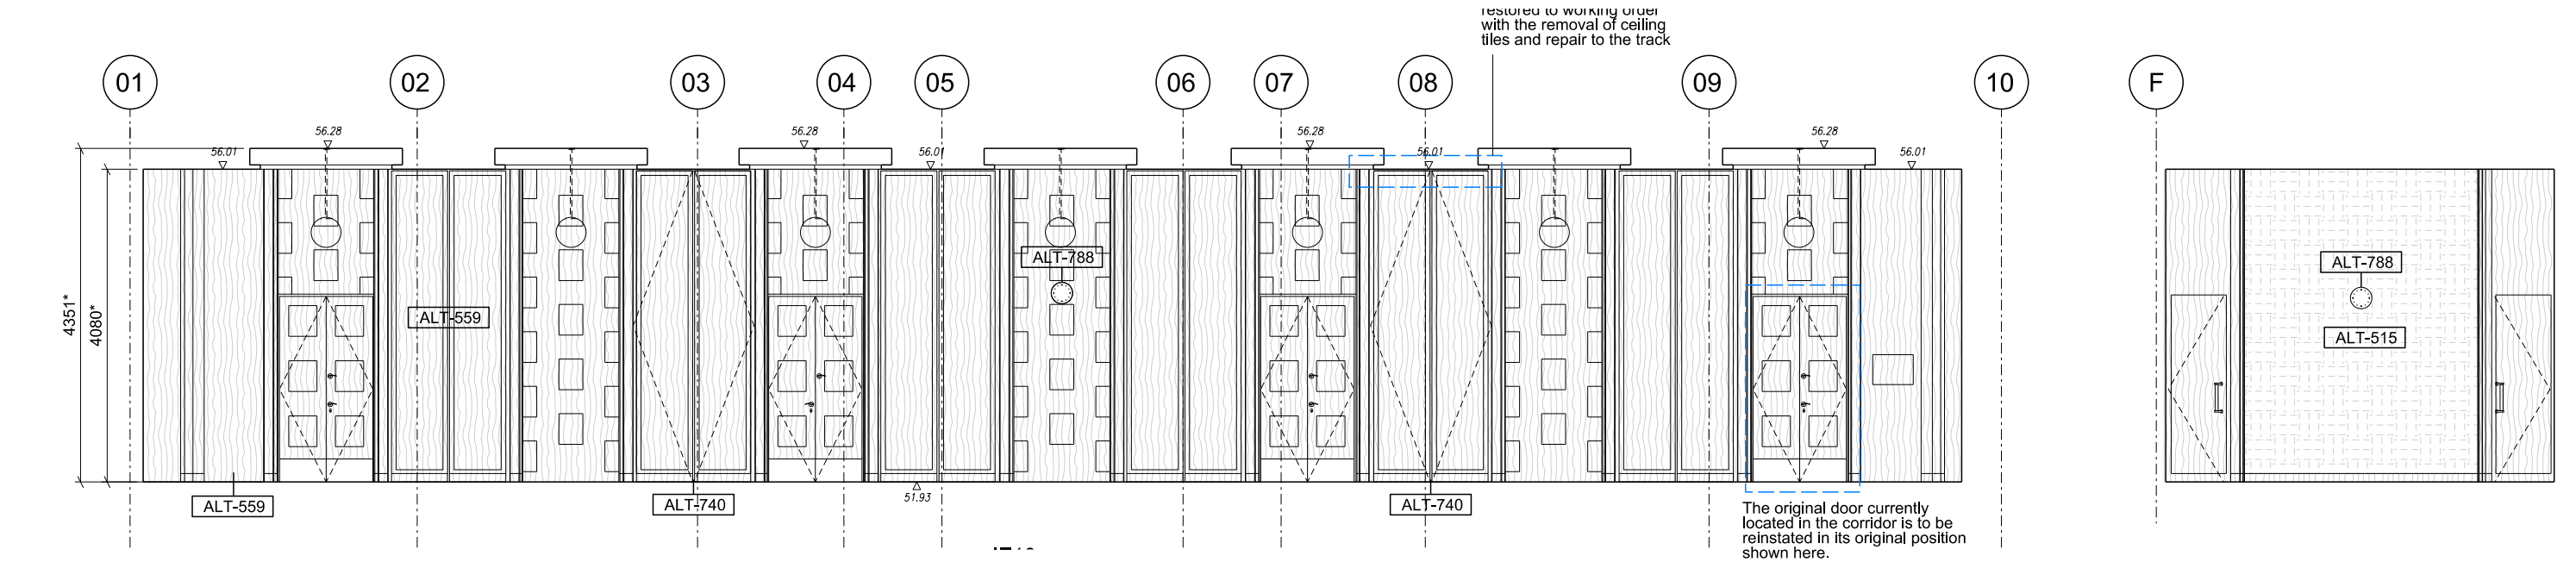
01 Internal Elevation  
1:50

ALT-559 Refurbishment of veneered wall lining  
The existing walnut veneered panelling was in a general condition and it to be refurbished to a near new condition. An approved sample of repair has been review and agreed on site and a detailed method statement of the works as the approved sample has been submitted.

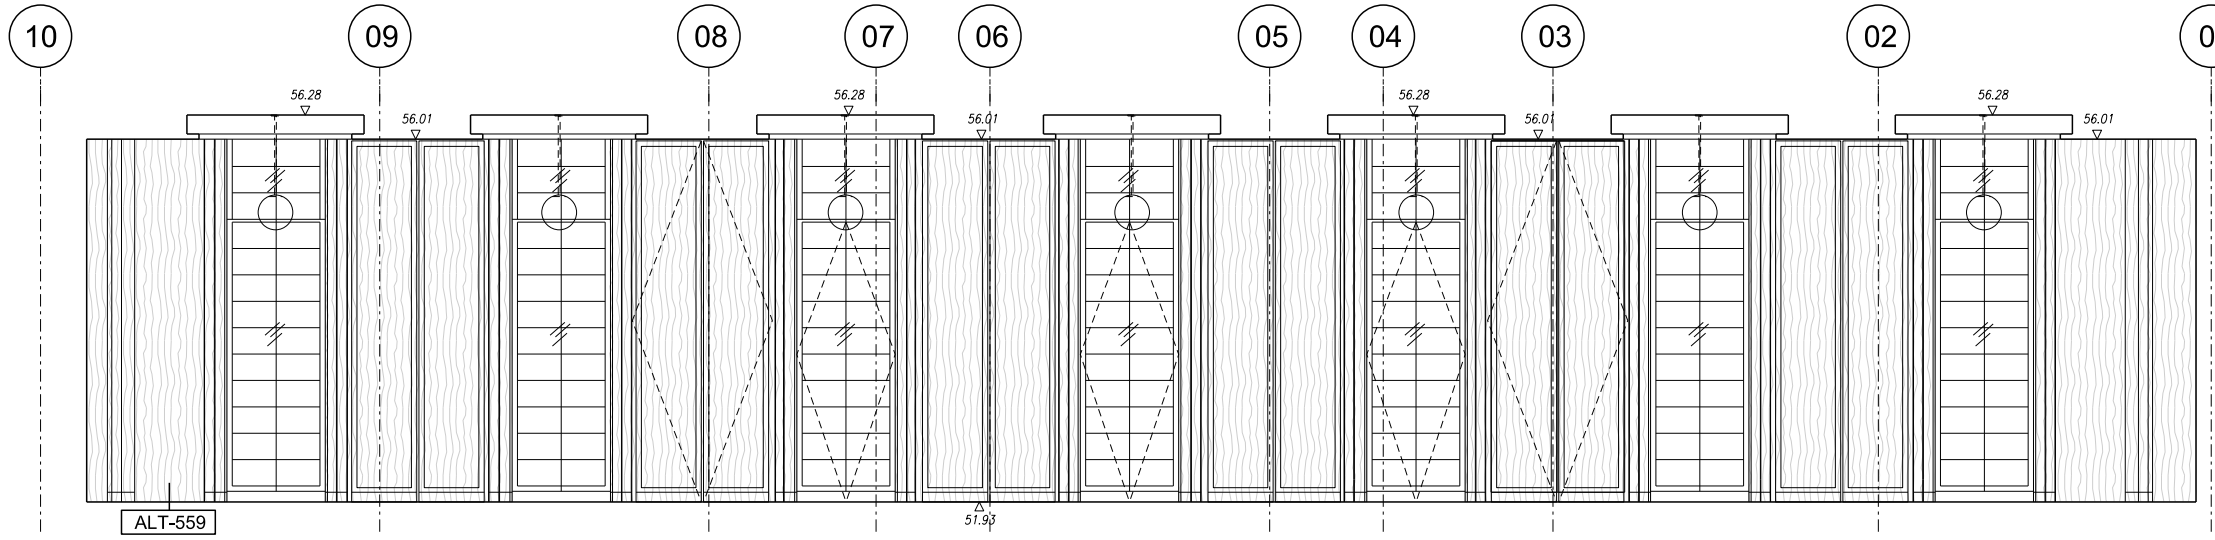
02 Internal Elevation  
1:50

ALT-559 Refurbishment of veneered wall lining  
Existing cork wall shows signs of wear, a sample of refurbishment has been approved on site (as bottom right panel). The cork is to be repaired in situ and where significant damage to tiles as middle right hand side, tiles are to be replaced with matching tiles as the approved sample

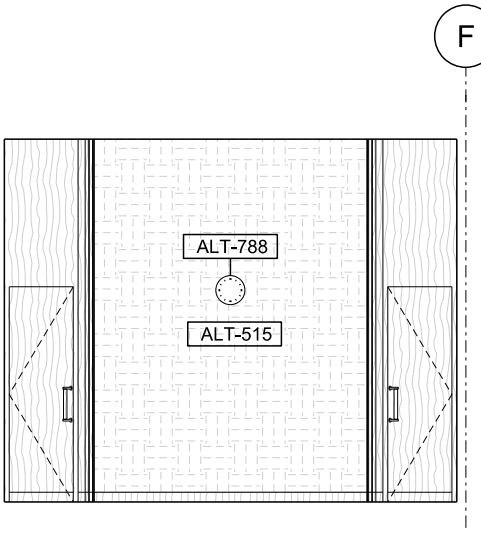
Original clocks are at opposite ends within the cork walling. The clocks were previously wired and connected to the Synchronome master clock. Due to the relocation of the clock to a central location on the

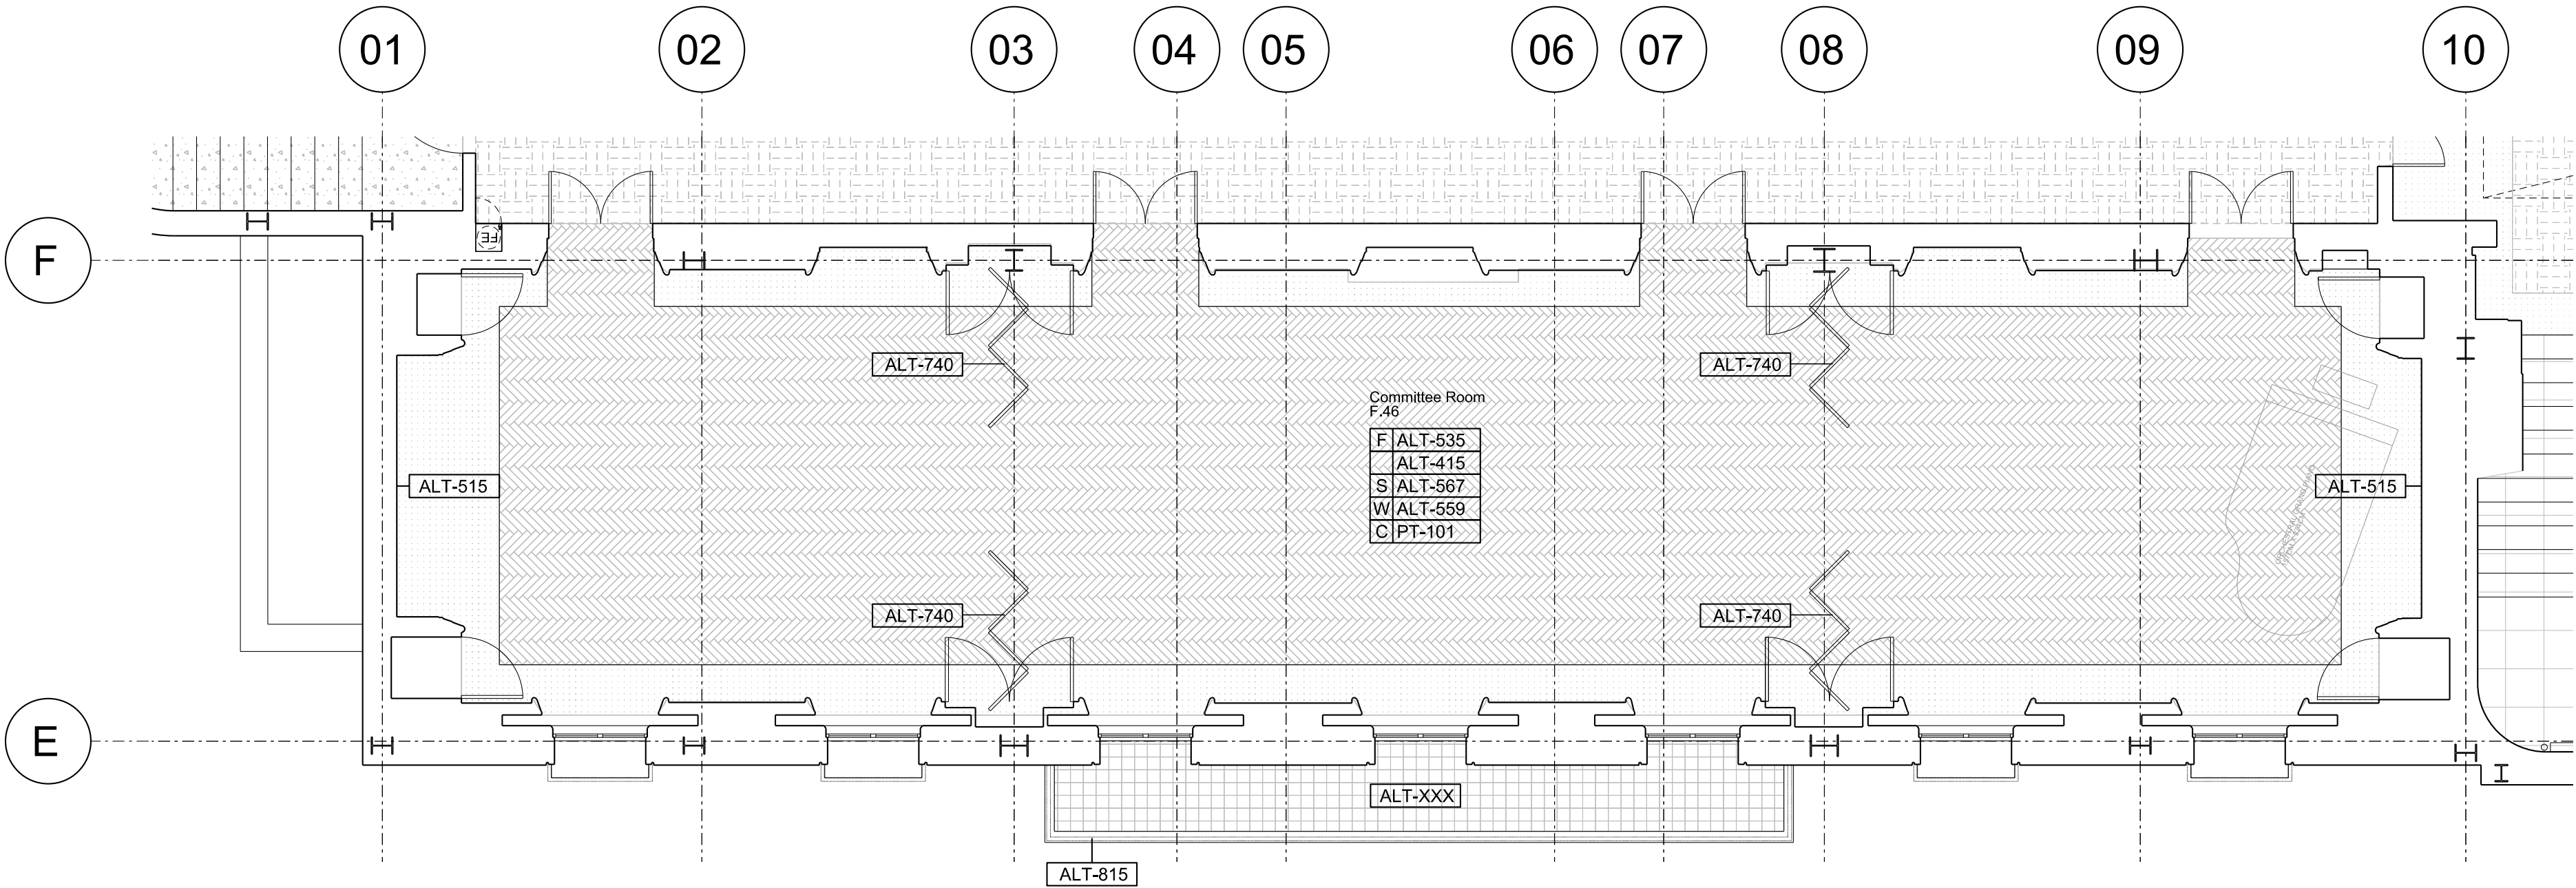
ALT-535 Repairs to Herringbone Flooring  
Existing timber herringbone flooring had localised damage that was apparent with areas heavily scratched and surface inconsistencies with marks and stain - the refurbishment of the flooring is bring the floor up to a good quality while maintaining its aged appearance.

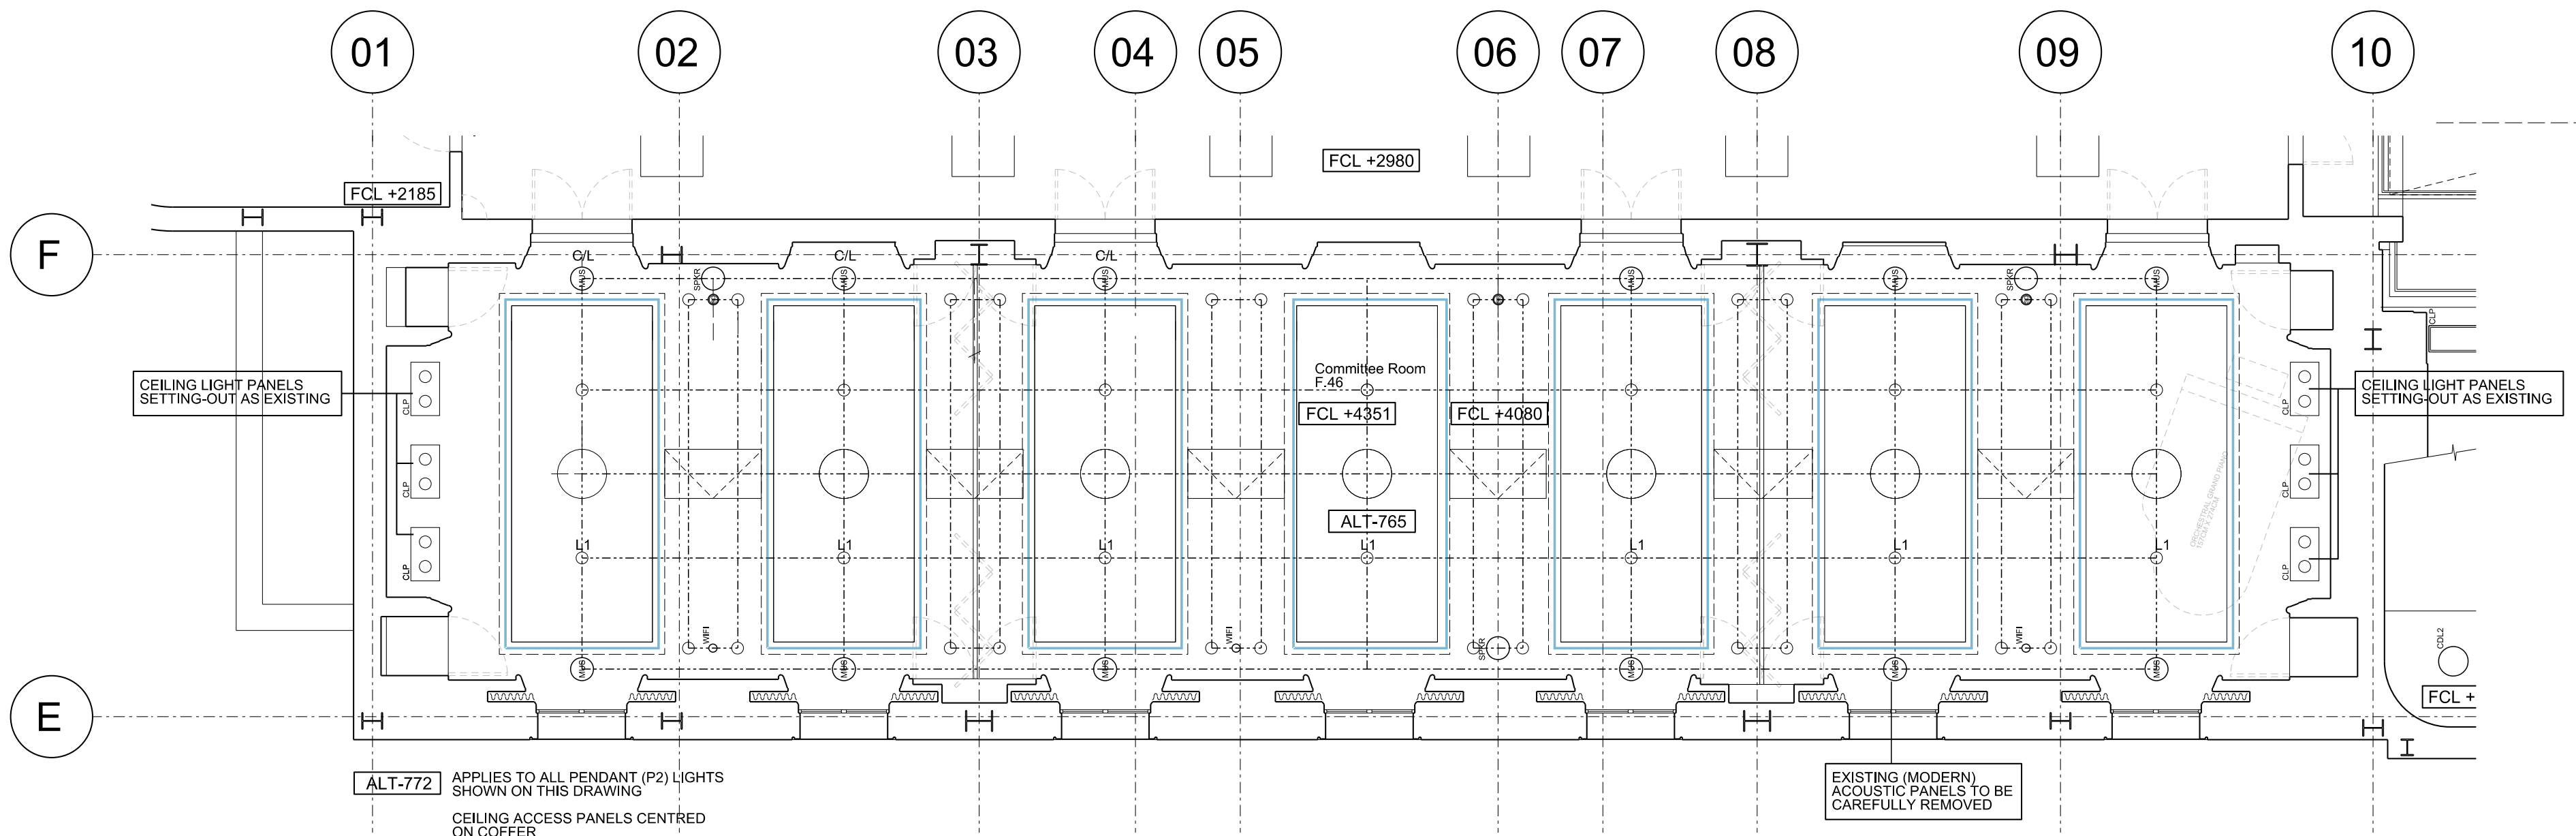
Modern introduction of acoustic ceiling panels blocking function of sliding dividing panels removed.

New flush plasterboard ceiling installed replacing acoustic panels, with track for partitions refurbished

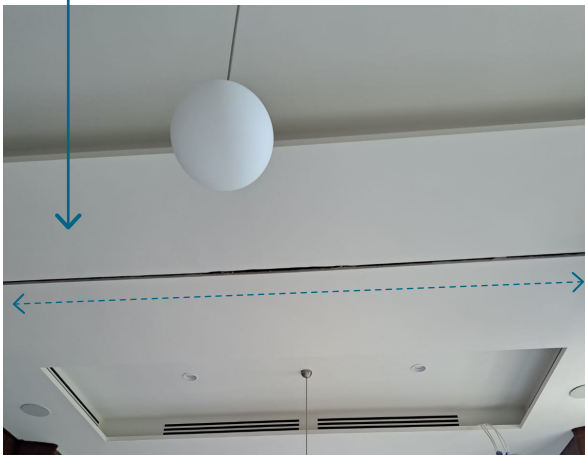
Existing globe pendant lights have been refurbished and relamped with modern LED fittings and reinstated in original position.
