D: Foyer (Entrance Hall)

Entrance Hall

Drawing Title  
Joinery  
Barista Room G.40  
Kitchenette and bar

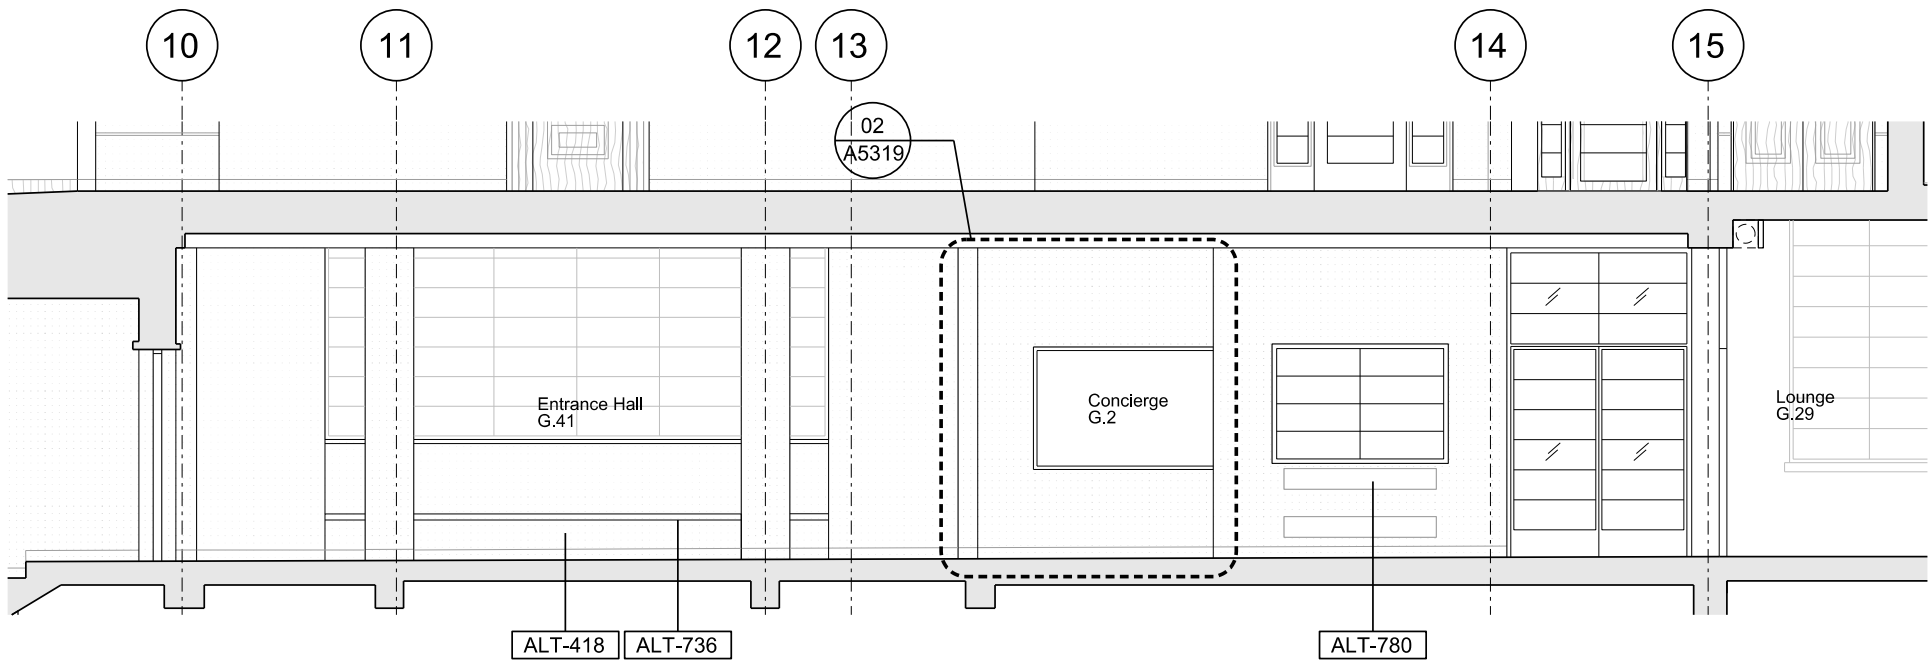
01 Internal Elevation

Walls; All original wall finishes are to be retained, refurbished and repaired. The only exception is a small area where new stone is being introduced to infill an opening to the Barrista counter G.40. This will be done using salvaged stone.

Detailed method statements have been submitted for the refurbishments of different architectural items. Referenced on the drawings with relevant codes to below drawings as below;

- ALT-418 Refurbishment of Stone Wall Panelling
- ALT-564/736 Refurbishment of Existing Furniture
- ALT-838 Refurbishment of Controls/Small Powers
