Project  
Hornsey Town Hall

Drawing Title  
Joinery  
Reception Room G.2  
Receptions desk and joinery

Foyer

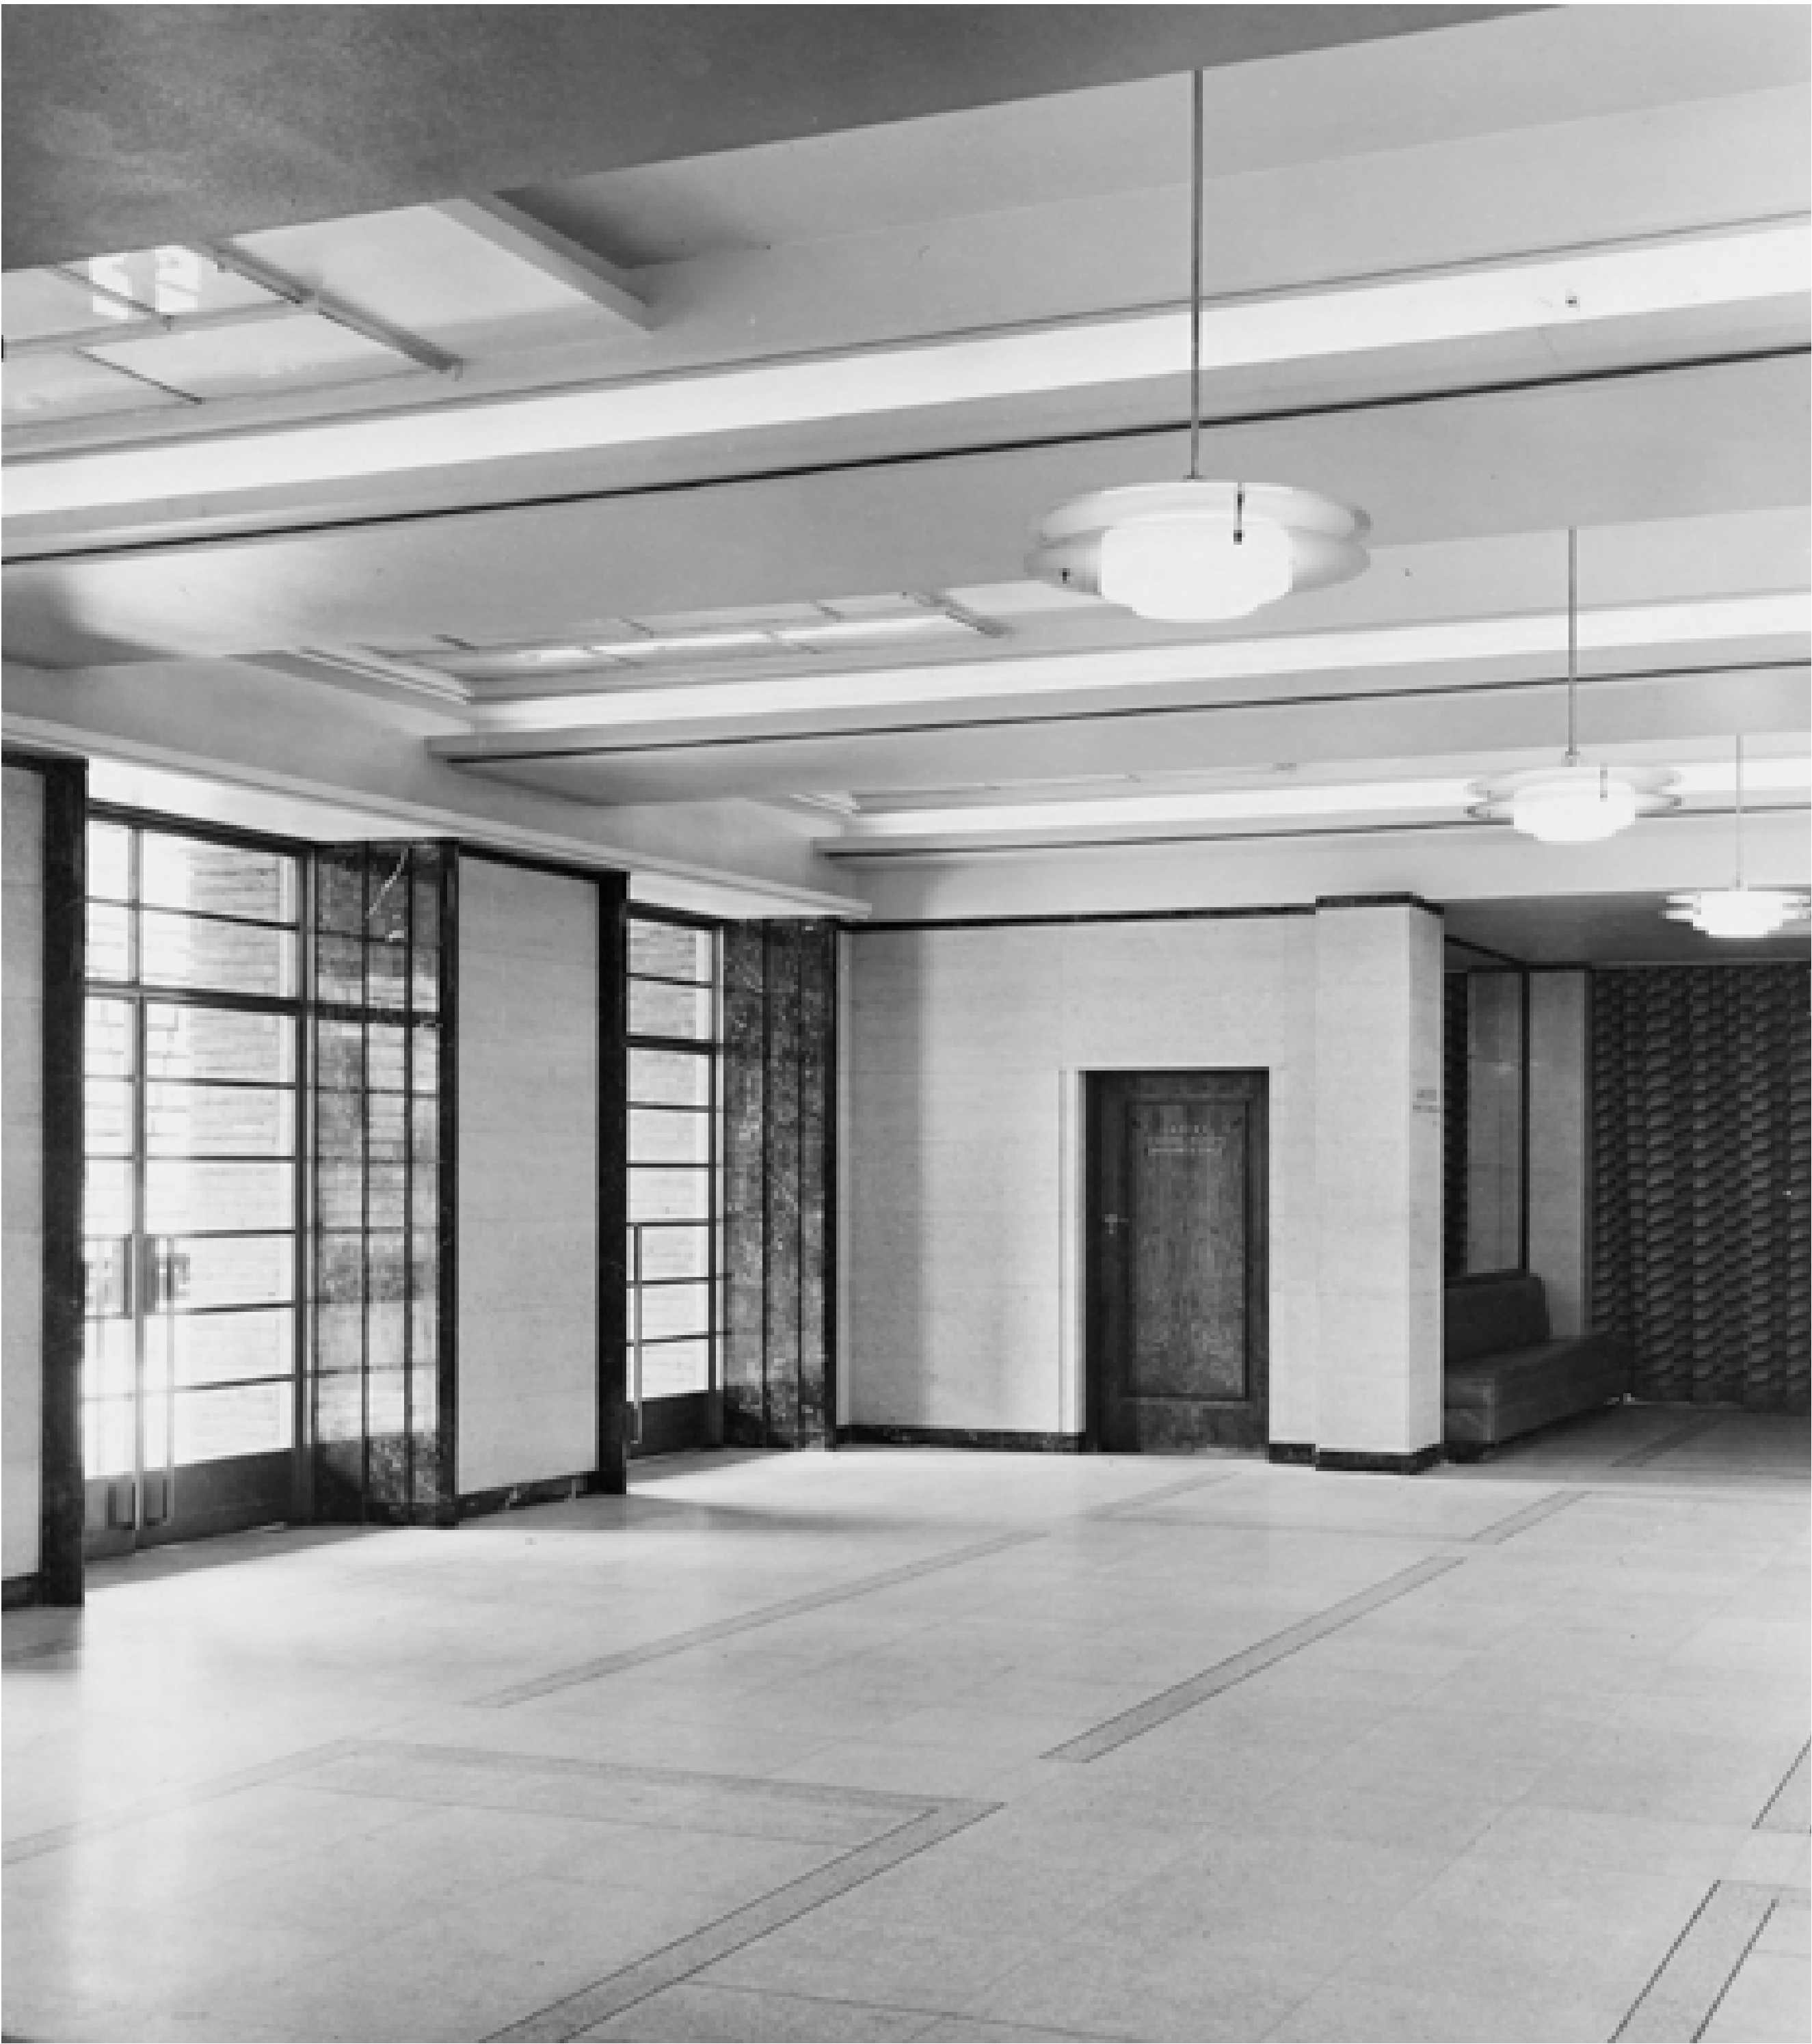
Summary; The original foyer has similar design aspiration to the Entrance Hall, it is connected to the entrance hall behind an original decorative screen and door which is to be refurbished and retained. The space is to be refurbished back to its original condition and use as a foyer to the main assembly hall. With the previous Ladies and Gentleman's Cloak Room's converted into new retail spaces leading off from the space.

Walls; Like the Entrance Hall, the walls in this space are clad in predominantly natural stone, this is to be refurbished and repaired with a section as marked up replaced with new to allow for the salvage of the existing stone to be used in repairs

There are two recessed seats with mirrored wall, these are in general good condition and are to be refurbished along with original seating.

Doors; The existing three entrance crittall doors have been replaced prior with modern timber doors, the existing frame and over-light remaining, these are to be replaced with replicas of the original doors as the refrence image. Similar all other doors in this space are to be refurbished or introduced with replicas to match the original doors.

elsewhere as the detailed mehtod statement ALT-418 and highlighted on page.

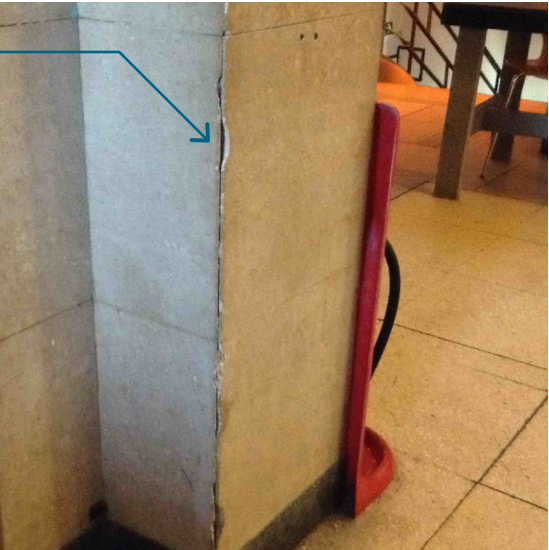
Cracked to edge of stones - to be repaired with resin infill by specialist

Missing stonework - to be replaced with salvaged stone
