Foyer

Detailed method statements have been submitted for the refurbishments of different architectural items. Referenced on the drawings with relevant codes to below drawings as below;

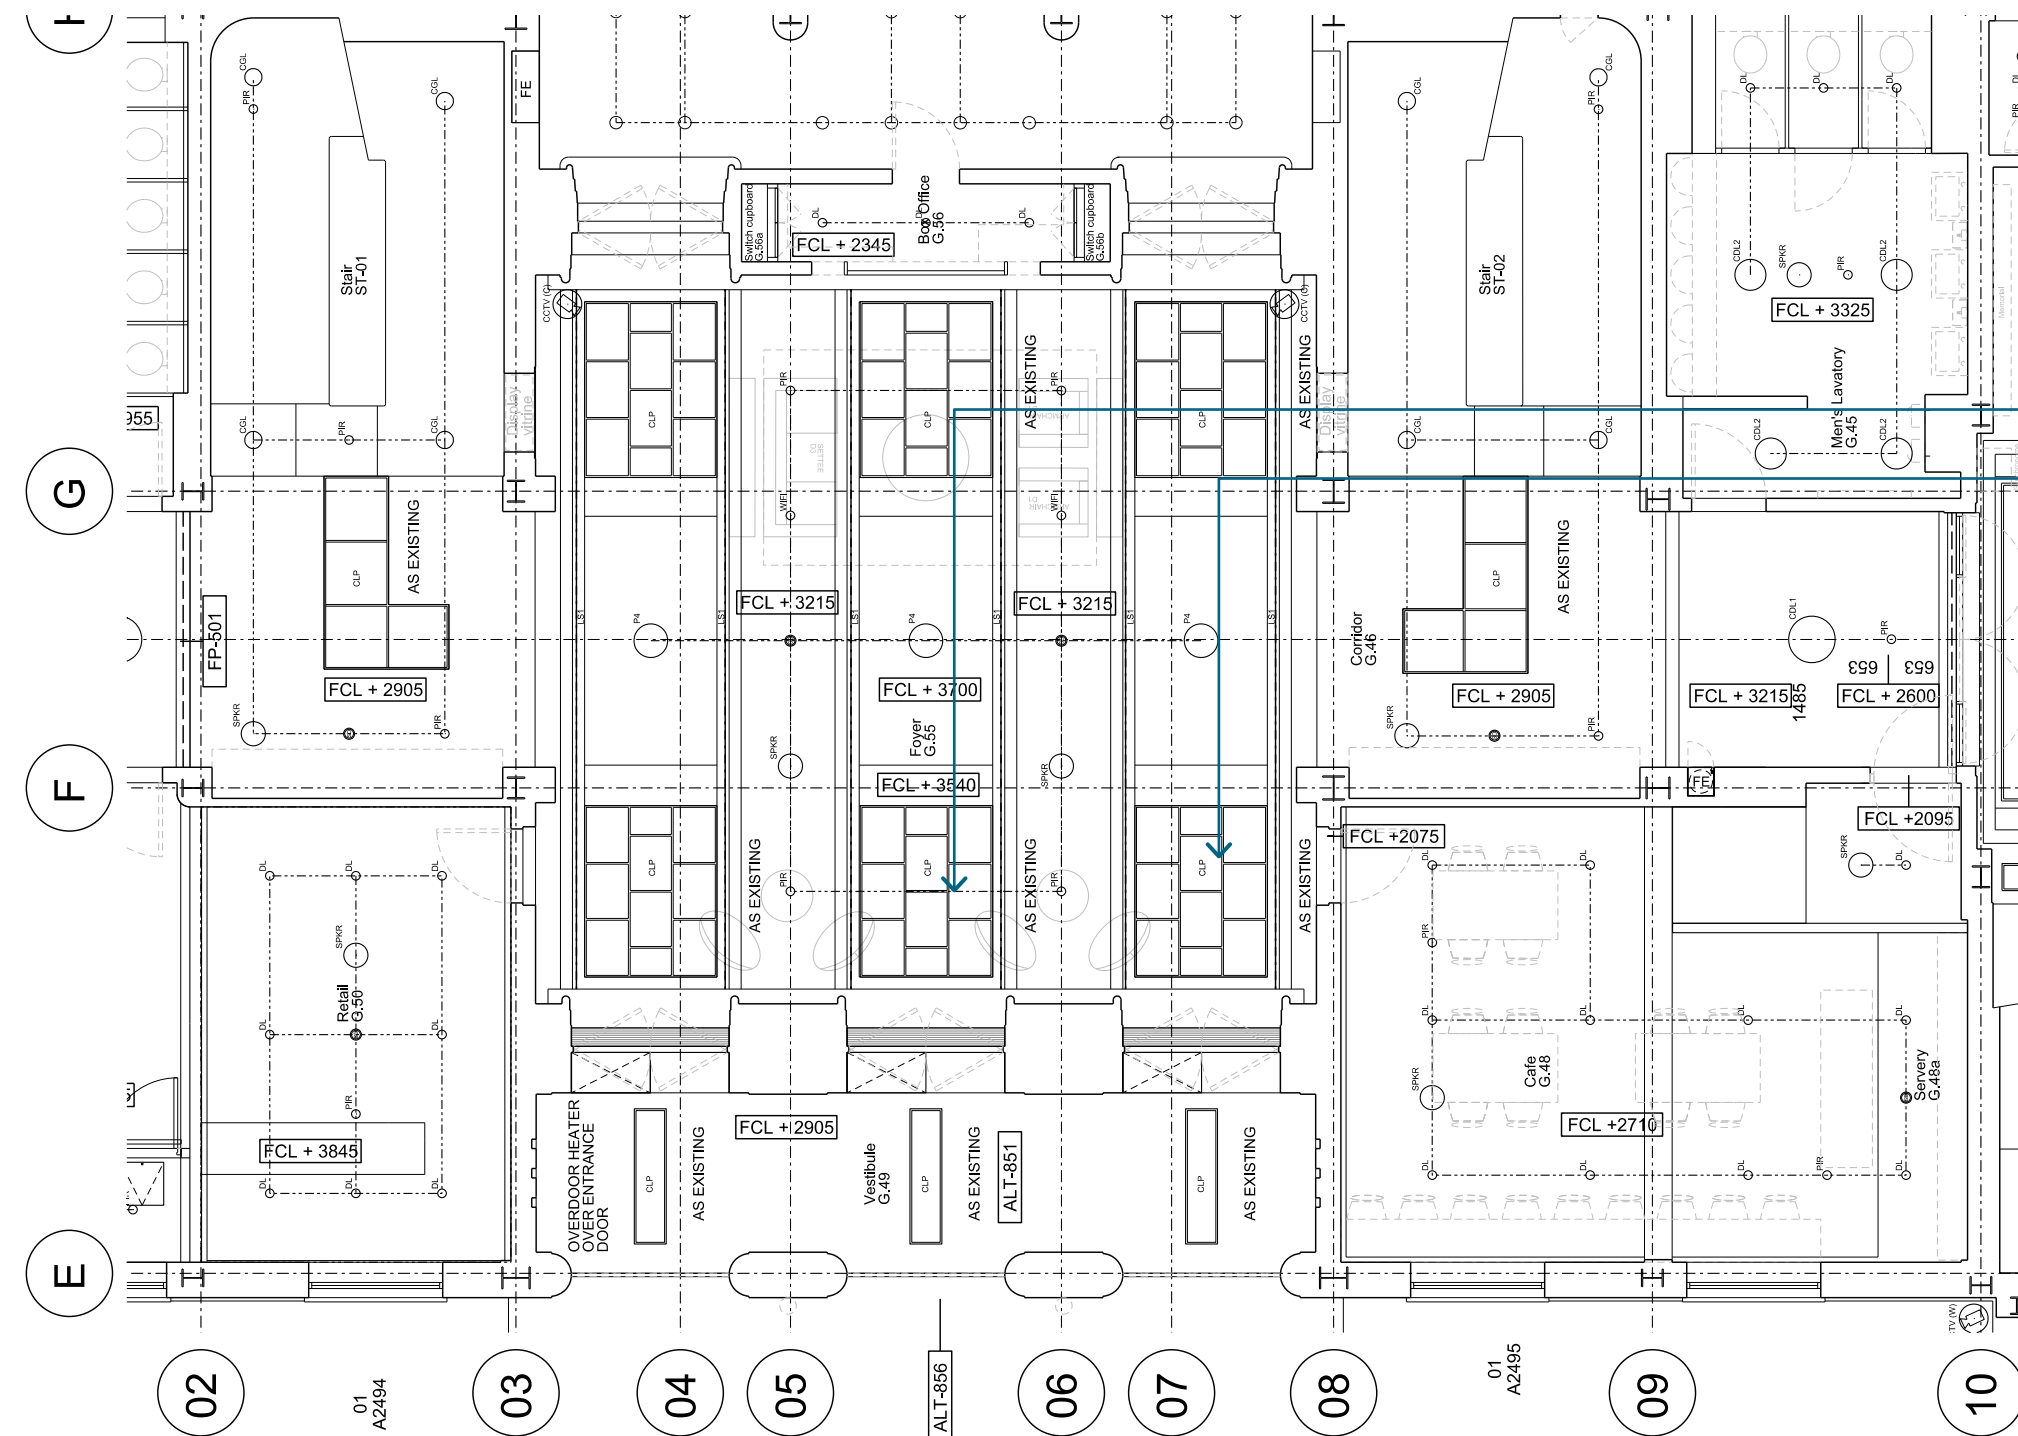
The majority of lighting is supplied from light-panels in the ceiling. These are off various configurations and are made up of a steel casement with glazing. They are to be repaired and refurbished with new LED lamps above.

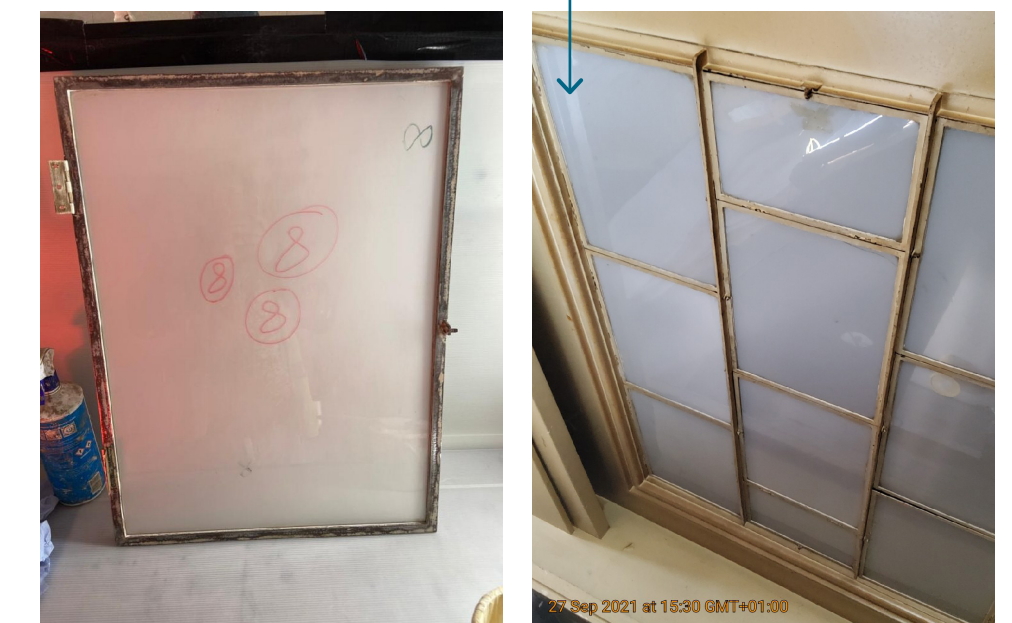
Light panel in existing condition

Each panel carefully released from position to be individually repaired and refurbished. Hinges, screws and ironmongery to be refurbished back to working order and replaced if missing. New paint finish to be applied and any broken glazing to be replaced like for like.
