## Report on Structural Inspection

**23b Cranbrook Park  
Wood Green**

**Job No. 21-113  
March 2021**

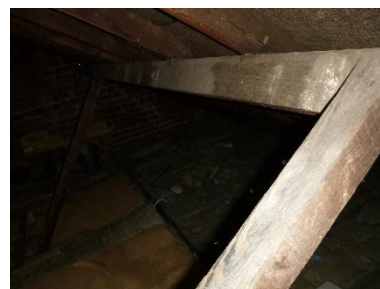
The roof structure is a traditional site-cut timber carcase with softwood rafters coupled at eaves level by the ceiling joists and supported by purlins braced with struts.

The size of the rafters and purlins was completely inadequate for the size of the roof and it is fortunate that the replacement tiles were not heavier concrete as used on the next-door property.

- ii. The rafters will not bear the weight of additional insulation and ceilings, and will most likely need to be replaced.
- iii. The ceiling joists (even if the normal size) would not support the imposed load on a domestic floor, and so would normally be augmented by timber joists laid parallel. The ceiling joists will need to be suspended from this new floor platform to allow the binders to be removed.
