2 Tree Claim - 20a Crescent Rd

#### **REQUEST FOR TREE REMOVAL**

We have been asked by AXA Retail - Avantia to comment on movement that has taken place to the above property. We are required to briefly describe the damage, establish a likely cause and list any remedial measures that may be needed.

# Arboricultural Appraisal Report

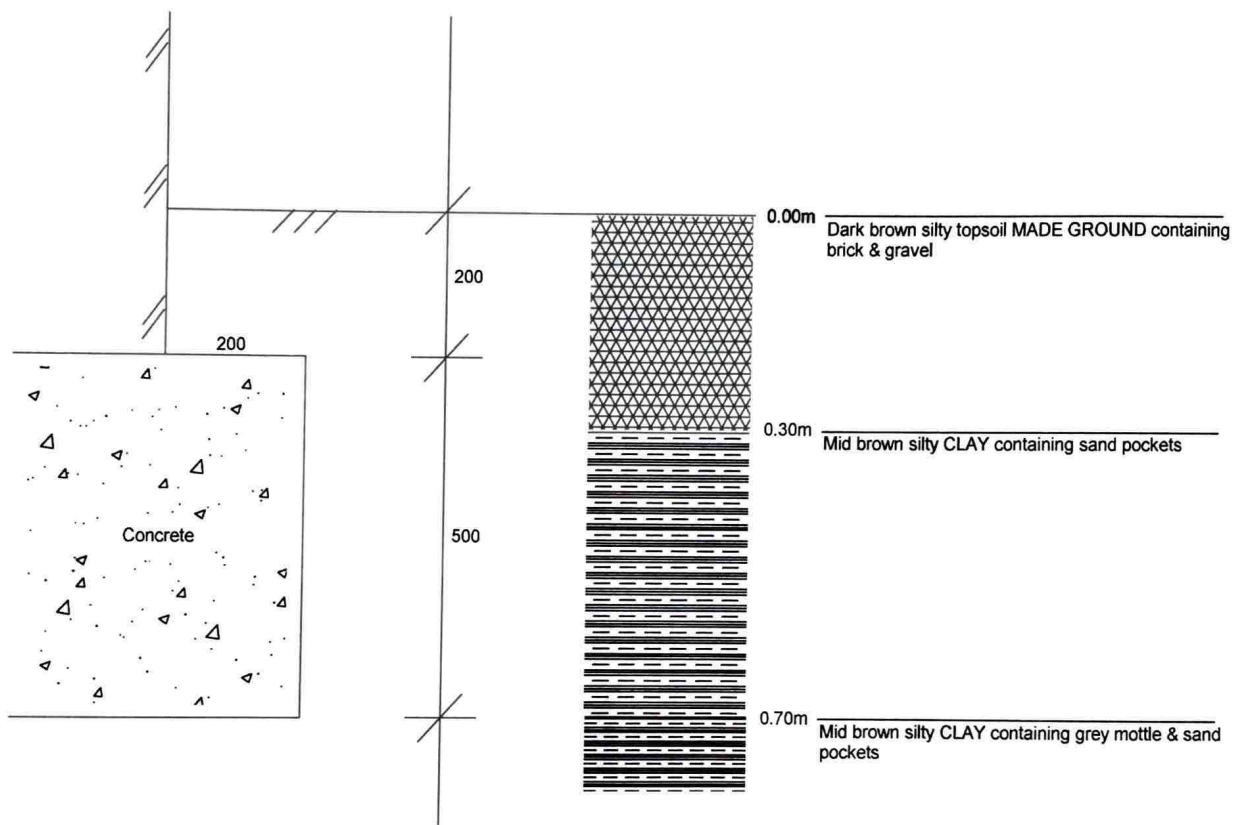
D1 @ F.L. (0.20m)

V = 92-94kPa

Founding strata: Mid brown silty CLAY containing grey mottle  
& sand pockets

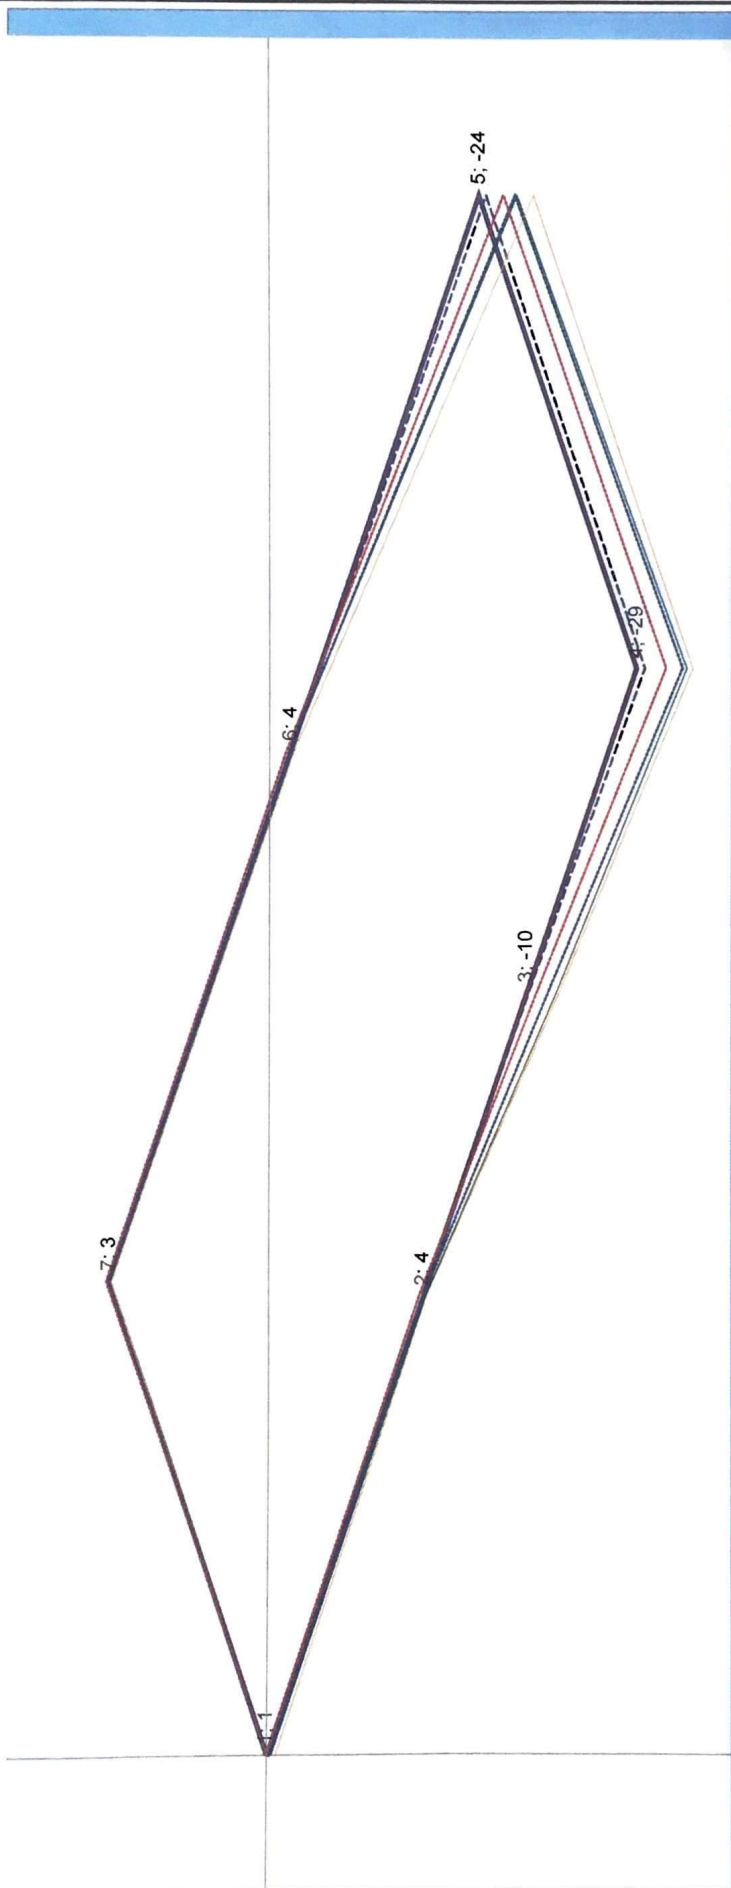
| Datum Reading | Reading 1 (11/4/22) | Reading 2 (6/6/22) | Reading 3 (11/8/22) | Reading 4 (3/10/22) | Reading 5 (1/12/22) | Reading 6 (9/2/23) |
