# Arboricultural Appraisal Report

## Subsidence Damage Investigation at:

19 Leaside Avenue  
London  
N10 3BT

CLIENT: Sedgwick  
CLIENT REF: 10935870  
MWA REF: SUB251128-17331  
MWA CONSULTANT: Andy Clark  
REPORT DATE: 17/12/2025

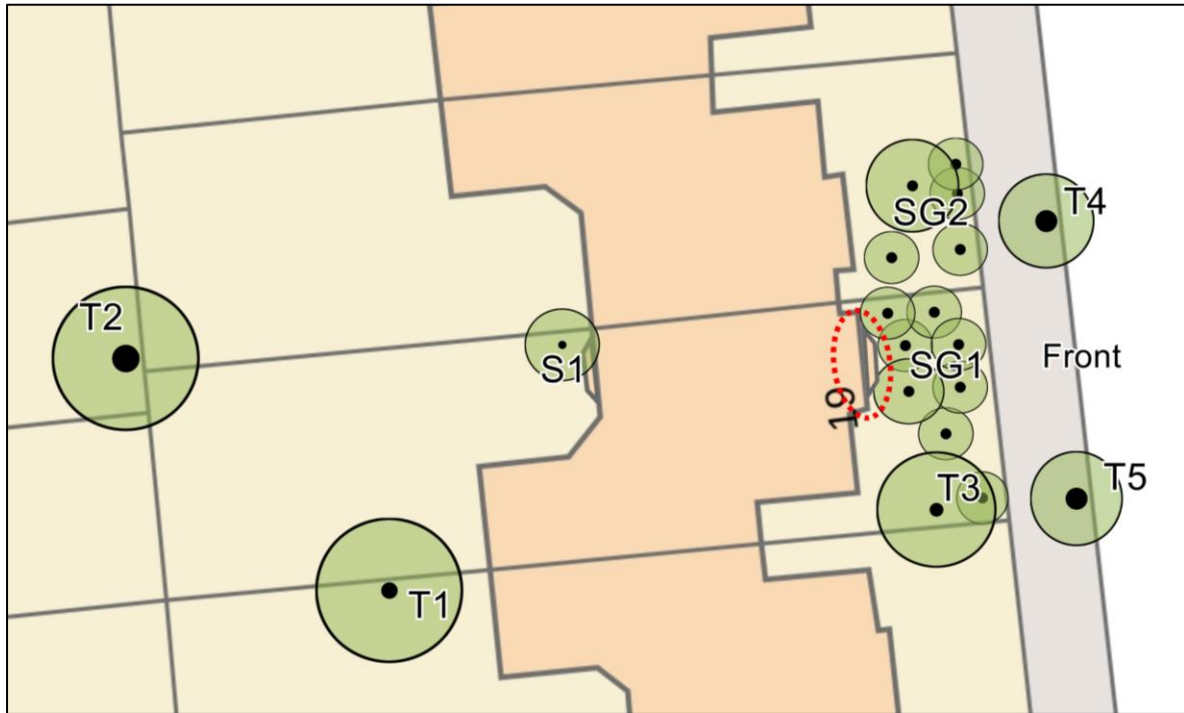
## Site Plan

Our survey has identified vegetation with the potential to influence soils below foundation level of the building/area of movement, the most significant of which are set out at Table 1 below.

Approximate areas of damage

If an arboricultural solution is to be implemented to mitigate the influence of the trees/vegetation considered to be responsible for the movement/damage, we recommend that the nearby shrubs of the SG1 group and the T3 Laburnum are removed in the first instance.
