Treeworks Application

43 Langdon Park Road, London N6 5PT

17 September 2024

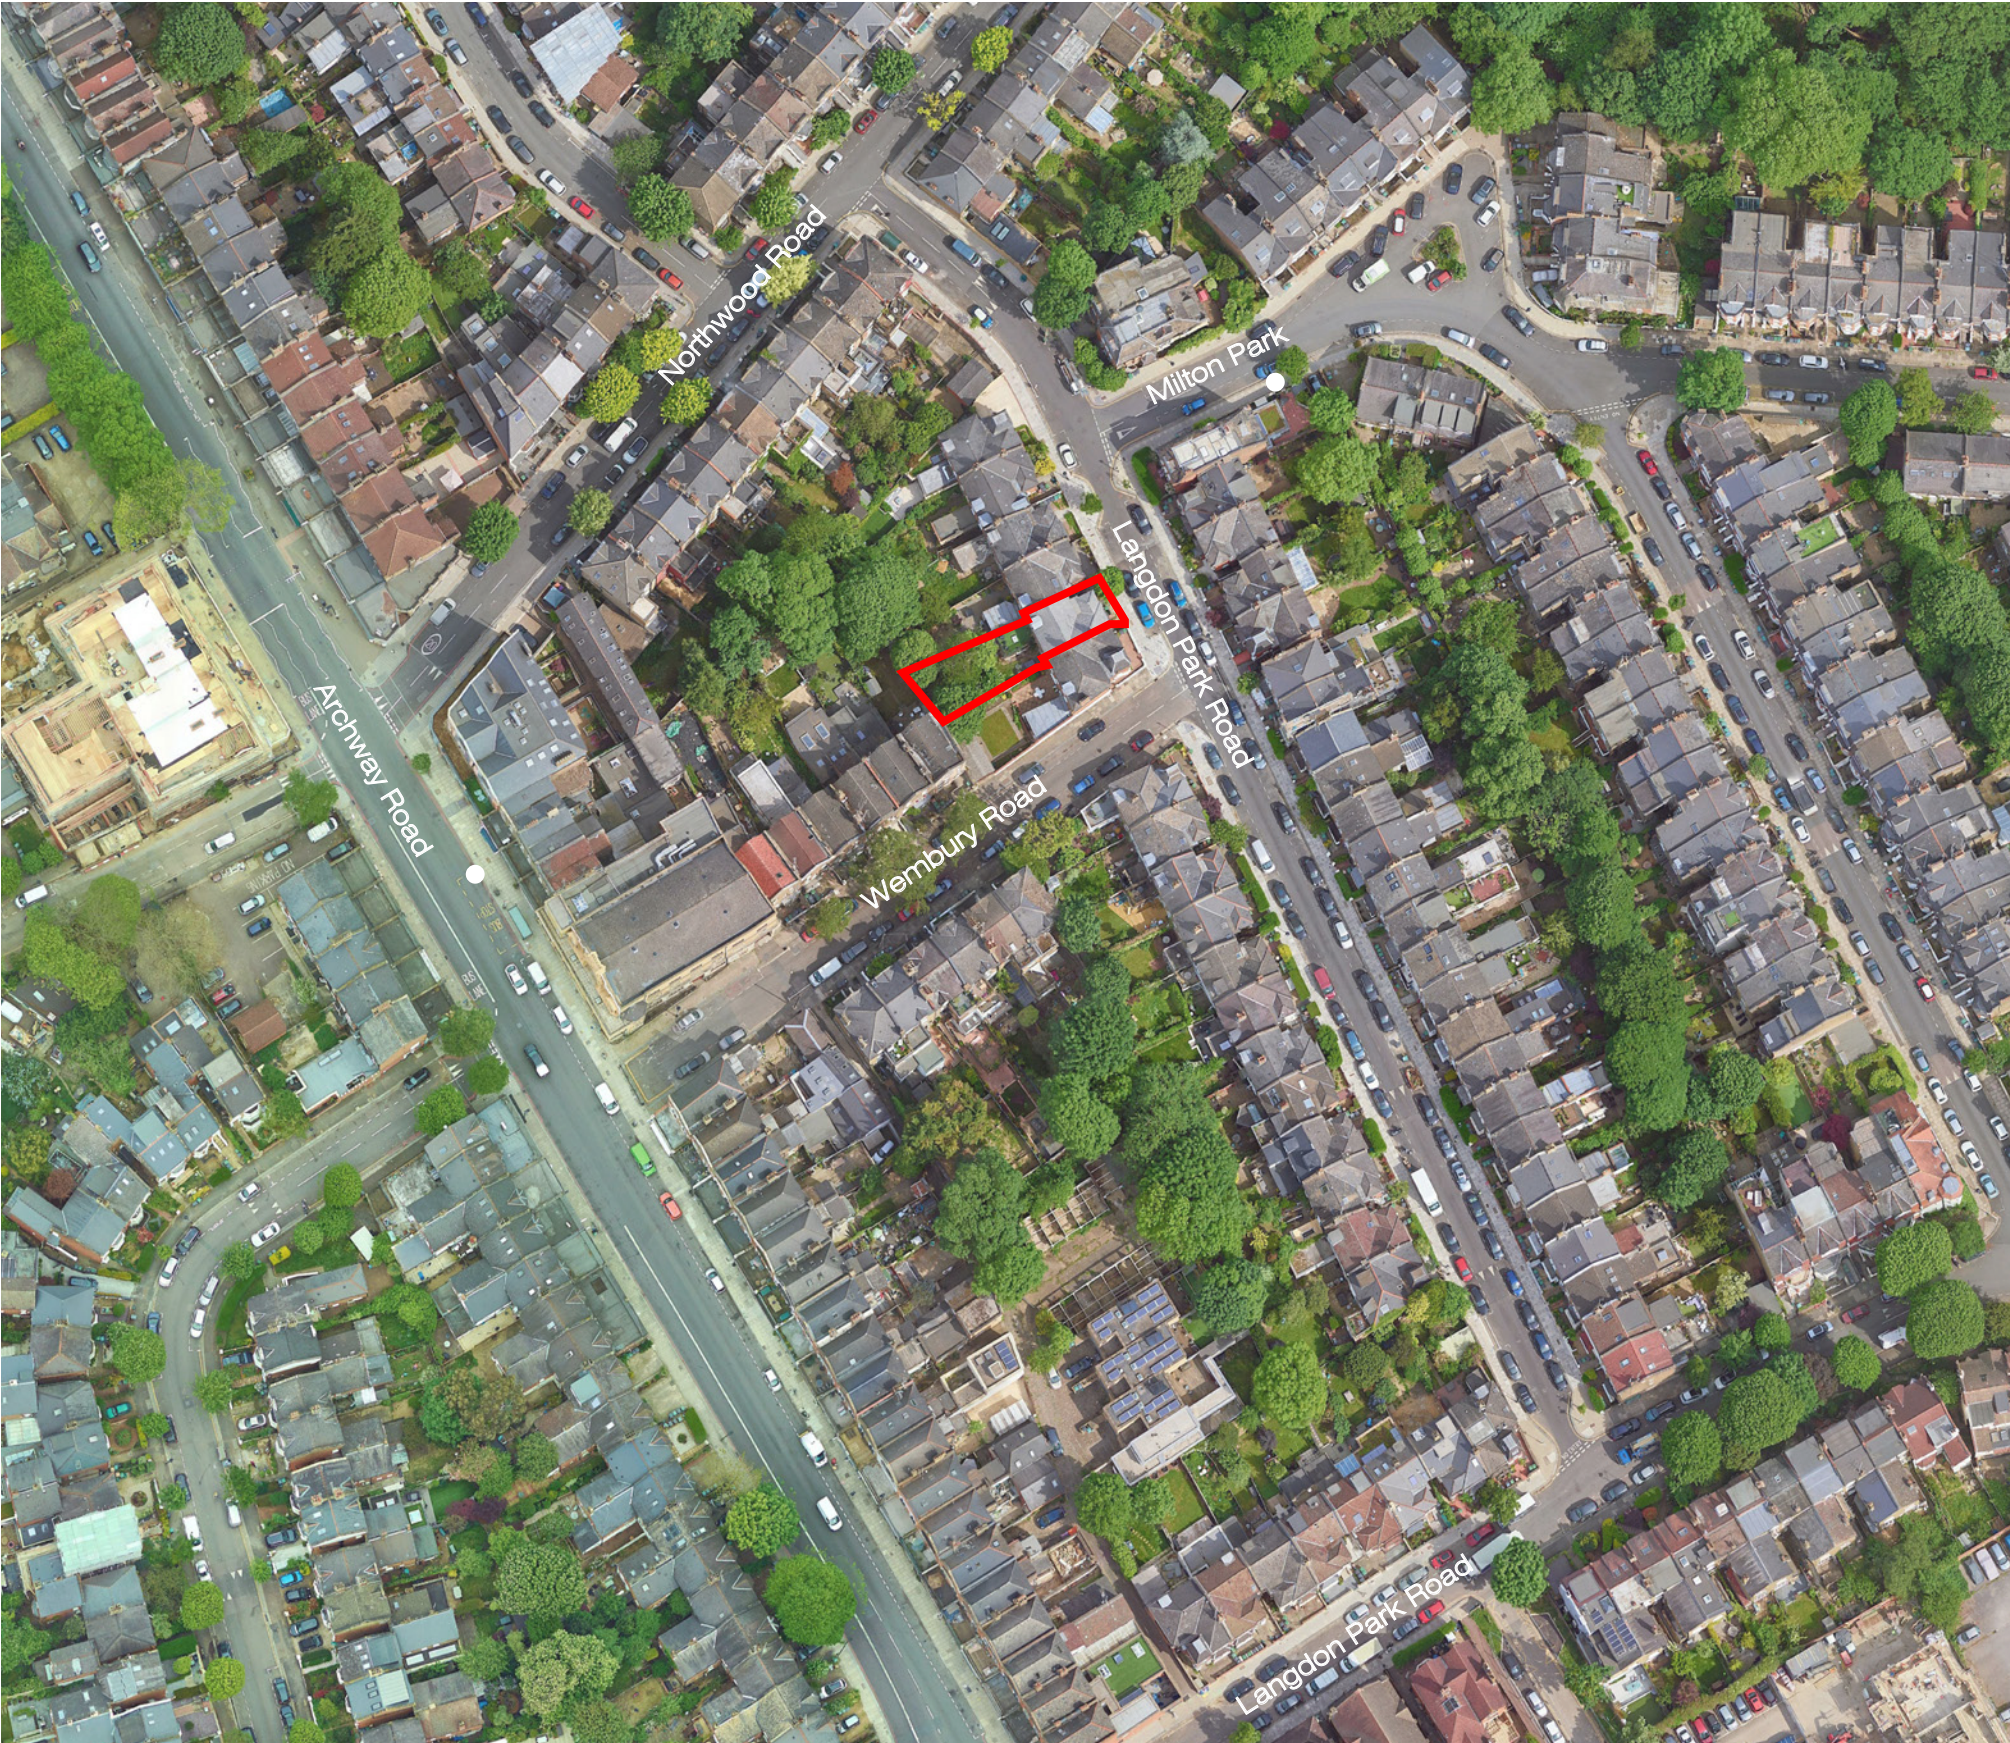
Approximate outline of site

The lime tree together with its root system are within influencing distance of the front of the house, 2.4 metres, and close to the boundary of the neighbouring property at 45 Langdon Park Road: see plan on page 4 and photos on page 6.

The following proposal is an application to remove a lime tree sited at the front boundary wall of 43 Langdon Park Road.
