**Re: 59 Glasslyn Road, London N8 8RJ**

**59 GLASSLYN ROAD**

*Geotechnical Interpretative Report*

***CGK/00136/63***

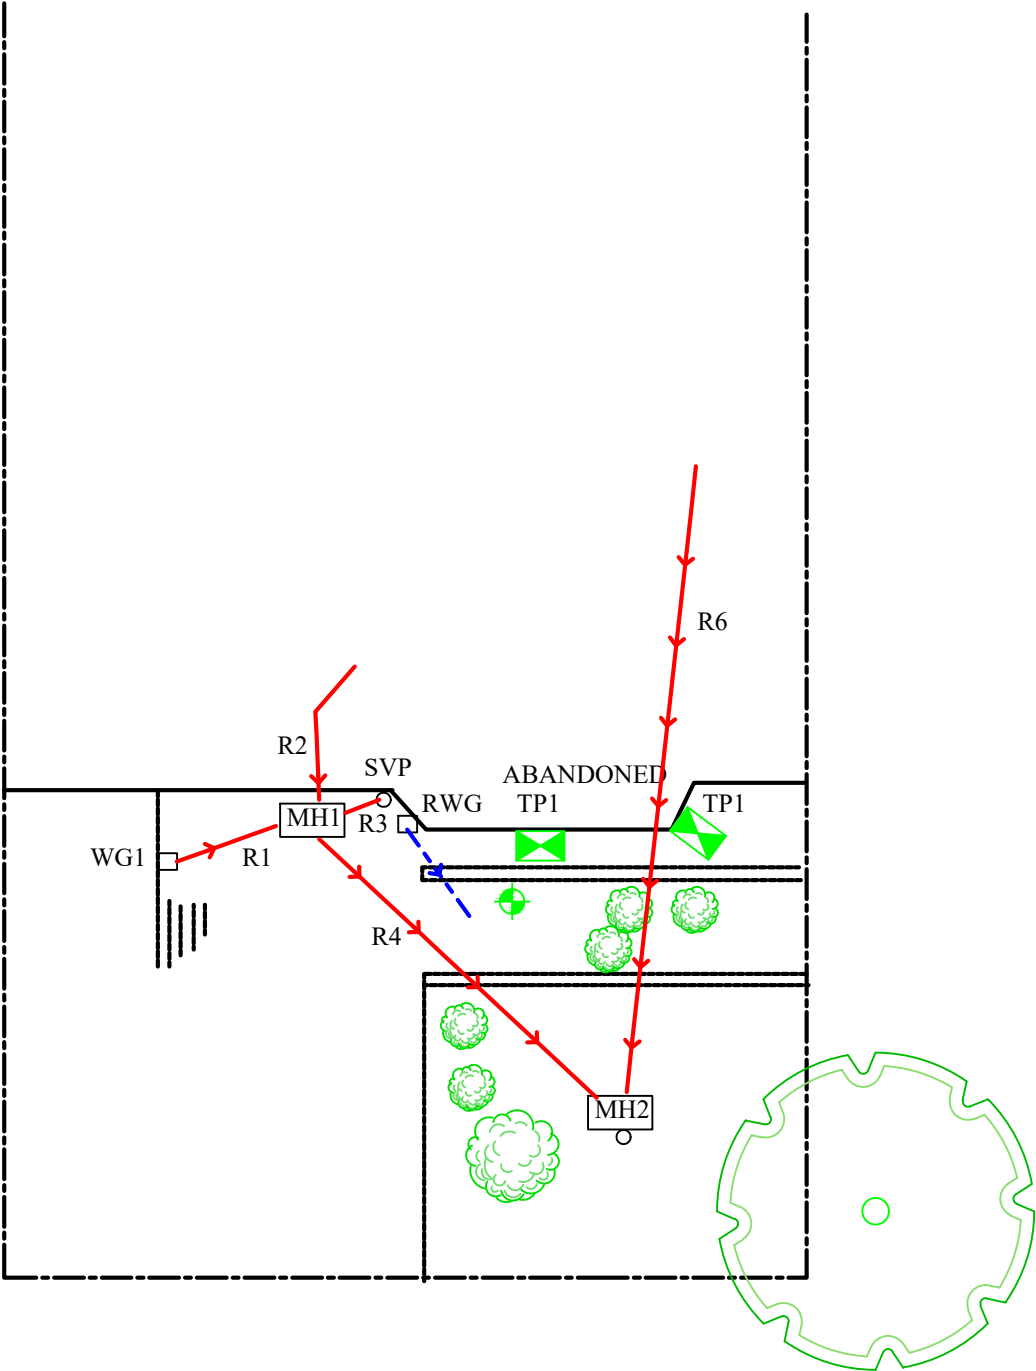
Roots were noted in the chamber of MH2, and within drainage runs R4 and R5. Runs R4 and R5 were also noted to have circumferential cracking in the CCTV survey.

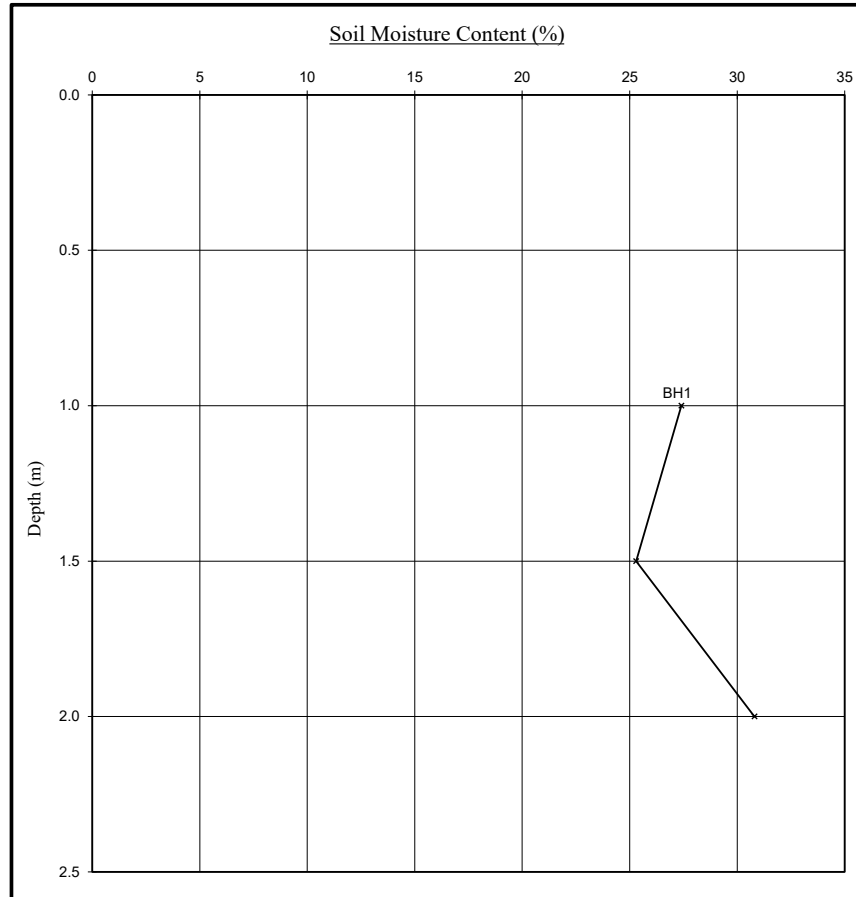
## Moisture Content Profiles

The moisture content of clay soils was compared to 40% of its Liquid Limit (LL) to give an indication of desiccation in the soil. Where the moisture content is greater than 40% of its LL, the sample would be identified as not desiccated. Using this method, all three samples are indicated to be desiccated.
