**“ST DUNSTAN’S COTTAGE”**  
**9 & 9a MUSWELL HILL, HARINGEY N10 3TH**

**HISTORIC BUILDING IMPACT ASSESSMENT**

Updated February 2026

COMPASS ARCHAEOLOGY LIMITED  
250 York Road, Battersea  
April 2025 / Updated February 2026  
Author: Gabriela Williams  
Amendments by Hannah Stralow Rees  
Telephone: 020 7801 9444  
E-mail: [mail@compassarchaeology.co.uk](mailto:mail@compassarchaeology.co.uk)  
Website: [www.compassarchaeology.co.uk](http://www.compassarchaeology.co.uk)  
©Compass Archaeology Ltd.

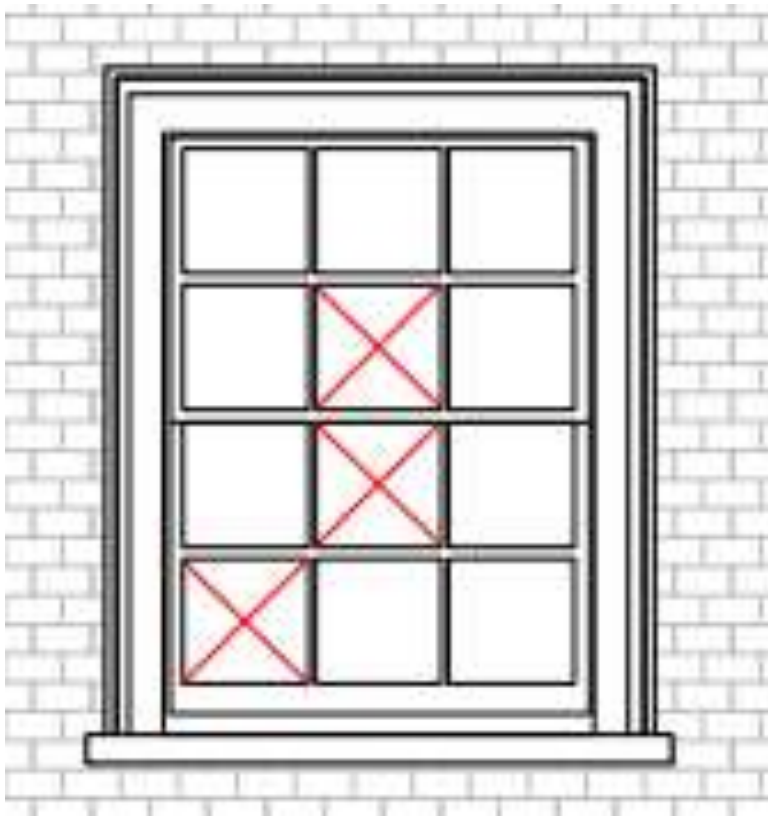
**Figure 16:** Lower left window, with possibly reused glass panes indicated.

The lower window within the stepped out section of the frontage is a traditional Georgian 6 over 6 sash window design; featuring four rows of three horizontal panes of glass separated by glazing bars. This window features three individual panes of glass which may be reused, whilst the remainder have been replaced (Figure 16). The older glass was indicated by warped patterns, striations and bubbling within the glass due to inconsistent glass production methods. This observation is also compatible with traditional methods of construction for sash windows as it was easier to produce smaller panes of glass and attach them via glazing bars to produce a larger design.

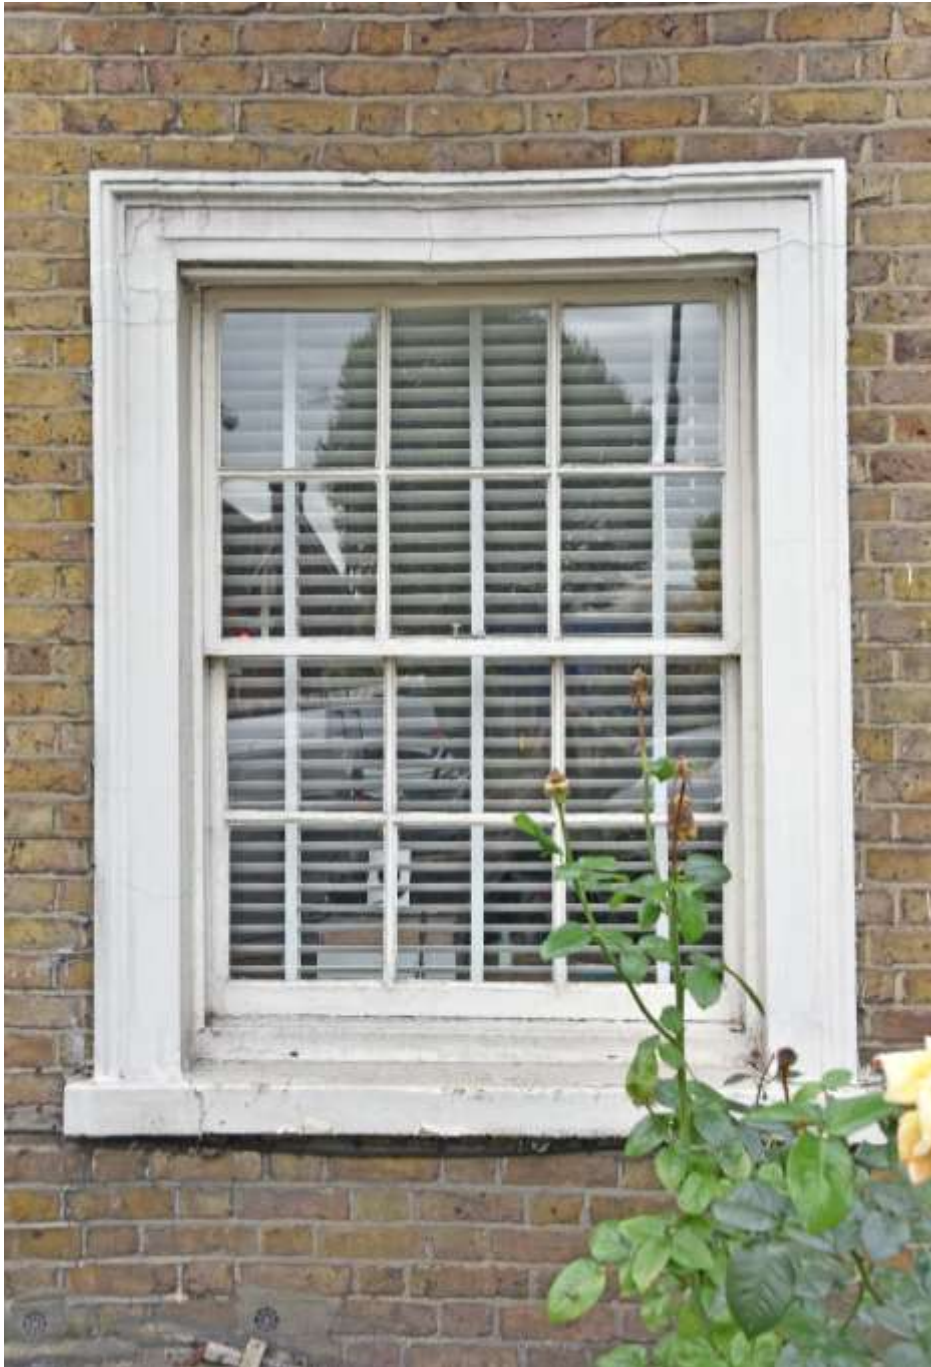
**Figure 17:** Photograph of the ground floor left window on the front façade. Taken 22.10.24.

The window surround features several cracks and is damaged in multiple areas. It has been repainted several times, with thickened areas of paint resulting in the decreased

functionality of the window (Figures 18 and 19). The bottom rail of the lower sash measured 60mm in height, whilst the meeting rails were 24mm in height. The glazing bars for this window typically measured 6-7mm in width, but it was apparent from the interior inspection that those within the lower sash had been replaced at some point (see 6.11.2, Area C).

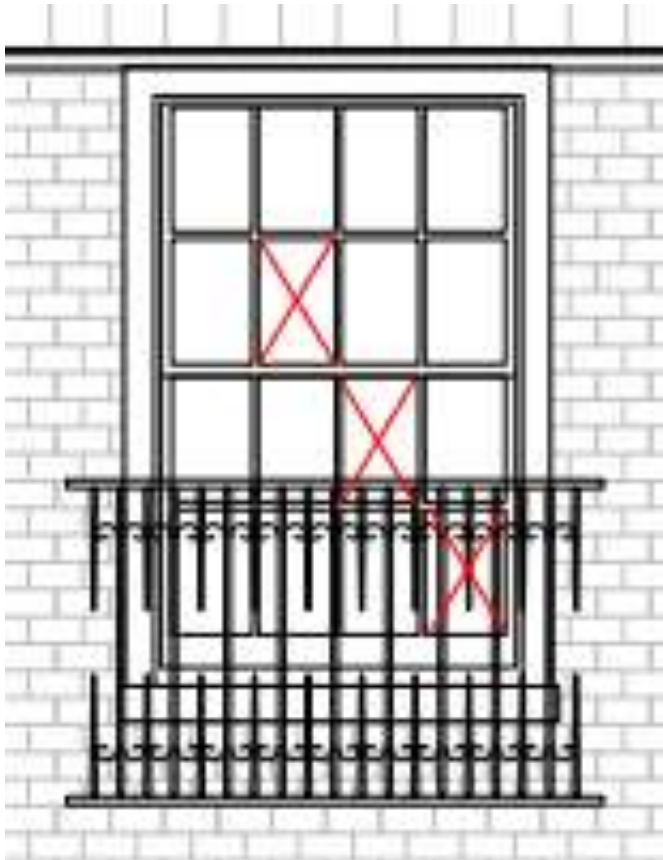
**Figure 21:** Upper left window, with the panes thought to be reused marked in red.

The upper window within the stepped out section of the frontage is immediately observable as differing from the remaining windows on the front façade of the building. Instead of the Georgian 6 over 6 sash window design which can be observed in the other windows, this window is an 8 over 8 design, hence four rows each of four glass panes separated by glazing bars. This window also features three panes of glass which appear to be older (Figure 21) – that is, in relation to the sash window rather than the

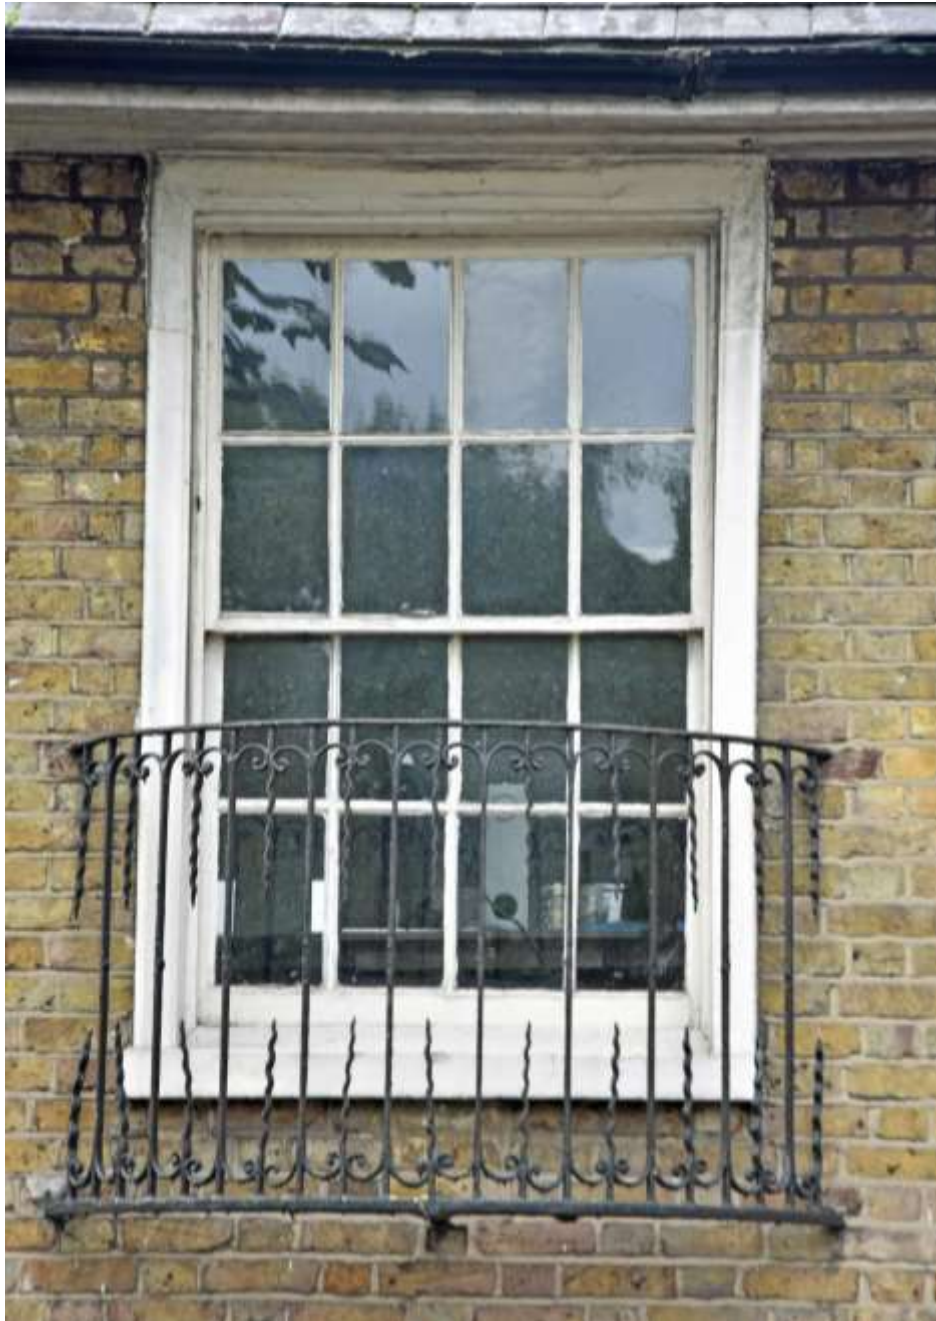
**Figure 22:** Photograph of the first floor left window on the front façade. Taken 22.10.24.

Similarly to the lower left window, the upper left window's surround features several cracks and is damaged in multiple areas. It has been repainted several times, with thickened areas of paint resulting in the decreased functionality of the window. The bottom rail of the lower sash measured 64mm in height, whilst the meeting rail was 18mm in height. The glazing bars for this window measured 3-4mm in width, making

Both the upper left and upper right (See Section 6.3.6) windows feature wrought iron segmental balconettes. As previously noted, these balconettes were not present in the c.1855 photograph of the house (Figure 5) but can be observed in the 1910 photograph (Figure 9). Therefore, the features can be dated to c.1855-1910 but are not original to the house's construction. The balconette for the upper left window features damage in the form of bent spikes and minor flaking to the paintwork.

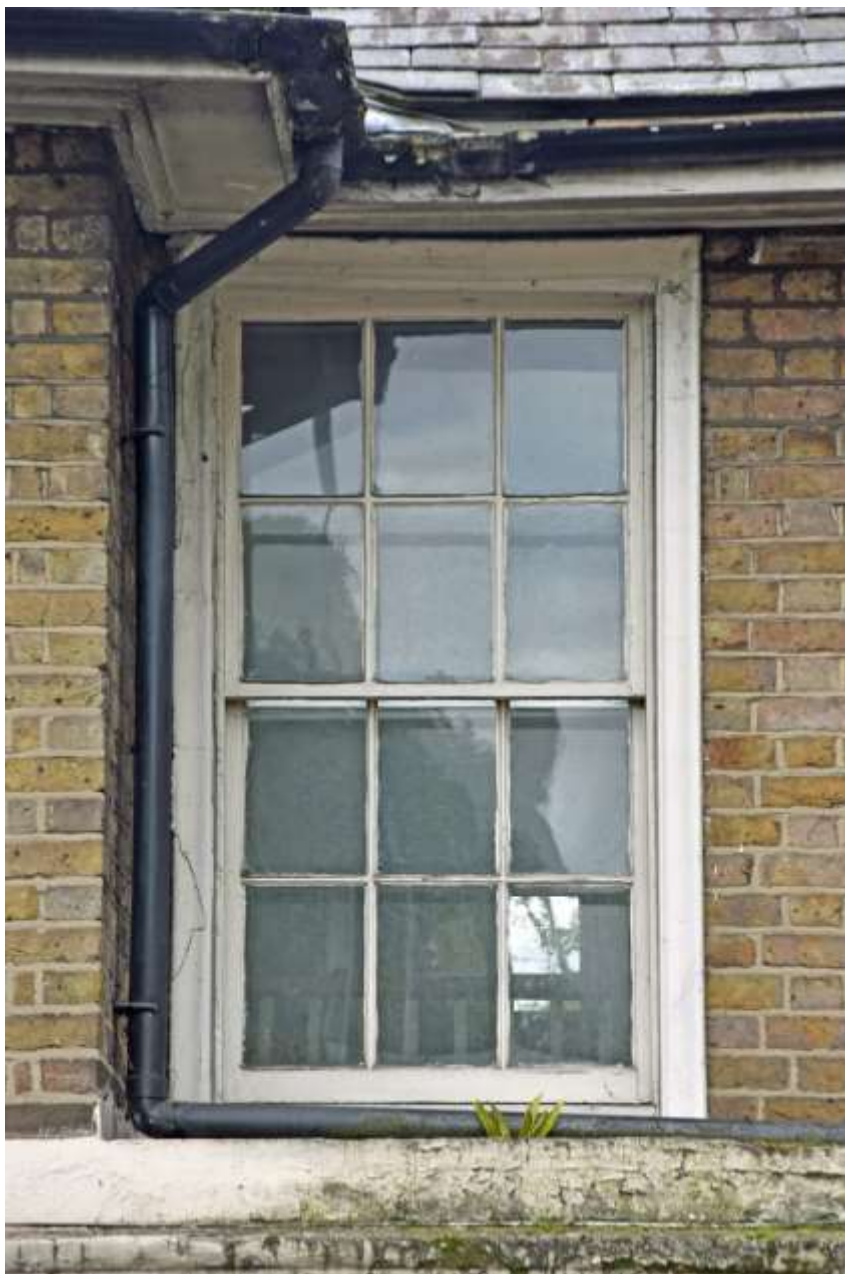
**Figure 25:** Photograph of the first floor central window on the front façade. Taken 22.10.24.

The upper central window is located directly above the front door, and is partially obscured by rainwater drainage pipes. This window also features a traditional Georgian 6 over 6 sash window design, although it is significantly smaller in width compared to the other windows on the building's frontage. This is thought to be the only window which is entirely original to the first phase of construction for the building, as it features older glass and a fluted style of glazing bar which has been identified as the lambs tongue style, popular in the 18<sup>th</sup> and 19<sup>th</sup> Centuries. The majority of the windows within the property were in the later Ovolo & Fillet design, suggesting they were, at least in part, replaced during the later 19<sup>th</sup> Century. In comparison, the upper central window appears to have retained all its original features, and is thought to be the only window in the property which has not been refurbished in some manner or replaced.

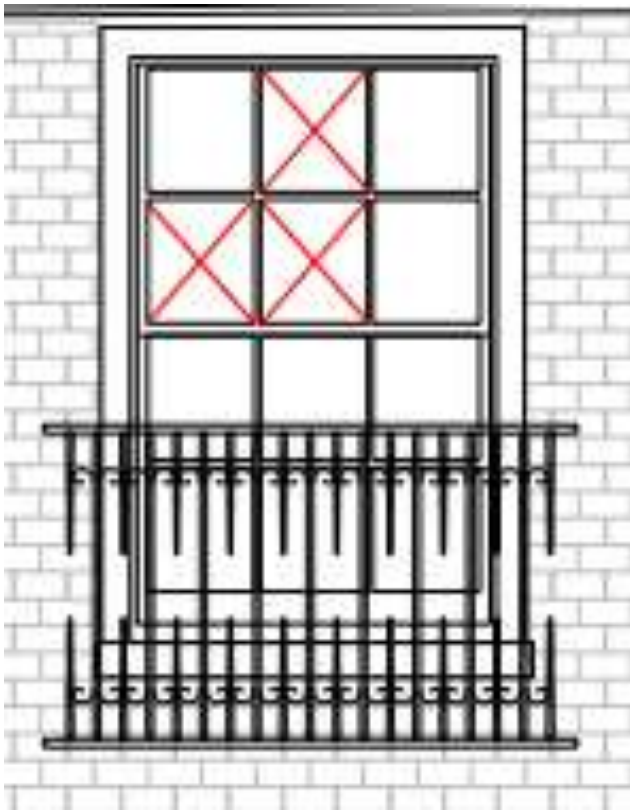
**Figure 27:** Upper right window, with the panes thought to be reused marked in red.

The upper right window also features a Georgian 6 over 6 sash window design, with horizontal lines of three panes attached by glazing bars. The glazing bars are in the later 19<sup>th</sup> Century Ovolo & Fillet design, with three panes in the upper sash that may have been reused or salvaged from elsewhere (Figure 27).

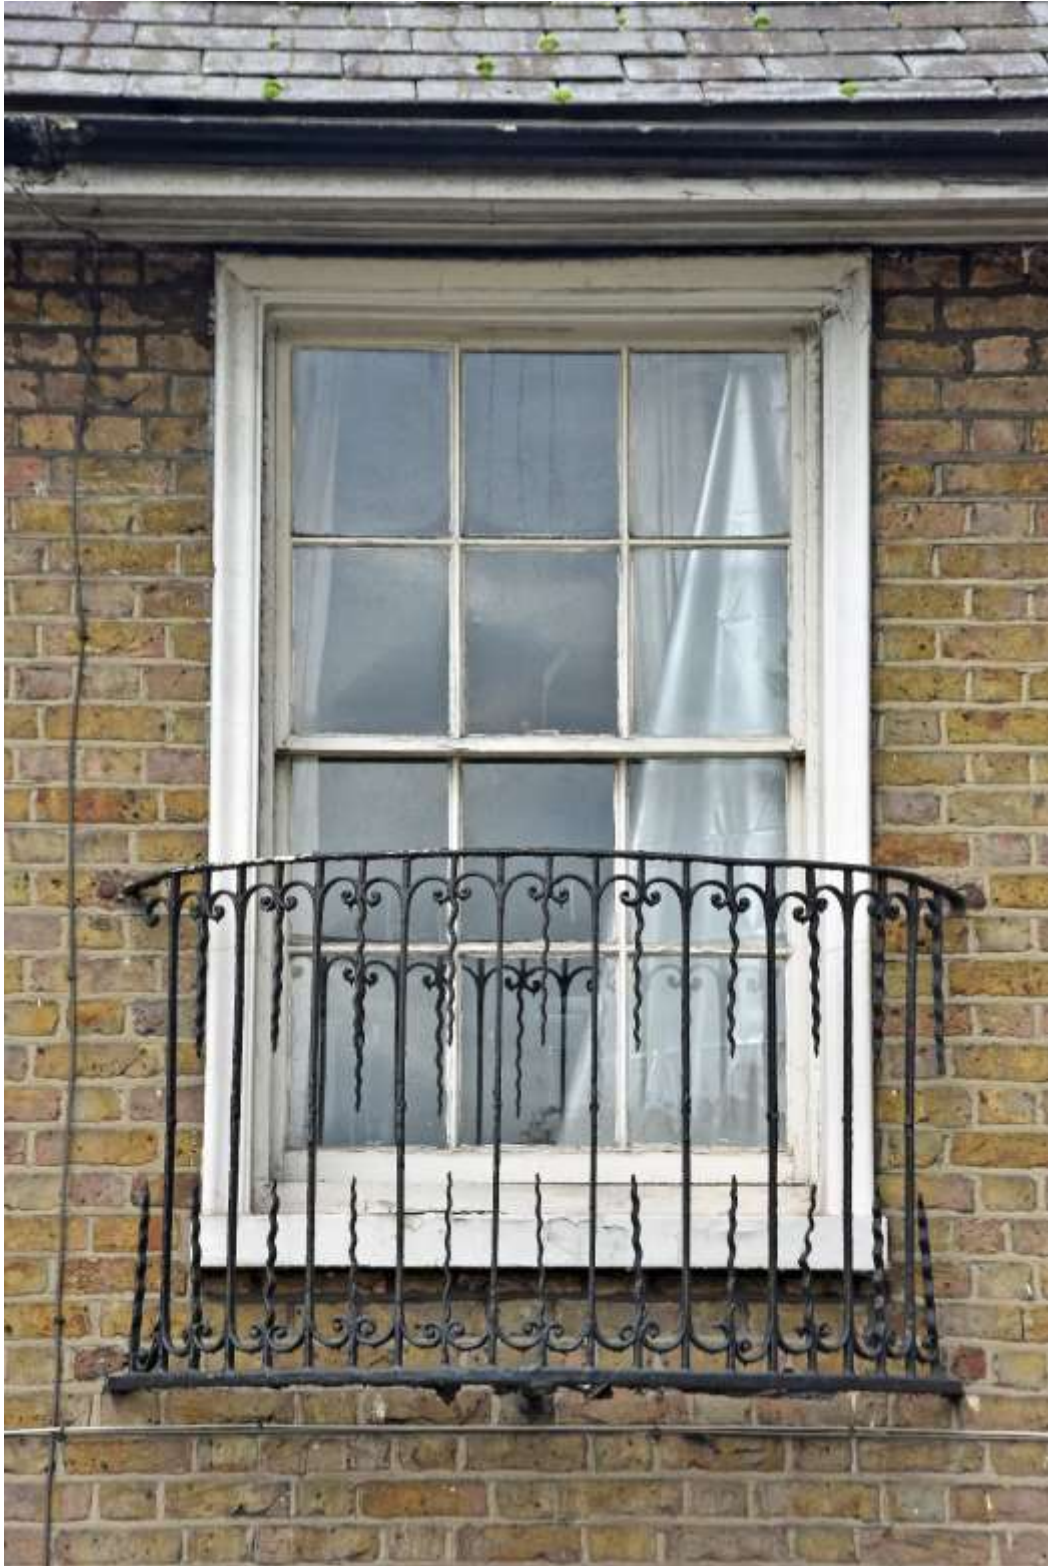
**Figure 29:** Photograph of the first floor right window on the front façade. Taken 22.10.24.

This window features a matching wrought iron segmental balconette to the upper left window (Section 6.3.4). As previously mentioned, these balconettes date to approximately 1855-1910, and are not original to the construction of the house. The upper right window's balconette features more significant damage than the left; with a spike missing from the design, warping of the metal, and extensive flaking of the existing paint (Figure 28, previous).

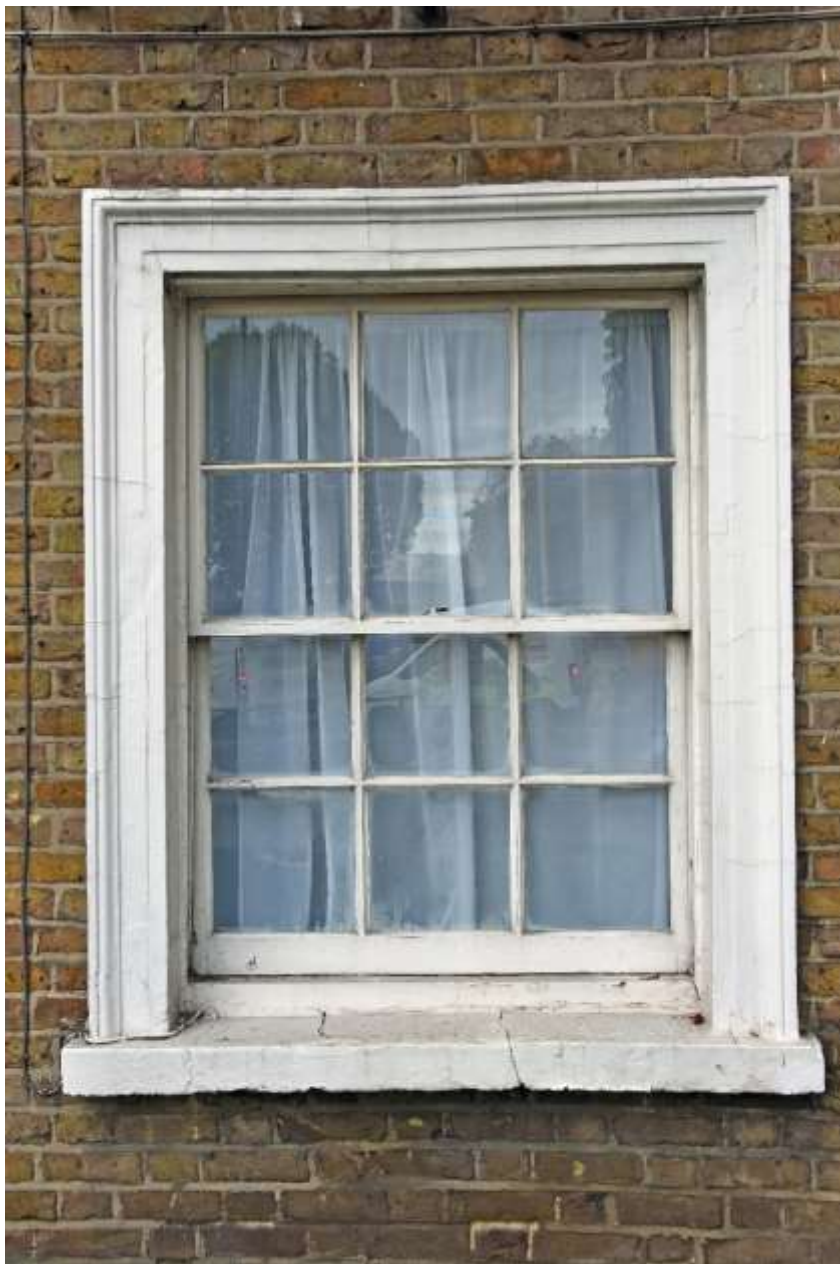
**Figure 31:** Photograph of the ground floor right window on the front façade. Taken 22.10.24.

On first glance, the lower right window is similar in design to the lower left window and is observable as a traditional Georgian 6 over 6 sash window; featuring four rows of three horizontal panes of glass separated by glazing bars. However, the windows are not identical and vary significantly.

Firstly, the dimensions of the windows differ with the bottom rail of the lower sash for the lower right window measuring 81mm in height, whilst the meeting rail was 26mm in height. The glazing bars for this window measured 7mm in width. Additionally, whilst the lower left window had retained some of its original features; the entirety of the lower right window appears to have been replaced. Notably, it is also the only window on the front façade in which the mortise and tenon construction that holds the glazing bars in place is not cut through to the exterior of the sash (& therefore visible top & bottom). The glazing bars are all a modernised version of the Ovolo & Fillet design. The glass within the window is also all modern and factory made, as determinable by the consistency of the glass and its lack of imperfections. The only feature thought to be original within this window is the stone window sill, which has been repainted several times.

The lower right window frame is in a similar state of disrepair to the lower left, as the window surround features several cracks and is damaged in multiple areas. It has been repainted several times, with thickened areas of paint resulting in the decreased functionality of the window and flaking paint is observable throughout (Figures 32 and 33).

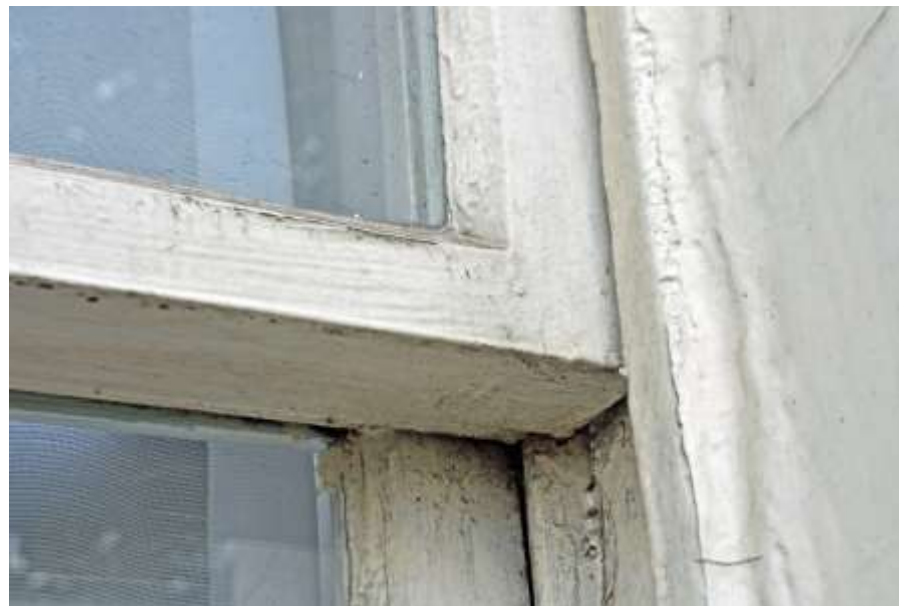
**Figure 32:** Detail of lower right window; areas of thickened paint visible.

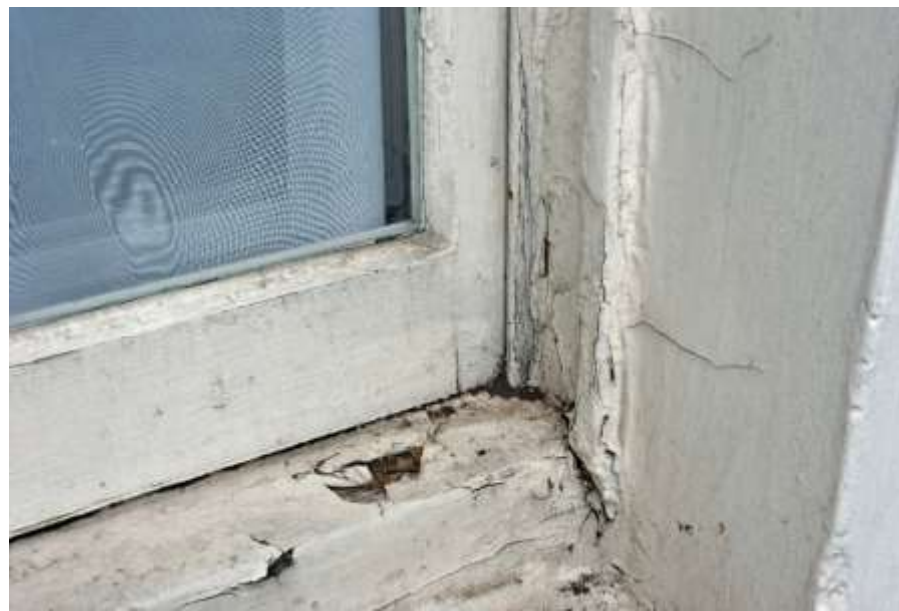
**Figure 33:** Detail of lower right window; areas of thickened/flaking paint visible.

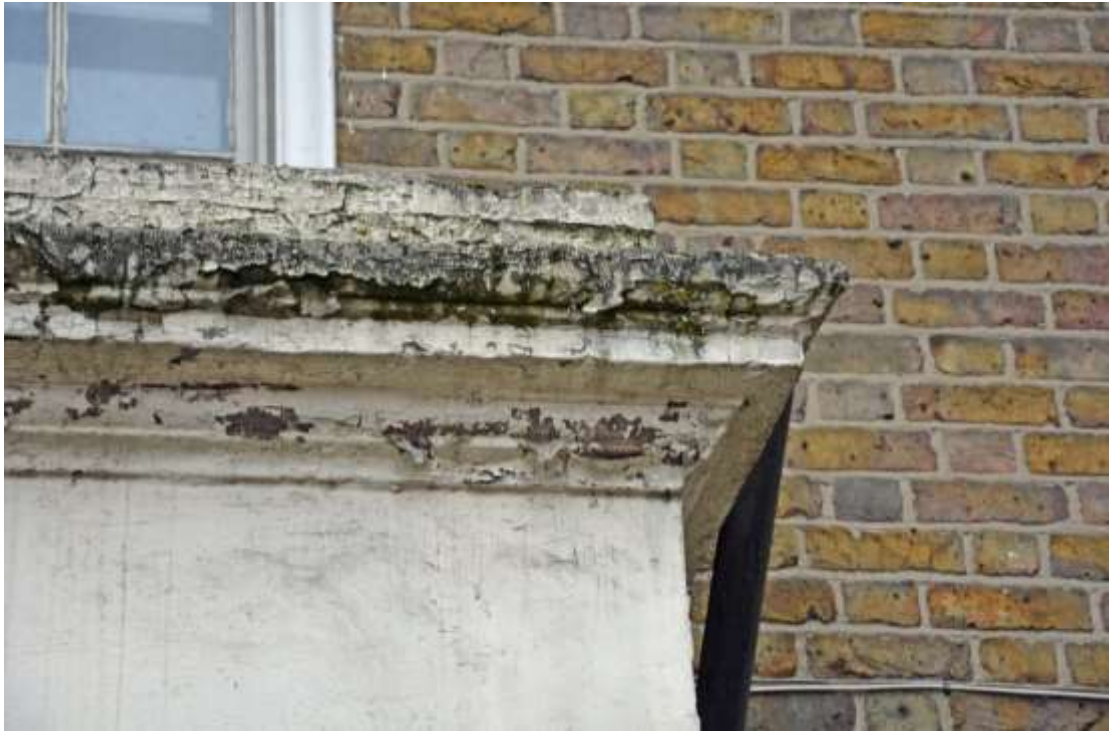
The principle entrance to 9 Muswell Hill features a prominent stucco porch with pilasters and entablature. The porch has a flat roof, and has been utilised in routing the rainwater drainage pipes. The condition of the stucco surface is poor, with significant cracking, discoloration, and flaking visible throughout the porch – although the upper right corner has been most affected (Figure 35). This porch appears to be original and is observable in the 1855 and 1910 historic photographs of the residence (Figures 5 and 9), although it has likely been repaired several times during the following years.

**Figure 35:** Detail of upper right corner of front porch, heavily damaged external rendering.

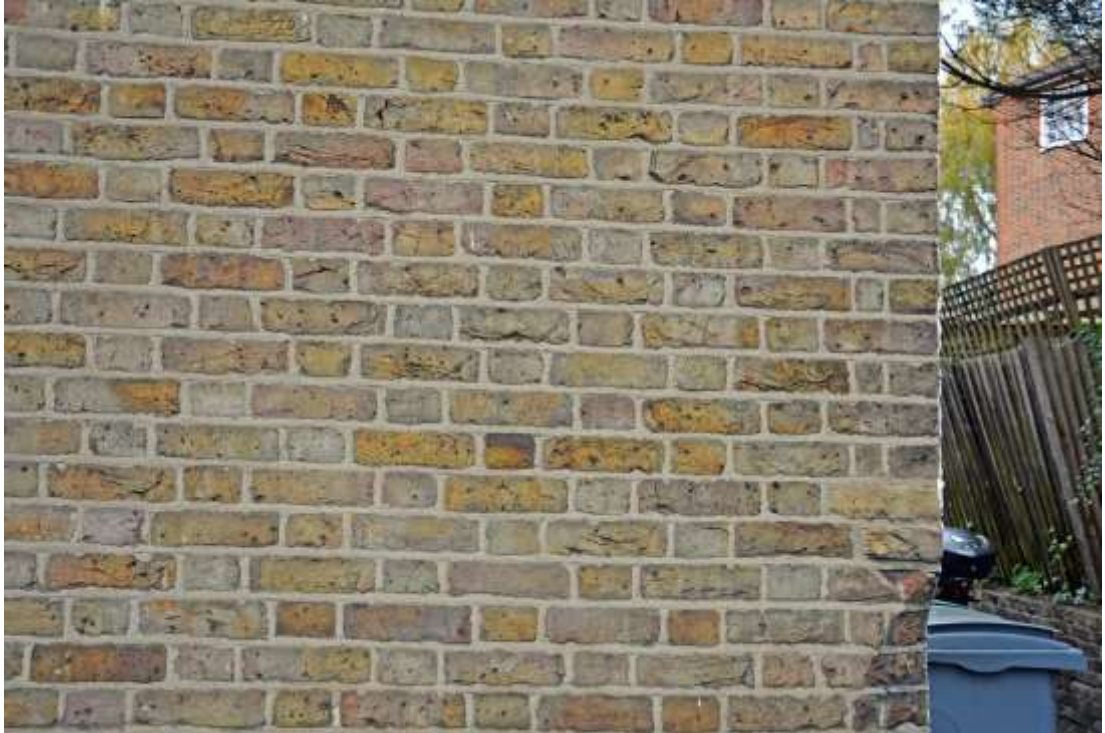
The frontage of 9 Muswell Hill has been constructed from standard yellow stock bricks, and reflect the original construction of the residence (Figure 37). The brickwork does however appear to have been repointed at a later date. Also several bricks to the base of the front façade have been replaced at a later date to allow for the installation of airbricks. Some of these now require further attention (Figure 38).

**Figure 37:** Condition of brickwork on the front façade of 9 Muswell Hill, right corner of the residence.

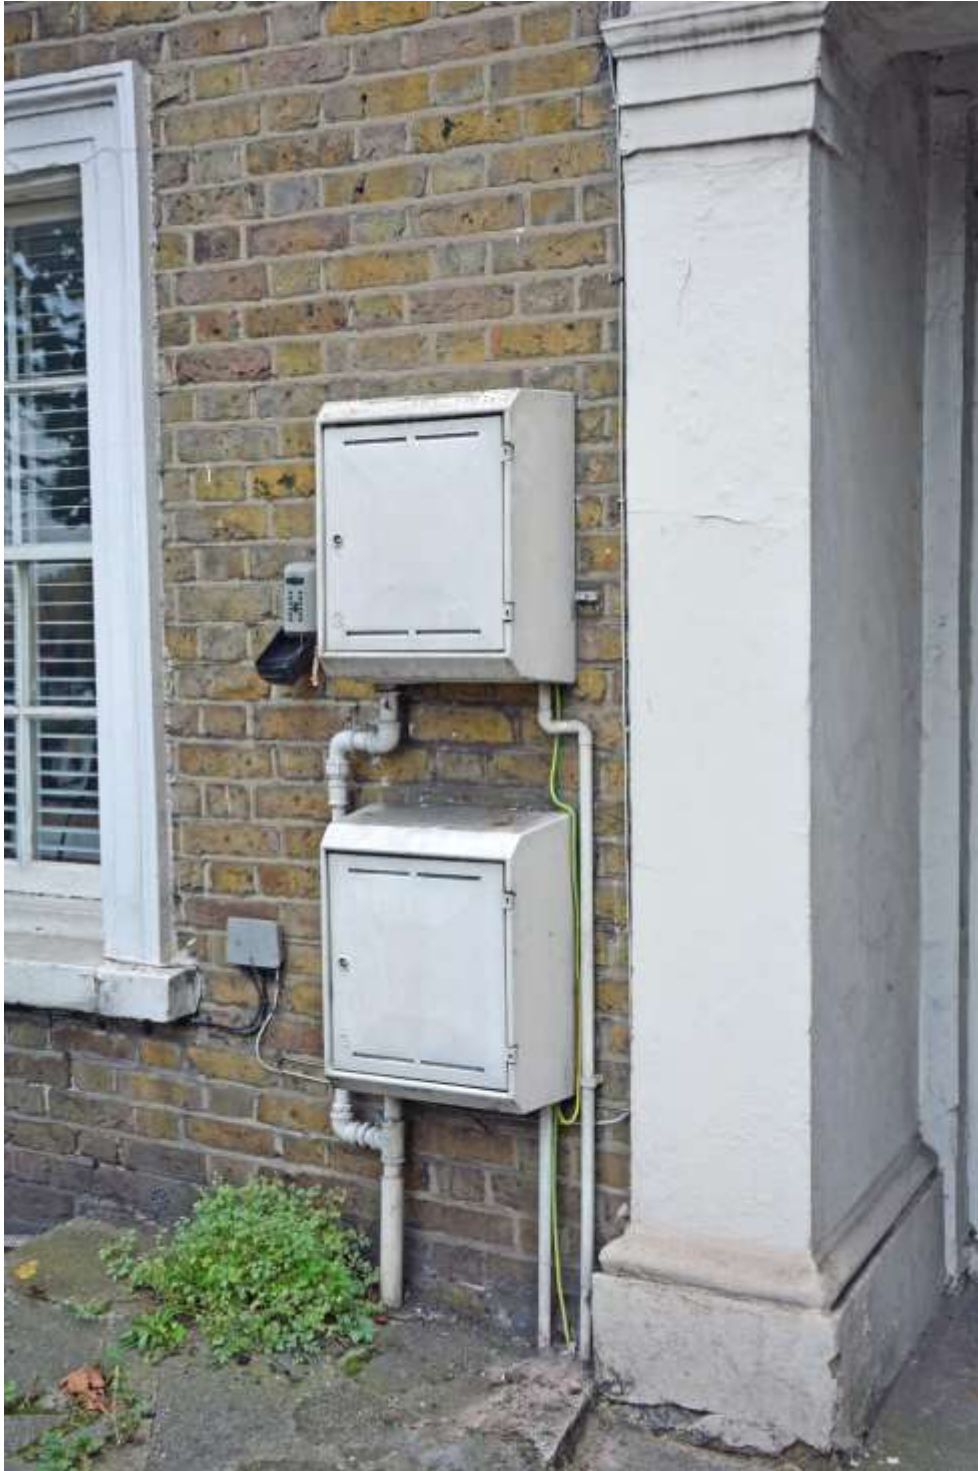
The final feature present on the front face of 9 Muswell Hill relates to the current utility provision. Directly to the left of the porch are two gas meter boxes which were installed post-2002 – as they are not visible in images held by Historic England (Figure 41). These boxes are very prominent within the existing frontage of the residence and their relocation is proposed within the planned works.

**Figure 41:** Utilities installed on the front face of 9 Muswell Hill.

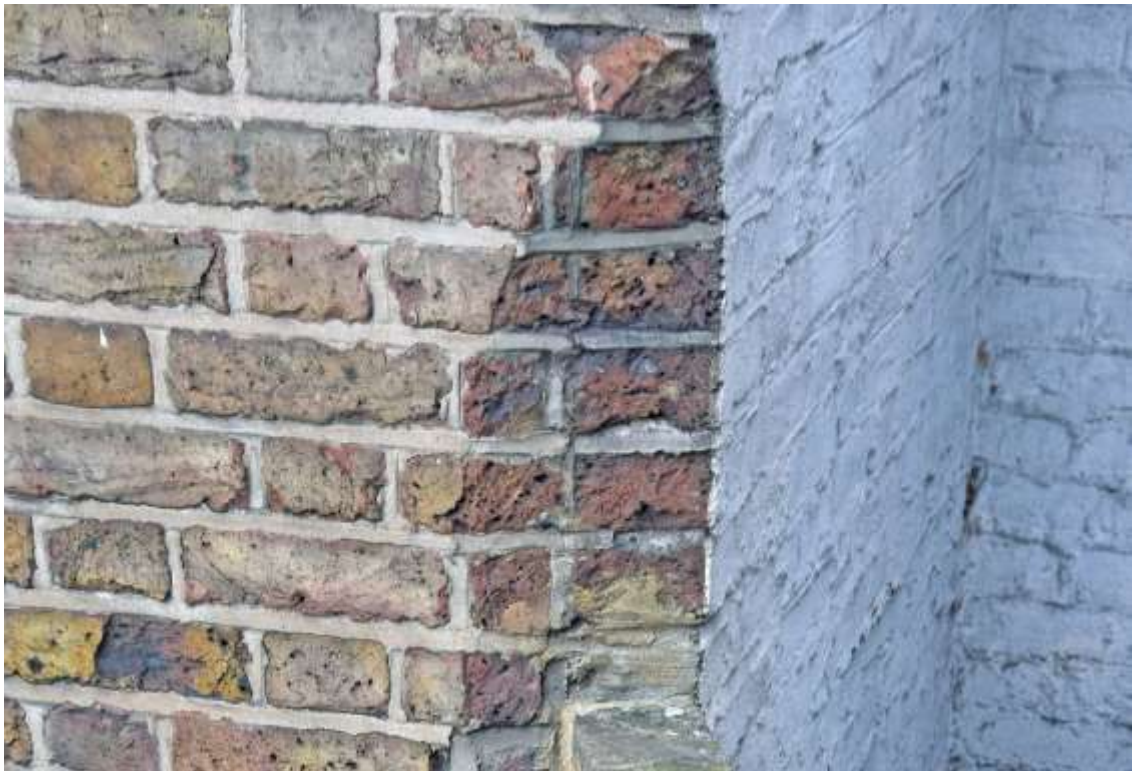
**Figure 47:** Detail of cut feature to the brickwork between the front façade and northern side elevation.

The north eastern section of the elevation also features a second feature, in the form of a prominent cut into the original brickwork of the building (Figures 47 and 48). This cut is observable at the point where the front garden wall meets the corner of the main residence, at the right hand side of the front façade. The cut is not original to the structure as an observable difference can be seen between the wear of the surrounding bricks and those within the cut. However, it is not clear what the purpose of this was.

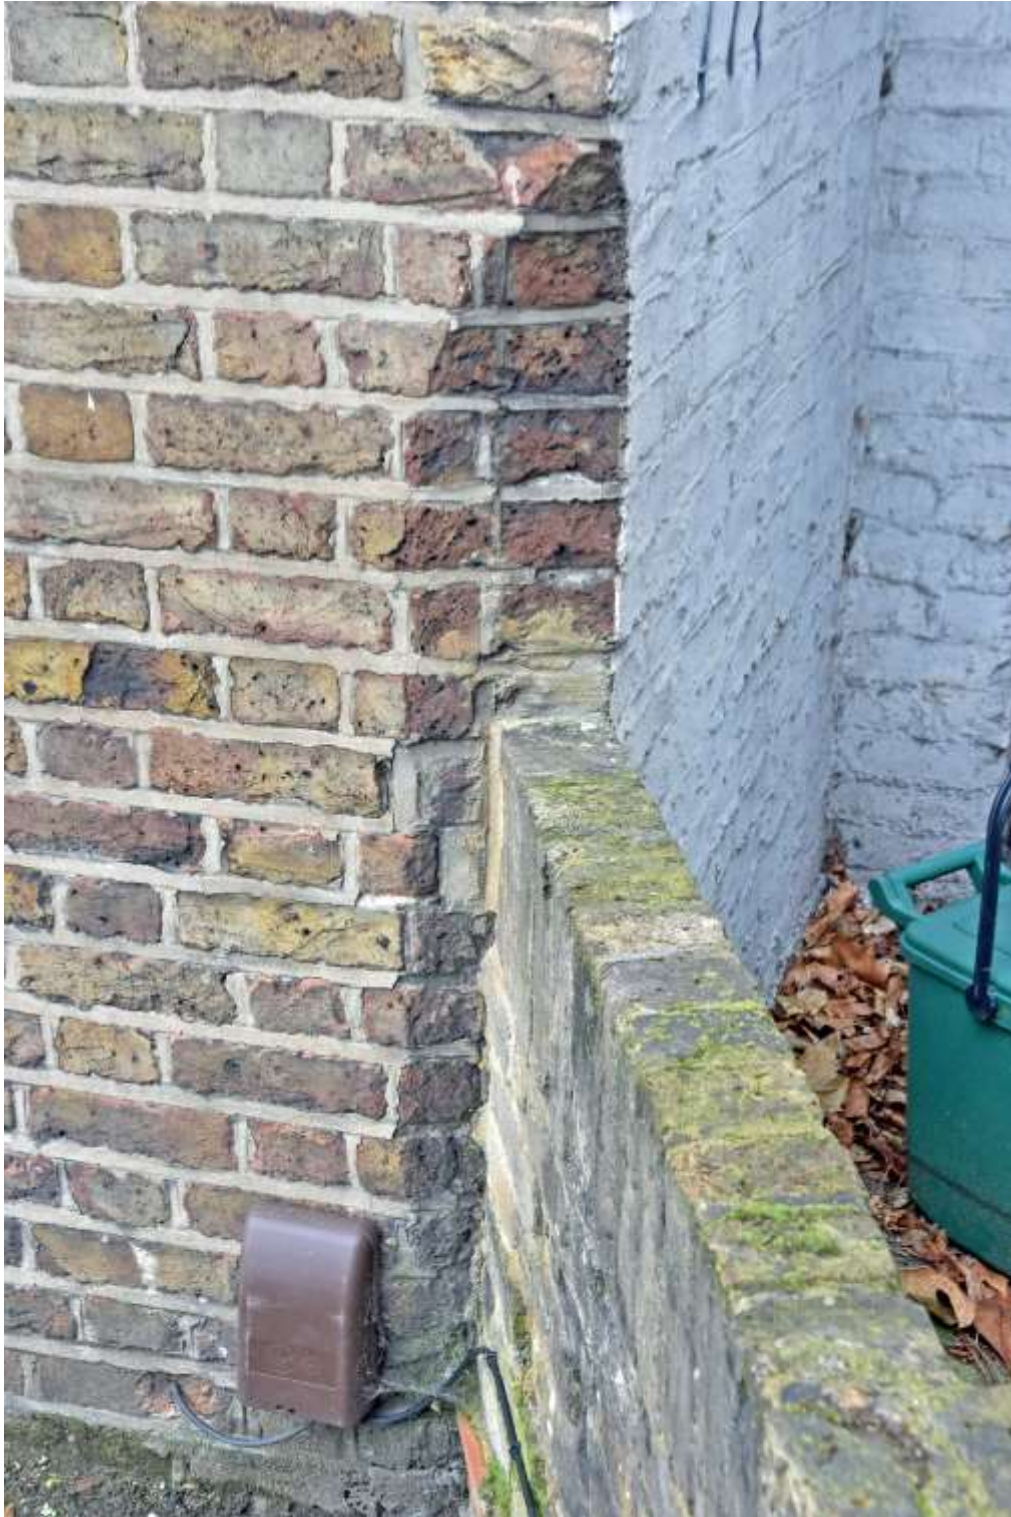
**Figure 48:** Overview of cut feature to the brickwork between the front façade and northern side elevation.

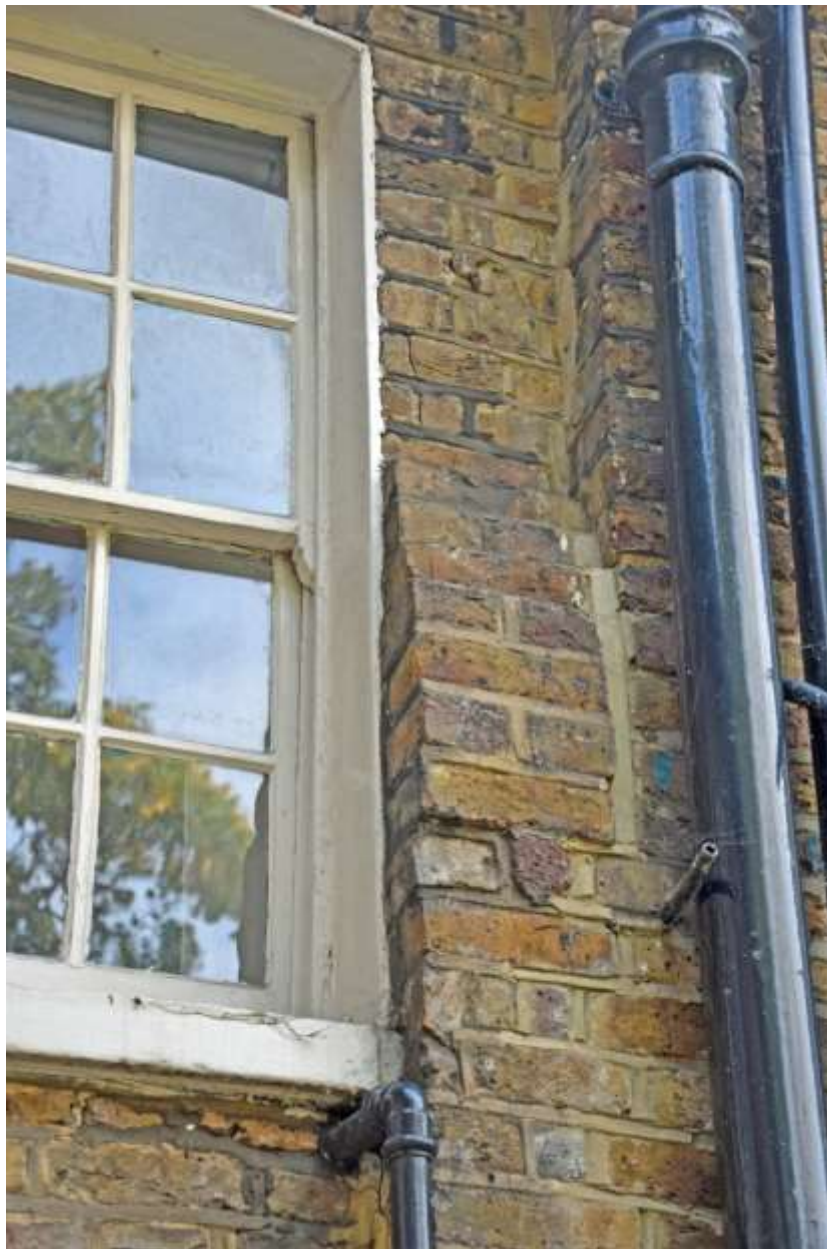
Directly to the west of the window is an irregular step out in the brickwork, more or less at the boundary between the original house and rear extension (Figure 55). This has also been repointed several times with areas of modern cement visible where two presumably separate phases of construction meet. It's difficult to understand exactly what has happened to cause this, but it is clearly associated with the extension works.

**Figure 55:** Detail photograph of stepped-out brickwork adjacent to the upper left window on the northern side elevation. Taken 22.10.24.

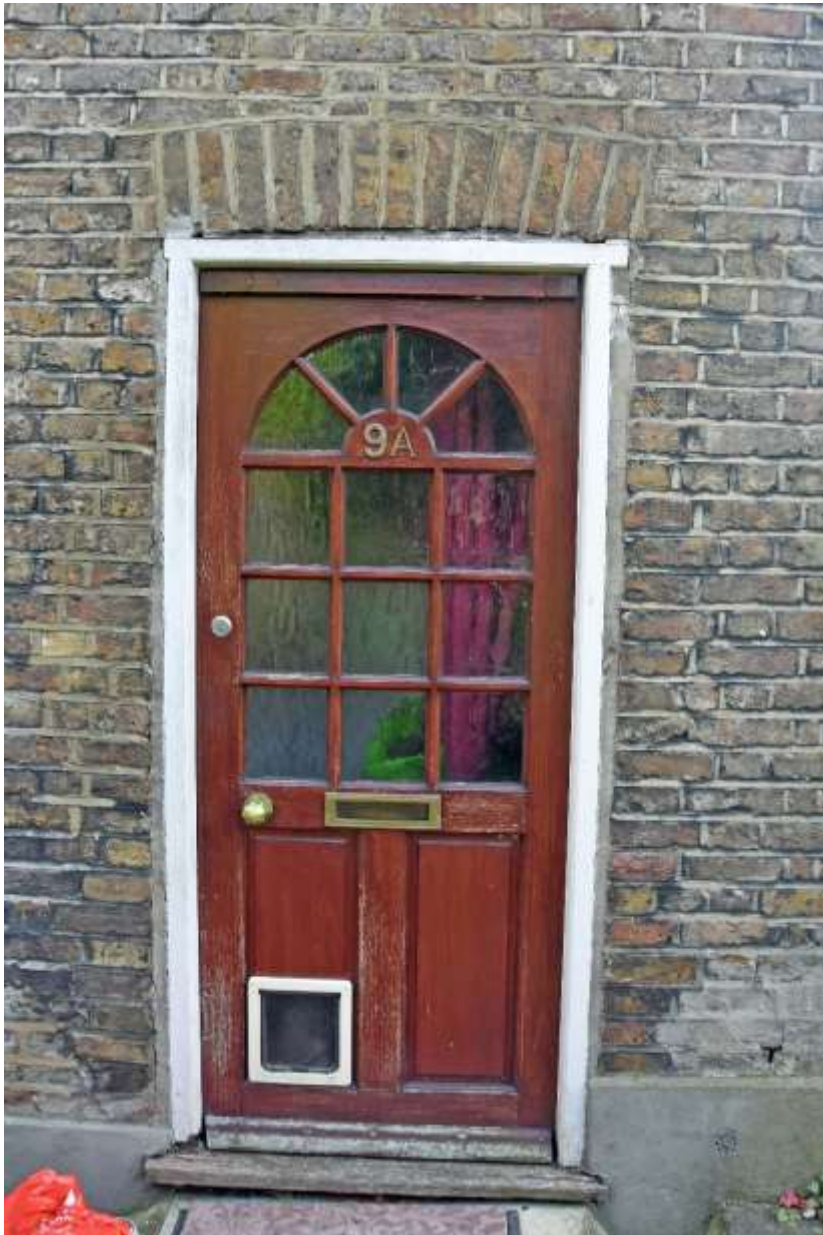
A later dating for the installation of the doorway to 9a is also supported by the surrounding brickwork. The brick closers (cut-down infills) seen elsewhere adjacent to original openings (Section 6.5.2) are not observable in this instance. Additionally, between the wooden frame of the doorway and the brickwork is a thick area of cement infill utilised to fill the gaps between the two, and with the bricks themselves having apparently been cut back (Figures 60, 61).

**Figure 60:** Overview Photograph of Front Door to rear property (9a Muswell Hill). Taken 22.10.24.

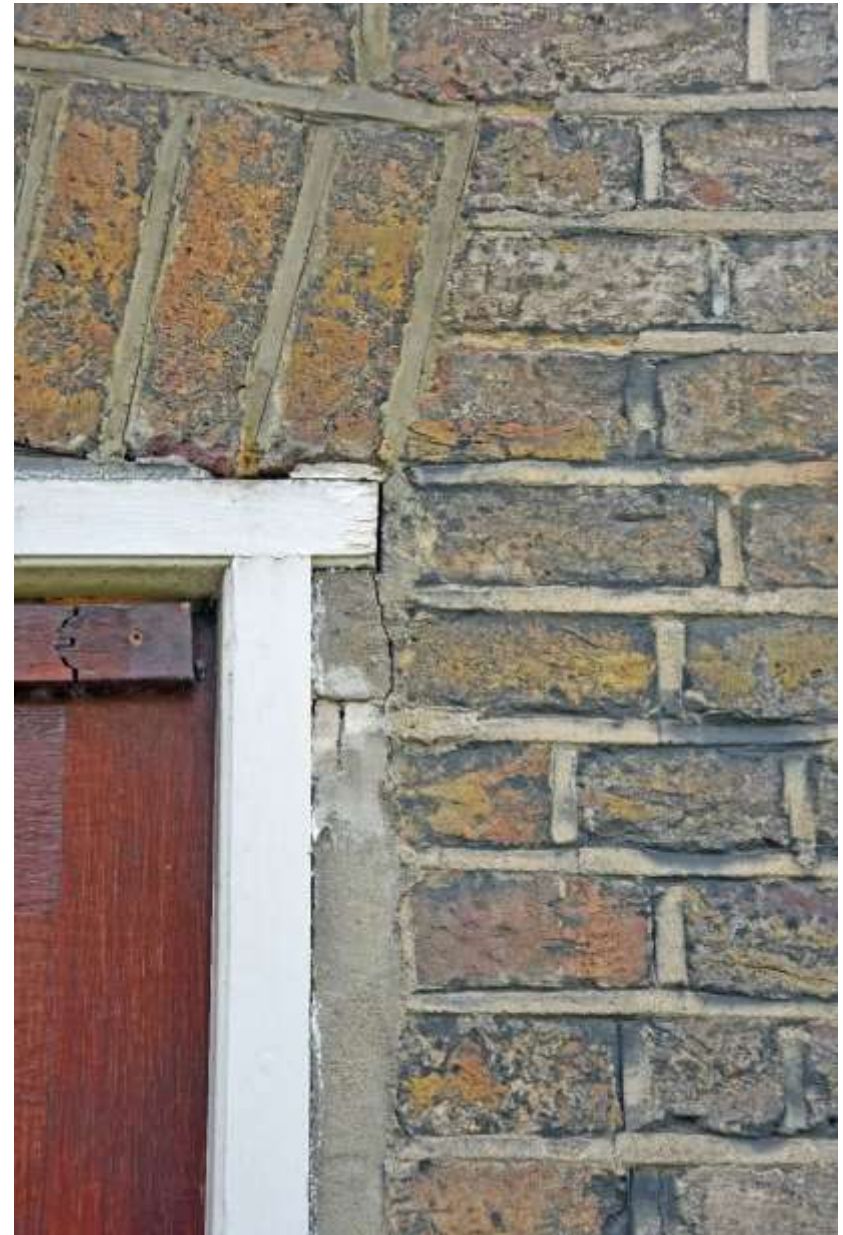
**Figure 61:** Detail Photograph of Front Door to rear property (9a Muswell Hill). Taken 22.10.24.

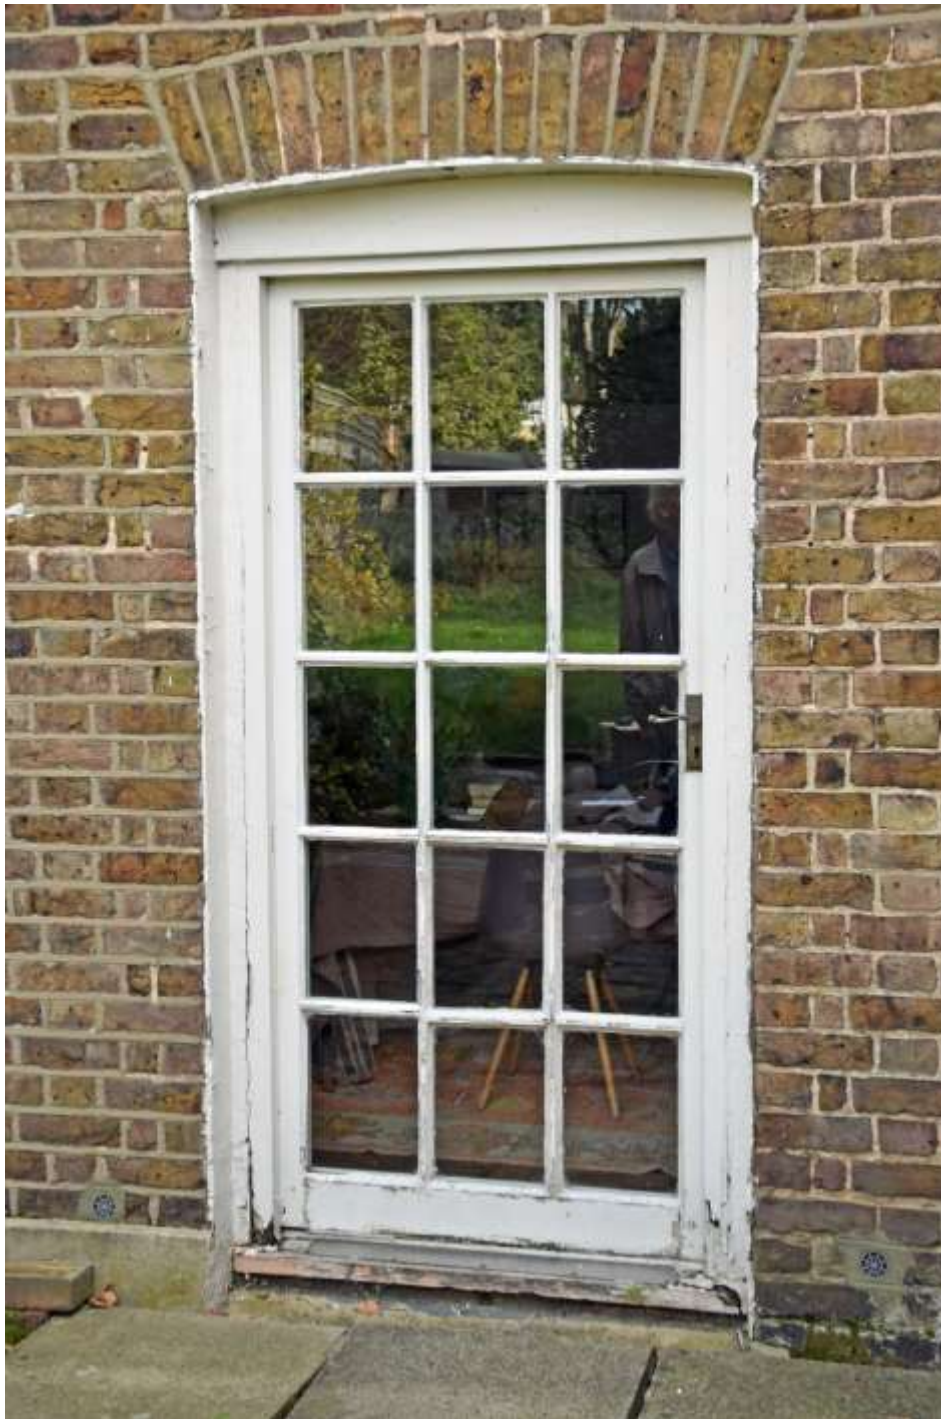
**Figure 67:** Overview Photograph of Garden Access door on rear elevation. Taken 22.10.24.

The first opening on the rear elevation of the residence is a doorway providing access between the garden and the living/dining room (Area G). The door itself is modern, featuring fifteen panes of glass subdivided by wooden glazing bars. The surrounding frame, hardware and kick bar panel to the bottom of the door are also noticeably modern. On first glance, the door appears to be the same as the one depicted in images of the residence from c.1970 (London Picture Archive; not included due to Copyright restrictions). However, the handle of the door is located on the opposite side of the frame; also the door depicted in the photographic image is significantly taller, with the infill panel directly above the current door not present in 1970. Thus the existing

represents a replacement, of similar style and standard size, sometime in the last 54 years. The current condition of the door is poor, with significant peeling and cracking to the frame observable. One pane of glass also features a large crack which has split into three separate fractures within the pane (Figure 68).
