**“ST DUNSTAN’S COTTAGE”**  
**9 & 9a MUSWELL HILL, HARINGEY N10 3TH**

**HISTORIC BUILDING IMPACT ASSESSMENT**

Updated February 2026

COMPASS ARCHAEOLOGY LIMITED  
250 York Road, Battersea  
April 2025 / Updated February 2026  
Author: Gabriela Williams  
Amendments by Hannah Stralow Rees  
Telephone: 020 7801 9444  
E-mail: [mail@compassarchaeology.co.uk](mailto:mail@compassarchaeology.co.uk)  
Website: [www.compassarchaeology.co.uk](http://www.compassarchaeology.co.uk)  
©Compass Archaeology Ltd.

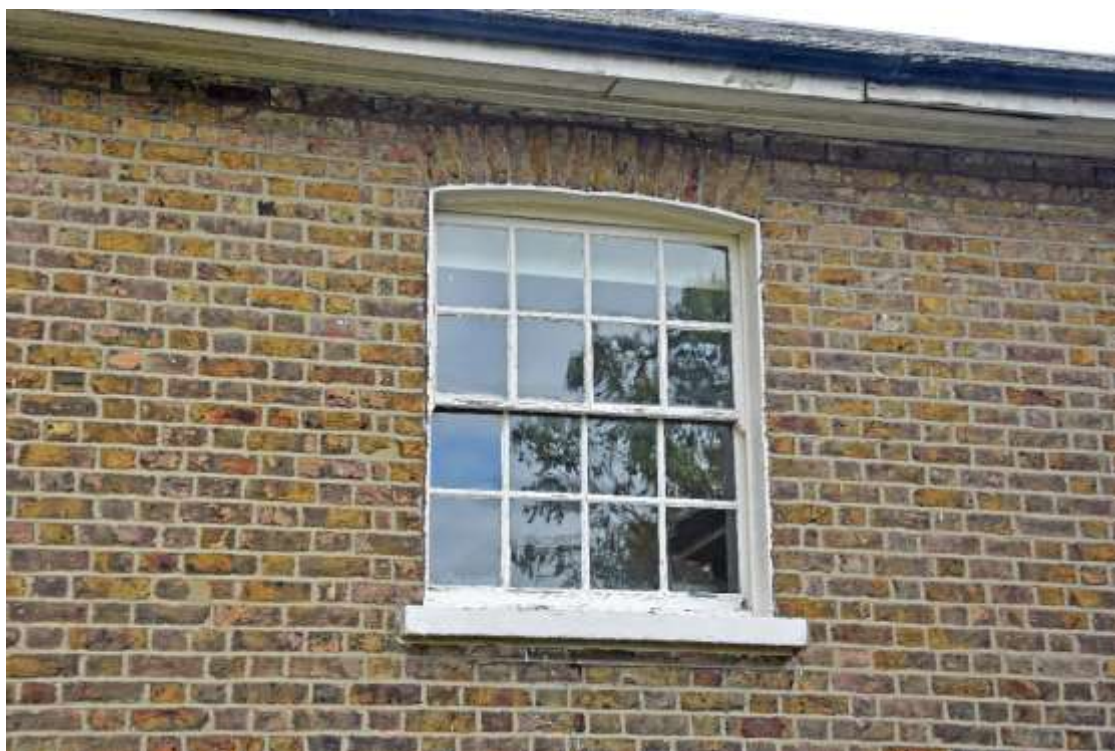
**Figure 70:** Photograph of Upper left window of rear elevation. Taken 22.10.24.

The Upper Left window of the rear elevation is an 8 over 8 Georgian sash window, similar in style to those seen elsewhere in the property. The 8 over 8 design features four rows of four horizontal panes of glass held together by glazing bars. The upper sash pane has a horns in this instance, similar to the one seen in the upper left window of the northern side elevation (Section 6.4.5). As previously mentioned sash horns are associated with mid-Victorian sash window design, particularly to support the additional weight of the larger panes of glass associated with 1 over 1 or 2 over 3 sash styles. Therefore this window is likely to be later in dating, although as described below the opening in the brickwork is clearly original.

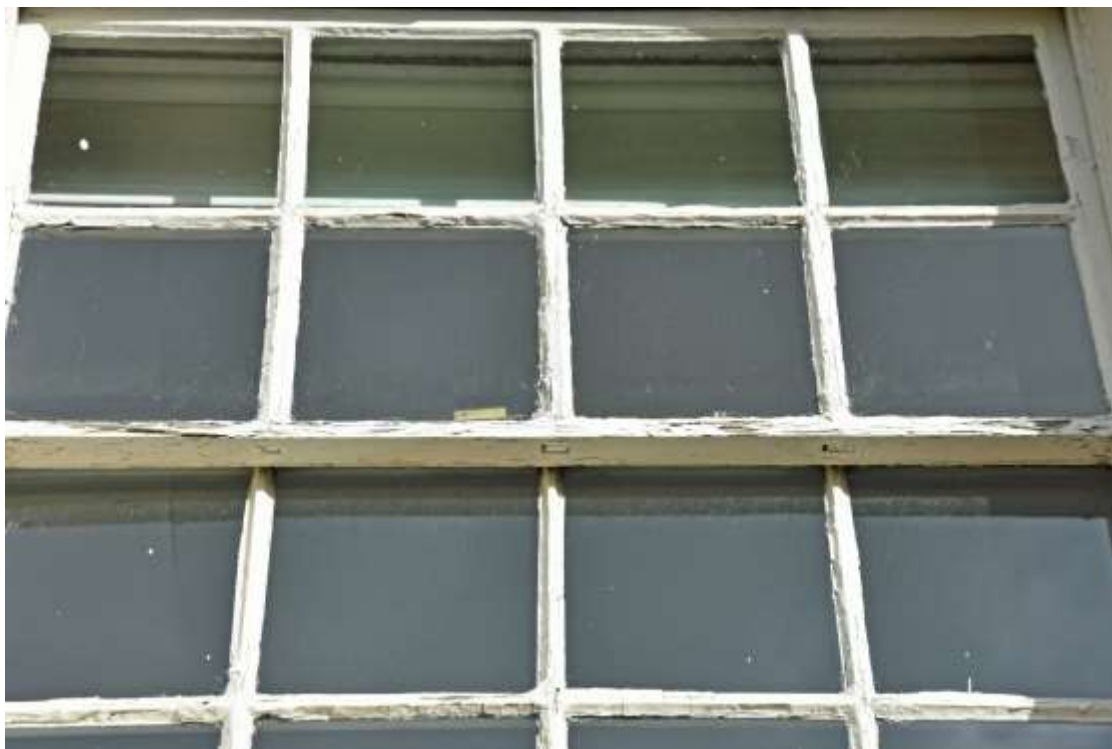
The lower sash has a height of 45mm whilst the meeting bar is 16mm in height. This window also appears to have different upper and lower panes as seen in several other windows within the residence as the glazing bars vary significantly. The upper sash window has glazing bars with a width of 11mm whilst those on the lower sash measure 6mm in width. The glazing bars also differ in design with the upper sash featuring a modern design and the lower pane has the Ovolo & Fillet style. The upper sash of the window has also been constructed by utilising mortise and tenon joints, with the glazing bars cut into the frame of the sash (Figure 71).

**Figure 71:** Detail Photograph of Upper Left Window of rear elevation. Taken 22.10.24.

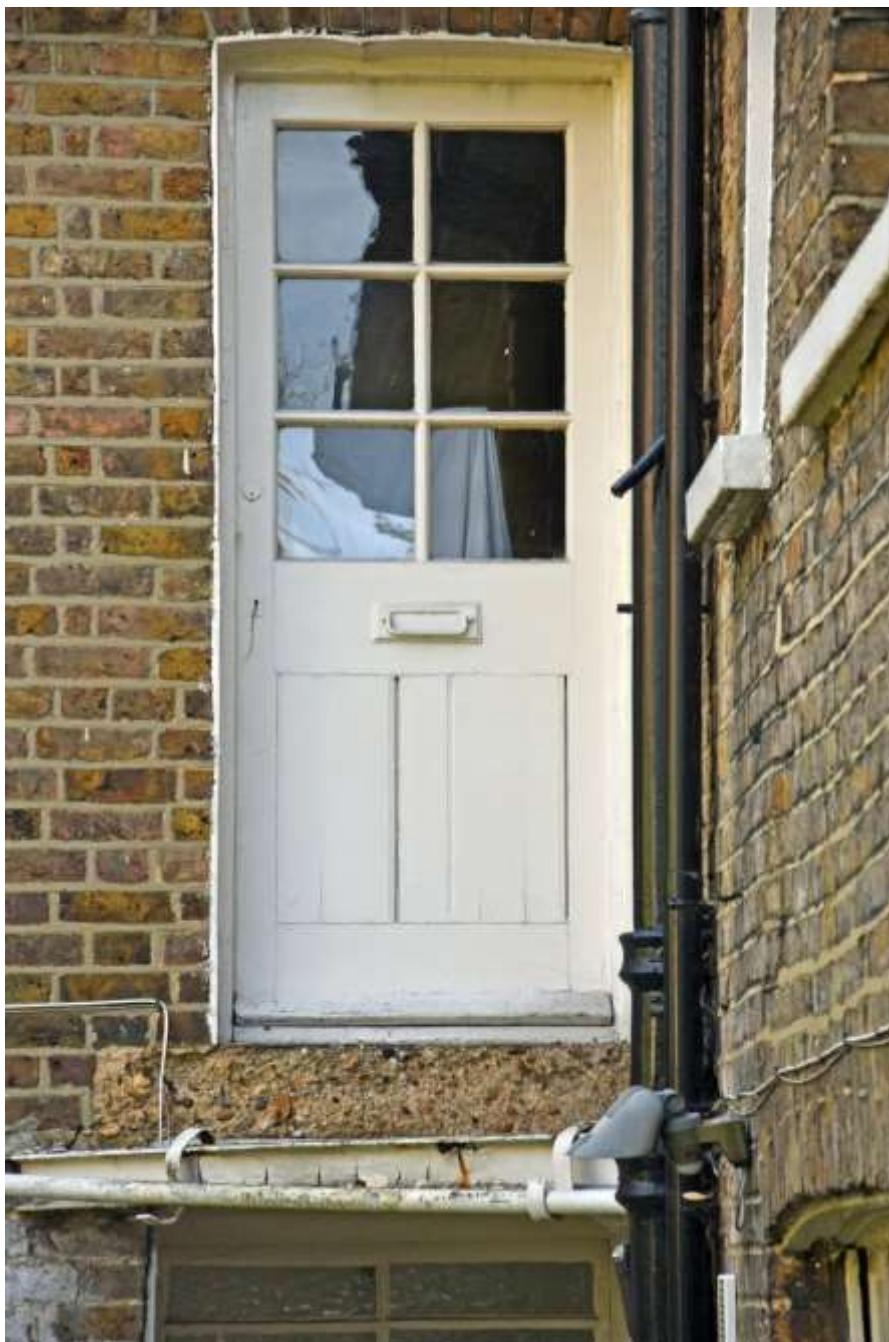
A significant feature within the rear elevation of 9 Muswell Hill is the presence of a first floor entrance. This door is a remnant from when the main house was divided by floor into two separate flats. In order to facilitate this change a new main entrance for the upstairs flat was introduced to the rear of the property with an external staircase to provide access. Meanwhile, it is assumed that the indoor staircase was wholly removed to separate the two residences. When the main building was restored into a single home the interior staircase was replaced (before 1970; see also Section 6.11.3) and the exterior staircase was removed. However, the steel beam supports and thick concrete floor base for the stairs can still be seen within the rear elevation (Figures 72, 73, Page 52) directly below the door – which was also left *in situ*. There is also a prominent area of damaged brickwork on the rear elevation where the steel supporting beam was implanted into the wall (Figure 74, Page 52).

The door itself is a modern, three panel design with glass in the upper panel which has been subdivided by decorative wooden bars. The cut for the doorway has been framed on all sides with white panelling in the same manner as the previous openings located within the rear elevation. However, the brickwork varies significantly: the alternating rows containing closers (1/3<sup>rd</sup> brick) can also be seen to the left of the upper part of the doorway, but cease directly below the level of the letter box/door handle feature in the centre of the door. This clearly suggests that a window previously existed in the same placement and the opening was simply extended downwards to allow for the installation of the flat front door. This is further supported by the positioning of the door, set back from the external brickwork in the same manner as other more original openings. Due to the window already set into the brickwork it would have been simpler to install the door this way, as well as directly accessing the first floor hallway.

**Figure 72:** Photograph of first floor flat door on rear elevation. Taken 22.10.24.

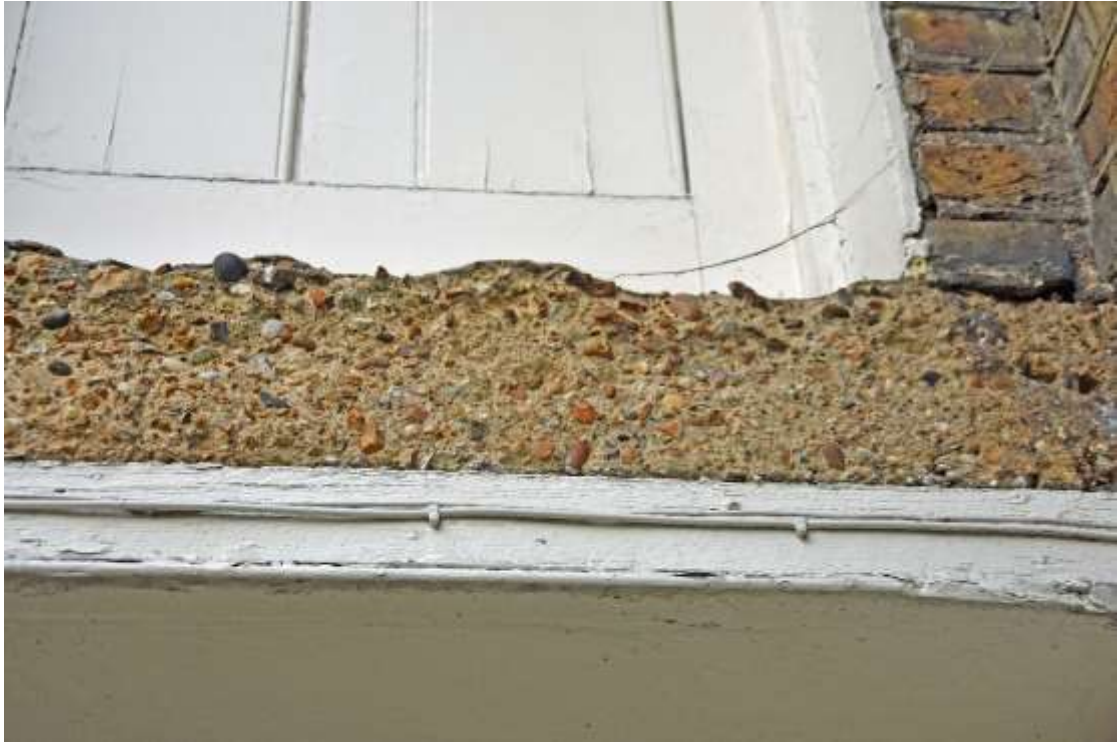
**Figure 73:** Detail Photograph of modern concrete slab for stair base – rear elevation. Taken 22.10.24.

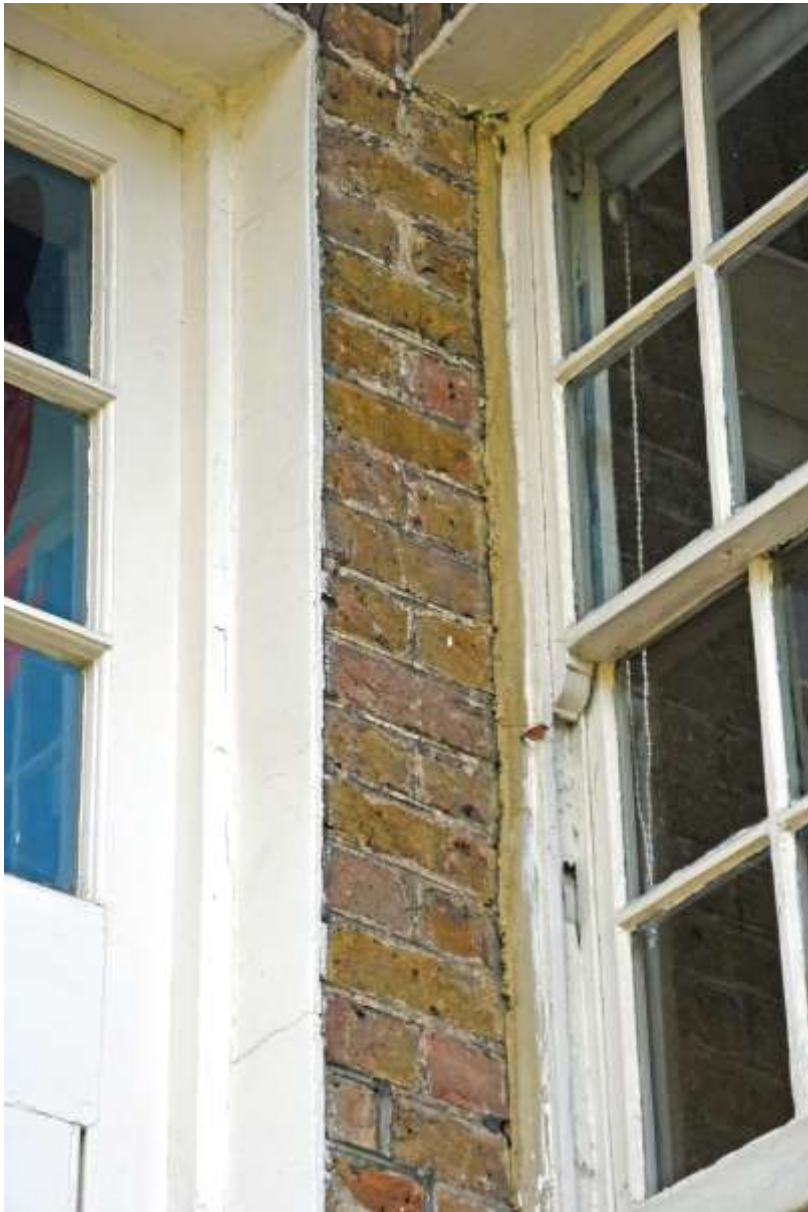
**Figure 75:** Detail Photograph of brickwork to the right of the first floor flat door. Taken 22.10.24.

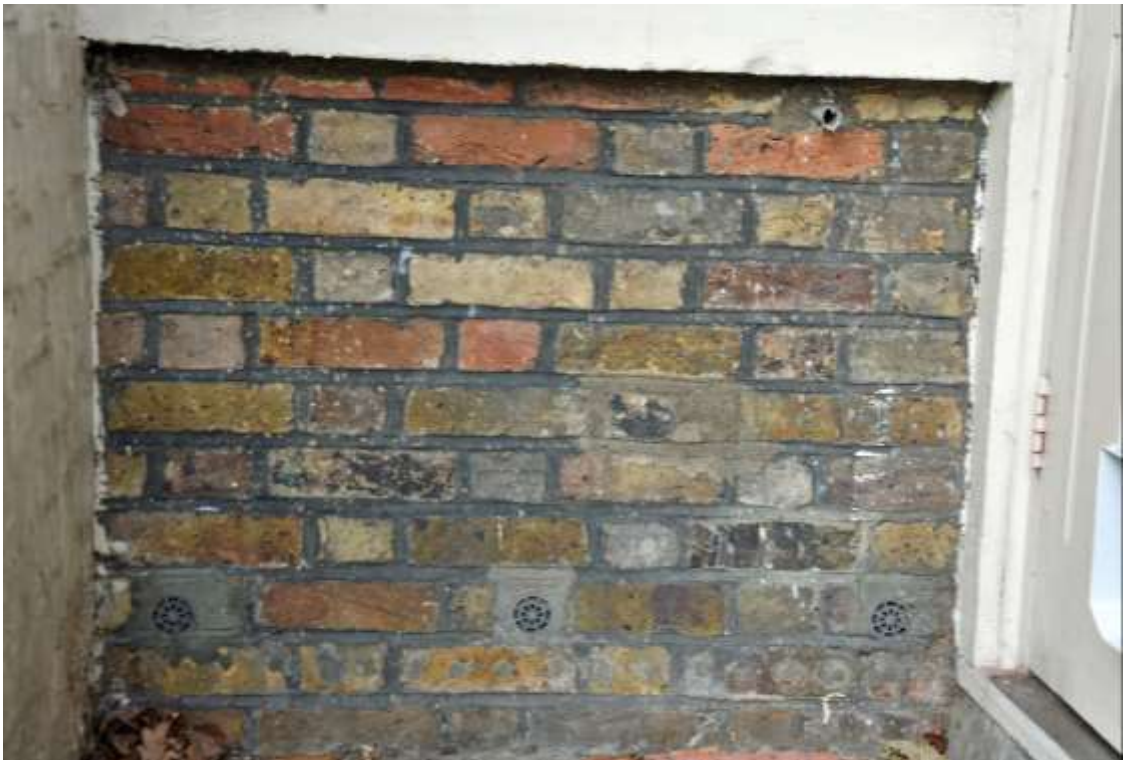
**Figure 79:** Detail Photograph of the modern brickwork directly underlying the lower central window. Taken 22.10.24.

This window placement is clearly not original, and moreover it overlies brickwork to ground level which is also quite modern in dating – an infill, and noticeably different to the standard yellow stock brick utilised for the remainder of the property (Figure 79). The exterior wall to the left (north) of the window has been whitewashed, so the

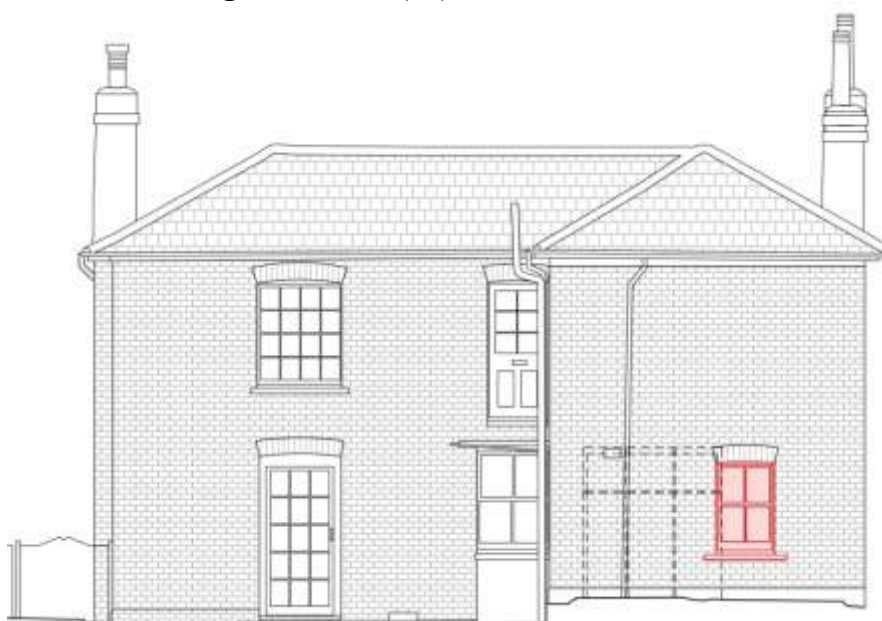
**Figure 80:** Rear elevation with the lower right window marked in red.

The condition of this window was poor with noticeable areas of rot and significant paint peeling across areas of the frame. The brickwork surrounding the window is consistent and a single row of vertical stretchers frames the upper boundary of the window as seen in other areas. However, no closer bricks are visible within the brickwork framing either side of the opening, so it is possible that the window was inserted at a later date rather than during the construction of the extension – perhaps when the presumed window in the adjacent wall as described under 6.6.2 was blocked. The window has also not been framed in white in the same style as other windows to the rear of the residence, with the brickwork left exposed.

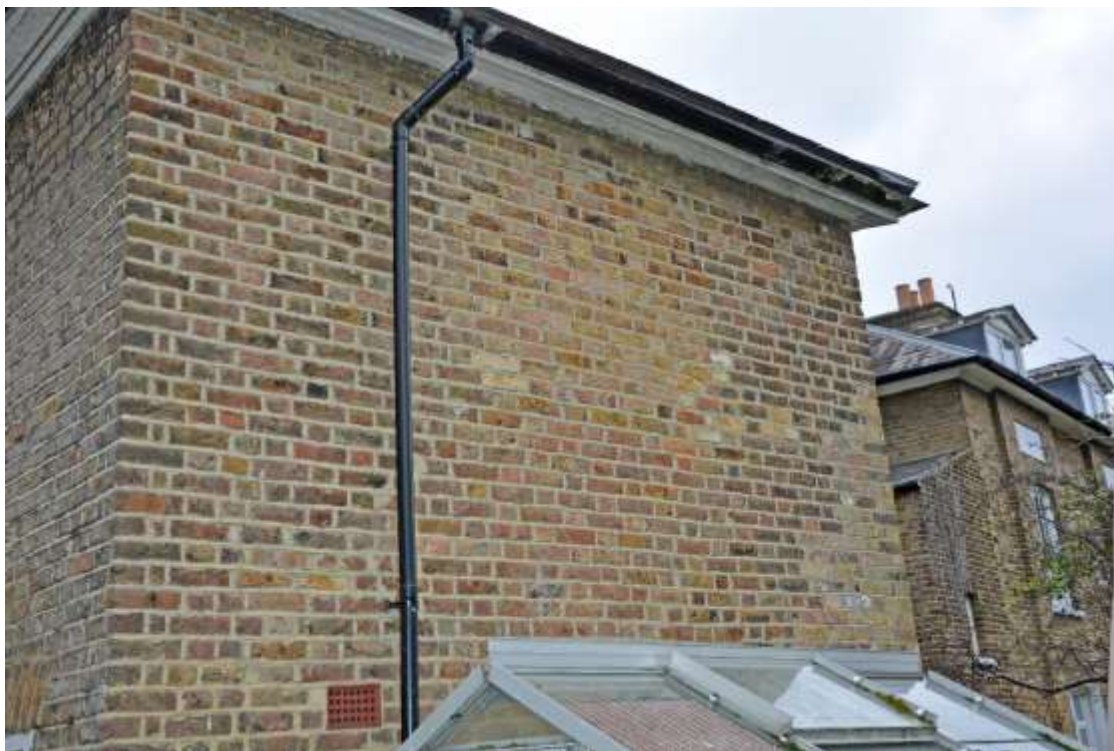
**Figure 83:** Photograph of the upper part of the rear elevation of the extension, with an area of restored bricks visible in the centre of the first floor. Taken 01.11.24.

Historical images of the residence dated to c.1970 (London Picture Archive, Not included due to Copyright restrictions) depict a rectangular patch within the first floor of the rear elevation, slightly to the left of the lower right window (Section 6.5.6). This was initially thought to correspond with a blocked window feature, with the brickwork in this location varying slightly from the surrounding area. In particular, an area of more prominent yellow stock brick can be identified to the centre of this area (Figure 83, previous). However, discussion with the existing tenant of the rear property (who has resided within 9a Muswell Hill continuously since 1971) indicates that this area of brickwork corresponded with a previous tank feature, associated with utilities for the building rather than a blocked window. This information was supported by a previous owner of the residence who had acquired the property in c.1955.

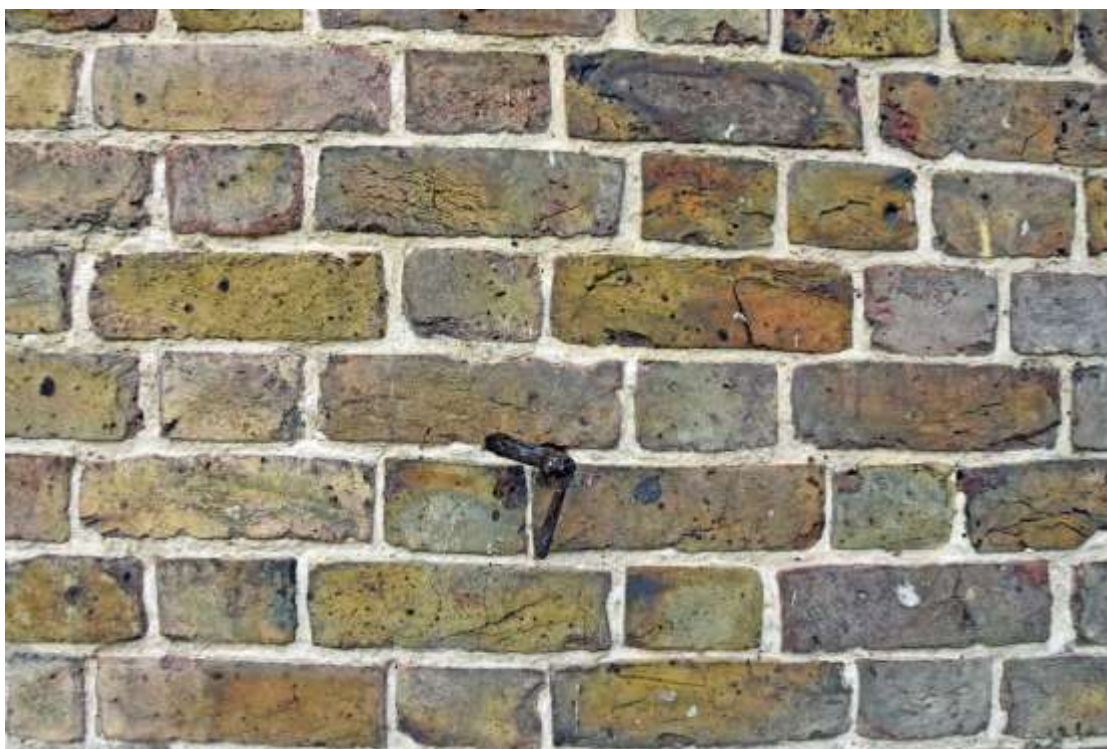
The final feature present on the rear elevation of the residence is a metal installation within the brickwork to the right of the garden access door (Figure 84). This fixture was most recently utilised for the storage of hose pipes as depicted in the 1970 photograph of the residence (London Picture Archive, not included due to Copyright restrictions). It is now loose and can be fully rotated. The feature is not thought to be original to the property or significant.

**Figure 84:** Detail Photograph of metal feature within the brickwork of the rear elevation. Taken 22.10.24.

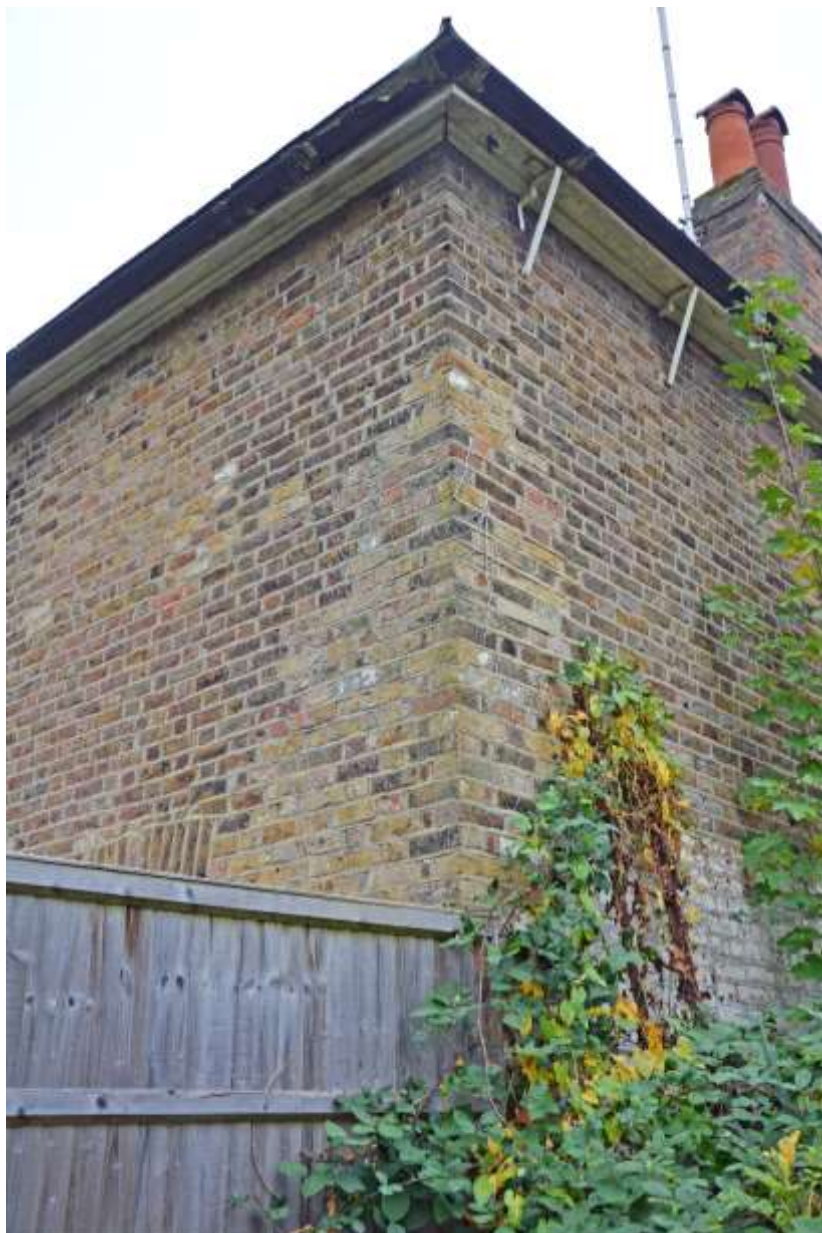
- 6.6.1** Working methodically along the southern elevation from rear to front the first notable feature is an abnormality within the brickwork at the southwest corner, between the rear (west) and side (south) elevations (Figure 85). The brickwork here differs significantly from the standard stock bricks of the surrounding walls, with some more prominent yellow stocks and others which have likely been sourced from a reclamation yard due to the existence of white paint or render attached to their outer surfaces. According to the tenant of the rear residence (9a) the entirety of this corner was rebuilt some years before due to root action damaging the structure – apparently a large tree present within the gardens of 7 Muswell Hill. The corner was underpinned and the brickwork repaired resulting in this area of contrasting brickwork. This section of wall is also the only area in which metal supports have been installed for the roof soffits, as can be seen in Figure 85.

**Figure 85:** Photograph of the corner between the rear (west) and side (south) elevations with clear evidence of rebuilding. Taken 01.11.24.

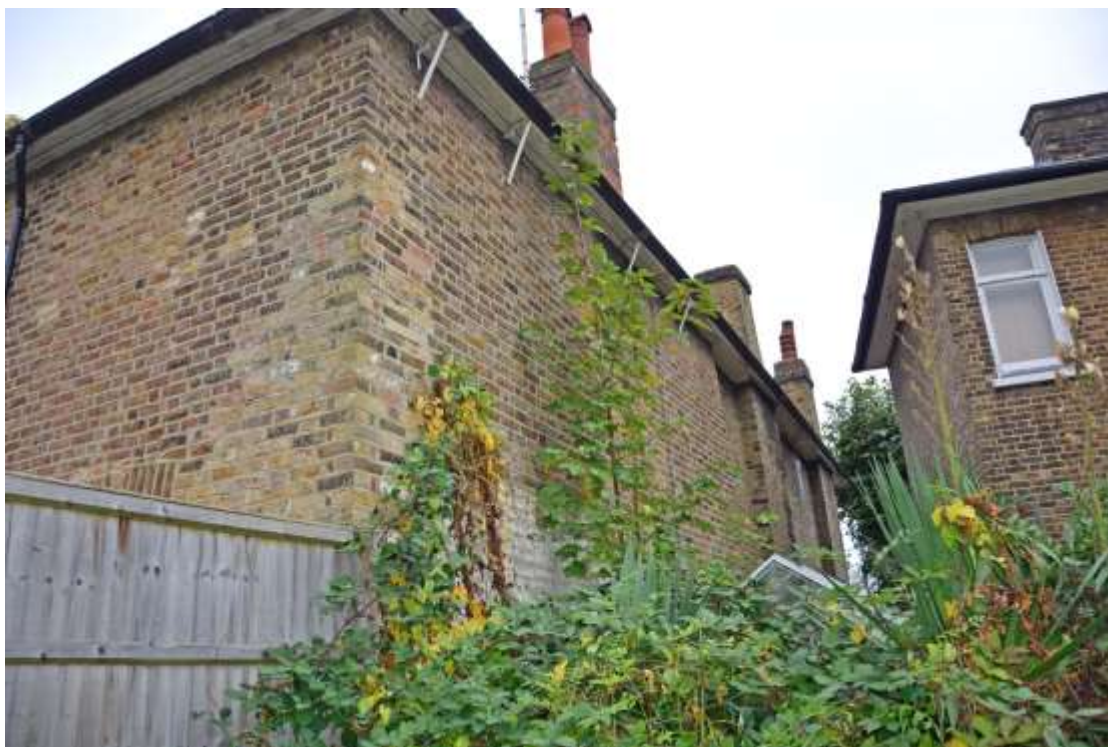
- 6.6.2** Immediately beyond the rebuilt corner is a prominent area of painted brickwork along the ground floor of the southern elevation (Figure 86). This area is partially obscured by vegetation and a greenhouse which is not attached to the property, but the brickwork here also appears to feature a blocked opening – apparently a window - to what is now

**Figure 86:** Southern side elevation looking towards Muswell Hill, 7 Muswell Hill visible to the right. Taken 01.11.24.

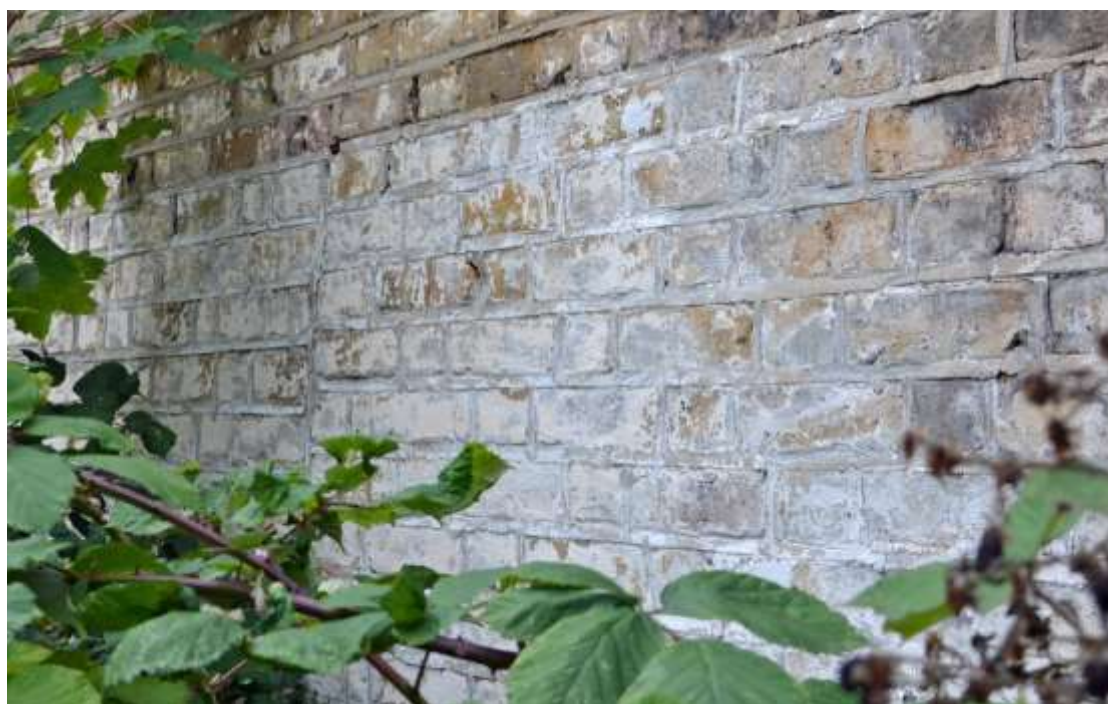
the bathroom of no. 9a. The full boundaries of the feature could not be observed due to the aforementioned vegetation although a vertical divides between areas of brickwork can be clearly identified within the painted area (Figure 87). This cut also appears to be bordered to the right by alternating rows of brickwork with 1/3<sup>rd</sup> brick closers included – a feature which is present in the brickwork surrounding other windows within the rear and side (north) elevations. Therefore, it is thought that a window or similar opening was present in this location and was subsequently blocked.

**Figure 87:** Detail Photograph of painted area within southern side elevation. Possible blocked opening visible to the right of the image. Taken 01.11.24.

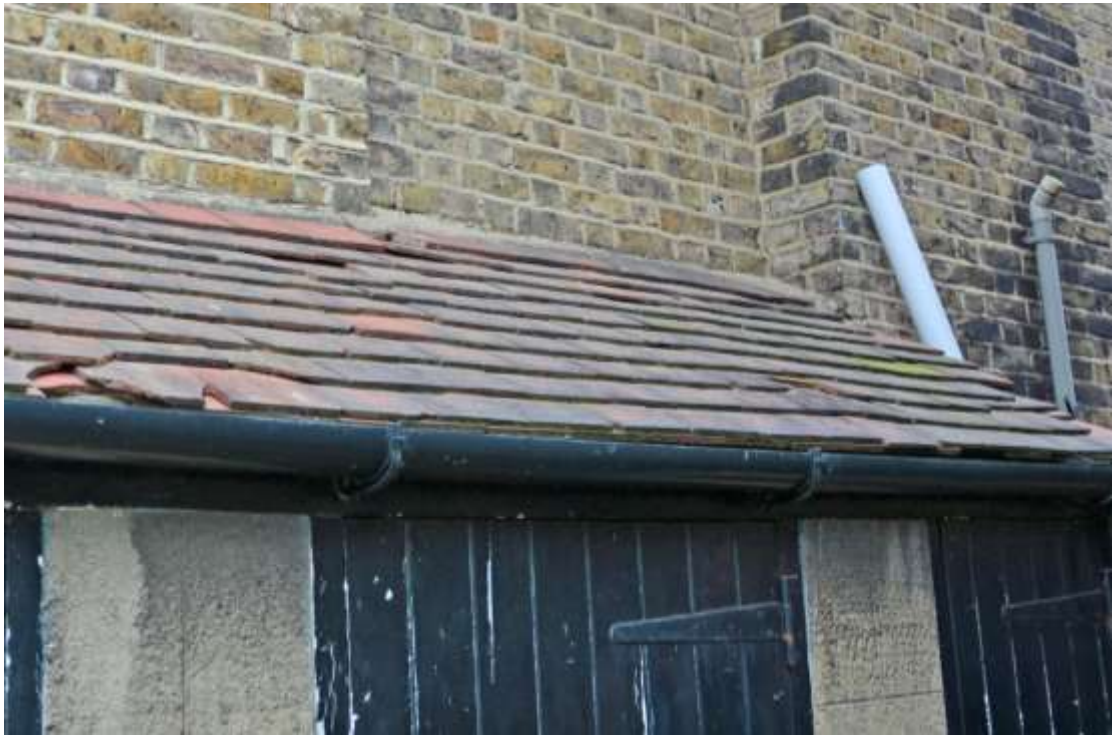
The next feature observable on the southern side elevation is a single storey standing structure with wooden doors and a red tile sloped roof, attached to the external brickwork of the southern side elevation. This shed feature is not part of 9 Muswell Hill and instead belongs to no. 7, and is also thought to be a fairly modern addition due to the rendering (see also Figure 90).

**Figure 90:** Detail photograph of 7 Muswell Hill shed feature and its attachment to the side wall of no. 9  
Taken 01.11.24.

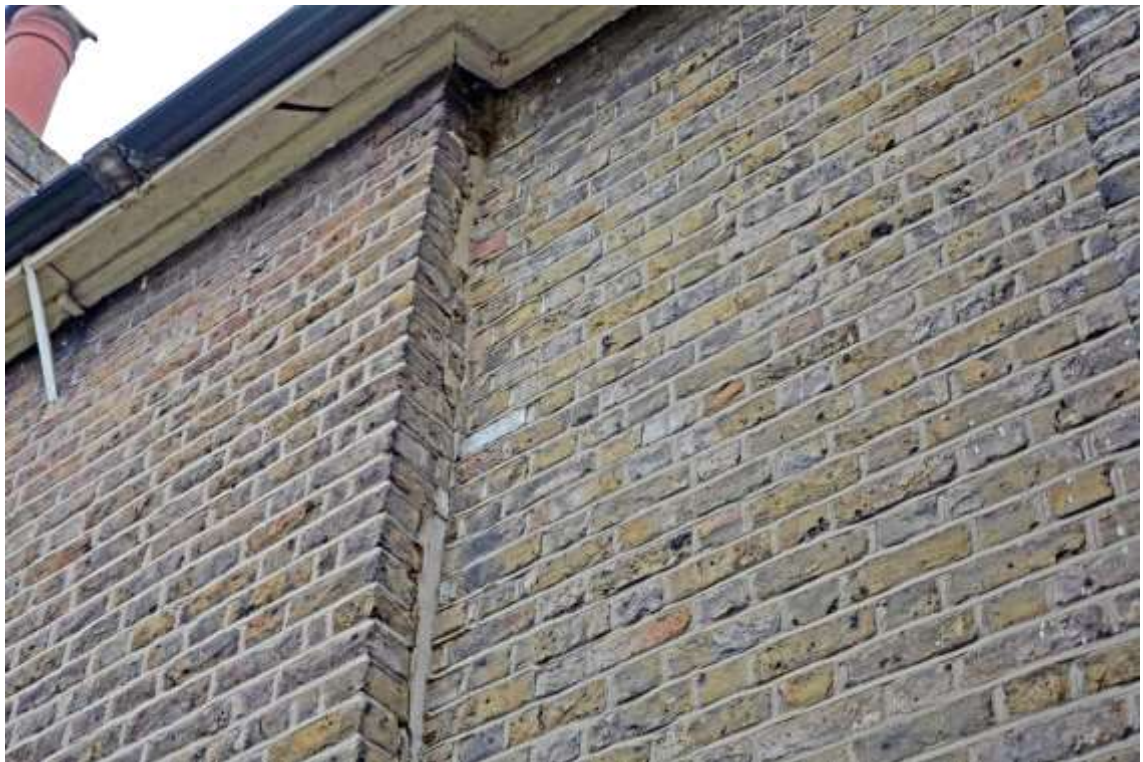
- 6.6.4** The position of this shed also overlaps the boundary between the original rear wall of 9 Muswell Hill and the extension that now forms no. 9a. Observations were made for any evidence associated with this: The first feature thus observed was an intentional 45 degree cut in the soffit approximately 220mm beyond the present western extent of the main property. This is thought to indicate the southwest corner of the original roof structure, which would have wrapped around the edge of the residence and then continued to the north. This cut can be seen in the top right-hand side of Figure 91.

**Figure 91:** Detail Photograph of boundary between 9a and 9 Muswell Hill on the southern side elevation.  
Taken 01.11.24.

The brickwork in this area also clearly indicates the presence of the extension, rather than a single building. Firstly, areas of render are visible in the seam between the two phases which appear to have been introduced to seal the gap. Additionally, the brick coursing of the main residence is slightly thinner than that of the rear structure, hence the bricks are marginally out of alignment when the two structures are closely compared. From the roof of the shed feature the main house has 21 courses compared with 20 for the same height within the extension. This one brick difference means the entirety of the structures' external brickwork does not match.

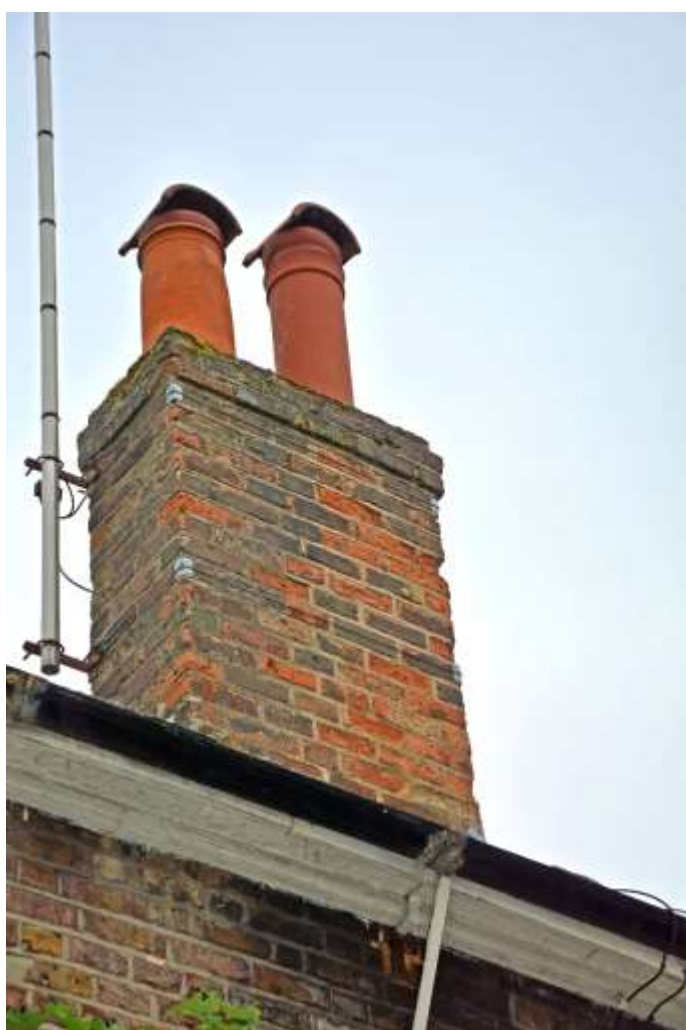
The chimneys of the two structures are also significantly different. The rear residence has a red brick chimney (Figure 92, also apparently softer and more weathered), whilst the two chimneys attached to the main residence are constructed in yellow stock brick matching the rest of the exterior of the building (Figure 93).

**Figure 92:** Photograph of the chimney associated with 9a Muswell Hill, southern side elevation. Taken 01.11.24.

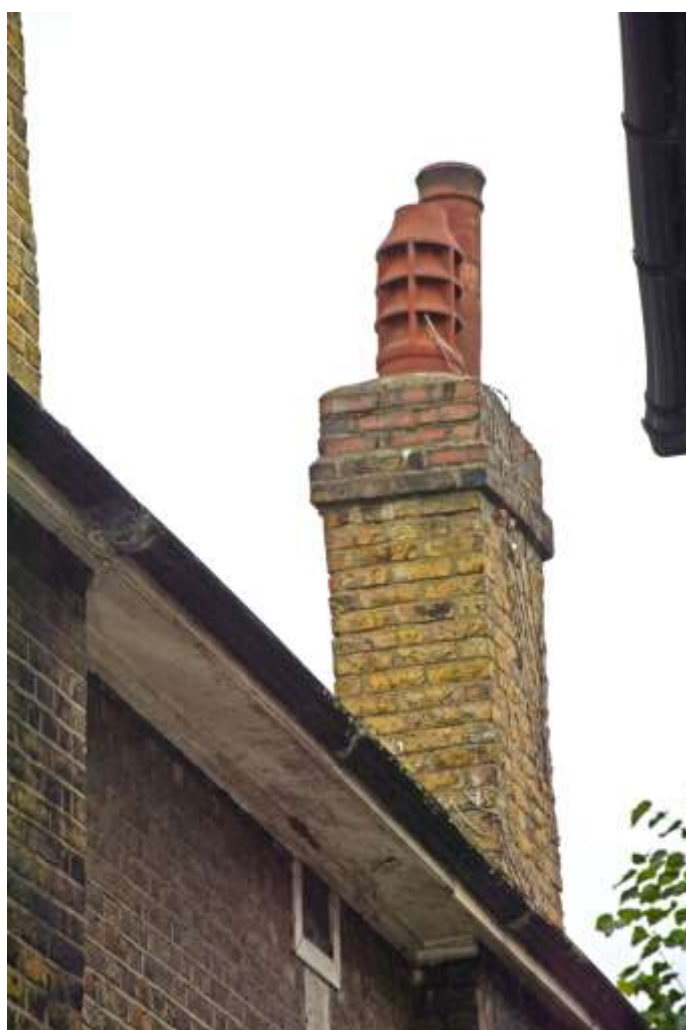
**Figure 93:** Photograph of one of two chimneys associated with 9 Muswell Hill, southern side elevation. Taken 01.11.24.

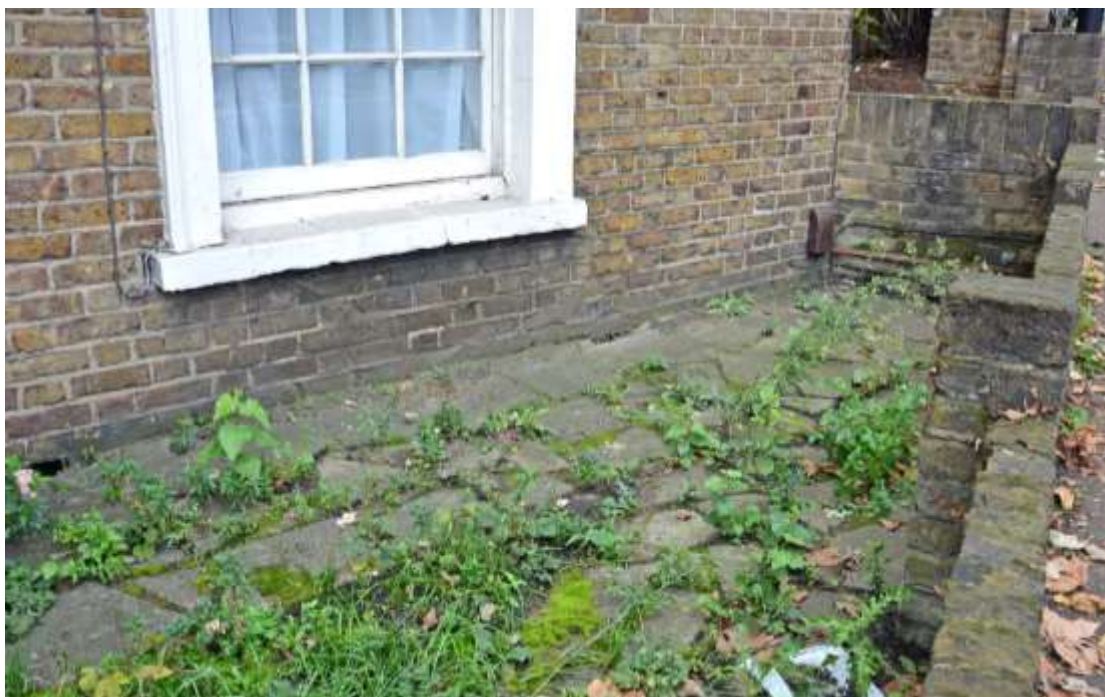
A fully contained small garden area exists to the front of the property. The eastern boundary is formed by the front elevation of the residence whilst the remaining three sides are bound by low brick walls constructed of standard stock bricks. The garden wall marks the boundary between the plot and Muswell Hill's pavement. The ground surface of the garden is occupied by modern concrete 'crazy paving' laid from reclaimed materials (Figures 97 and 98). The paving is in poor condition and is uneven.

**Figure 97:** Photograph of crazy paving in front garden of the residence. Taken 01.11.24.

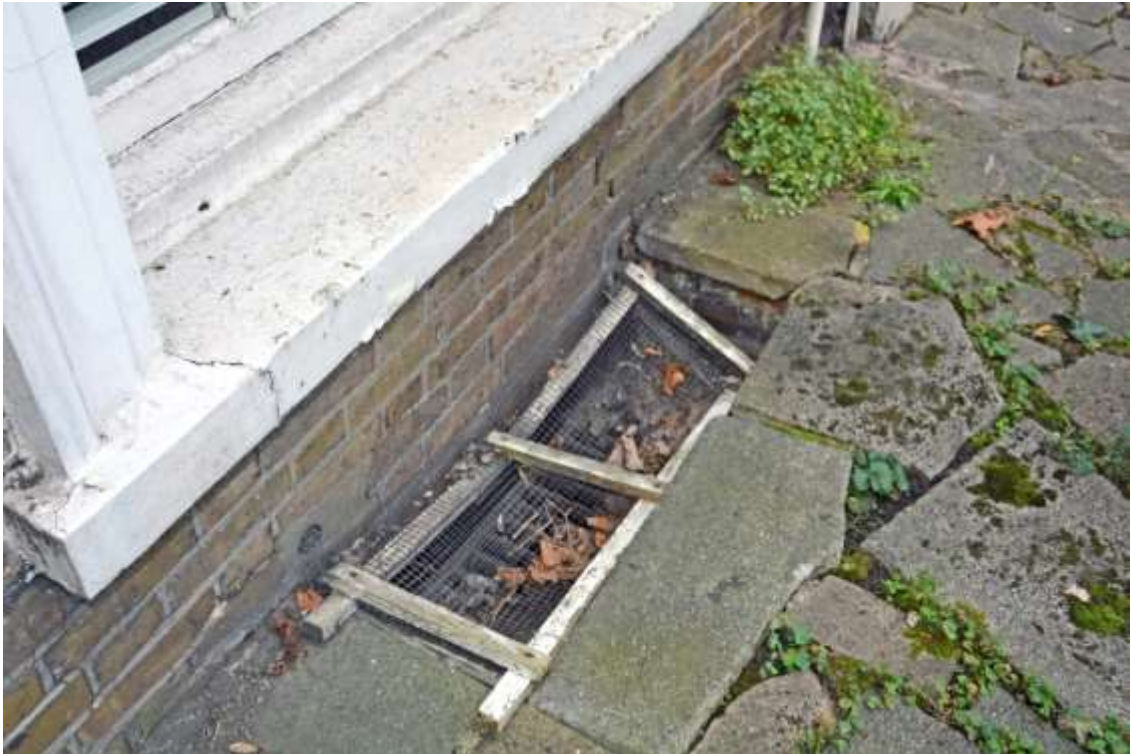
The only additional feature present within the front garden is a lightwell under the lower left window (Section 6.3.3). The lightwell consists of a metal grate level with the ceiling of the basement and a chicken wire covering. The wire cover is broken and in need of replacement (Figure 100).

**Figure 100:** Photograph of lightwell feature within the front garden. Taken 01.11.24.

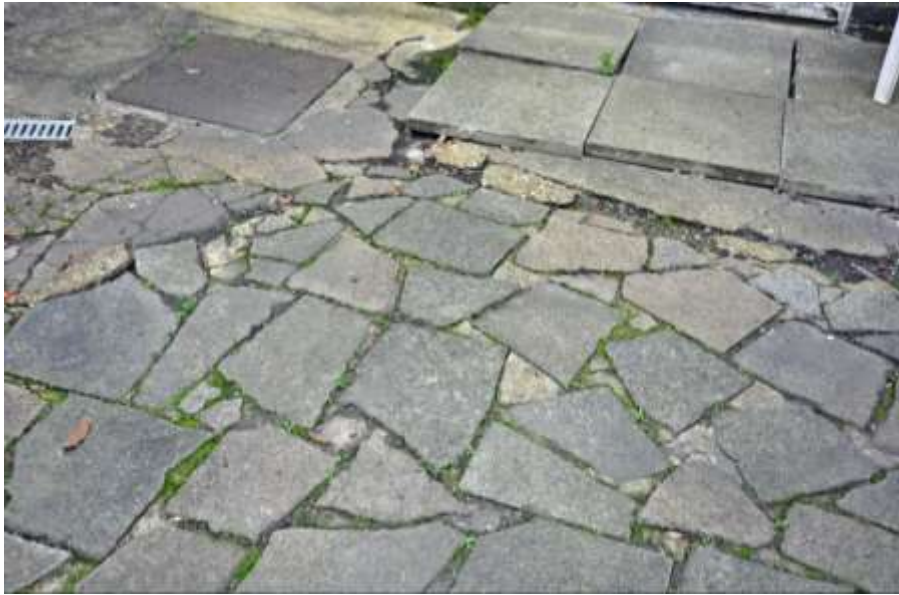
consisting of modern concrete slab tiles, separated from the lawn by a low modern stock brick planter wall (Figure 105). The condition of the patio is poor with areas of missing paving and a significant variation in the level of the patio surface (Figures 106 and 107). The patio area is located lower than the surface level of the grass creating a stepped effect to the garden. Modern steps have been introduced to allow access to the lawn (Figure 109), with a slab of marble partially exposed to the left of the steps.

**Figure 107:** Current condition of rear garden patio paving by the garden access door. Taken 01.11.24.

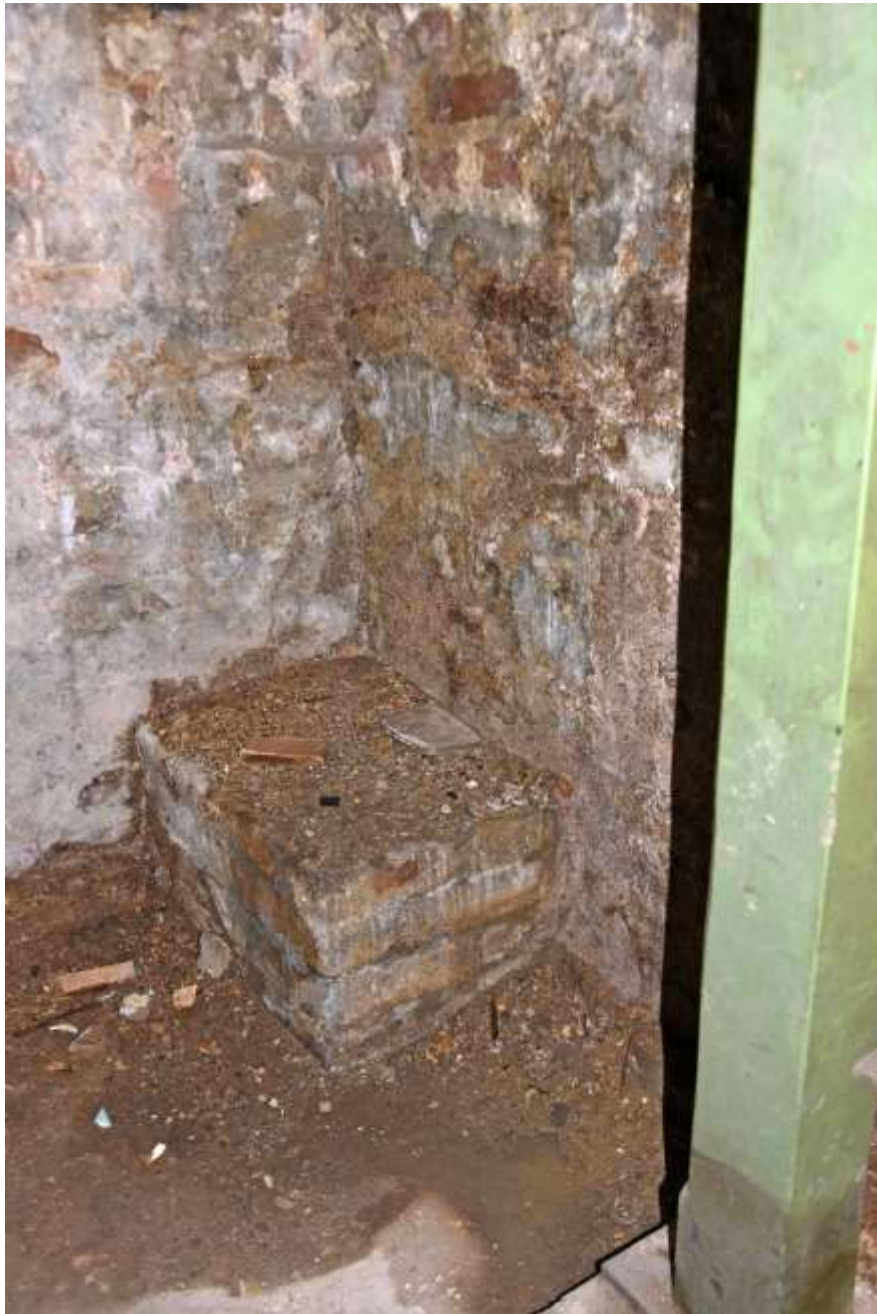
A small additional feature is also present within the basement, observable as a partial column or stack of brickwork in the northwest corner. The stack is four bricks tall, but its' purpose is unknown. The brickwork of the feature does not appear to match the surrounding basement walls and was presumably constructed later (Figures 114 & 115).

**Figure 114:** Stepped brick feature in northwest basement corner. Taken 22.10.24.

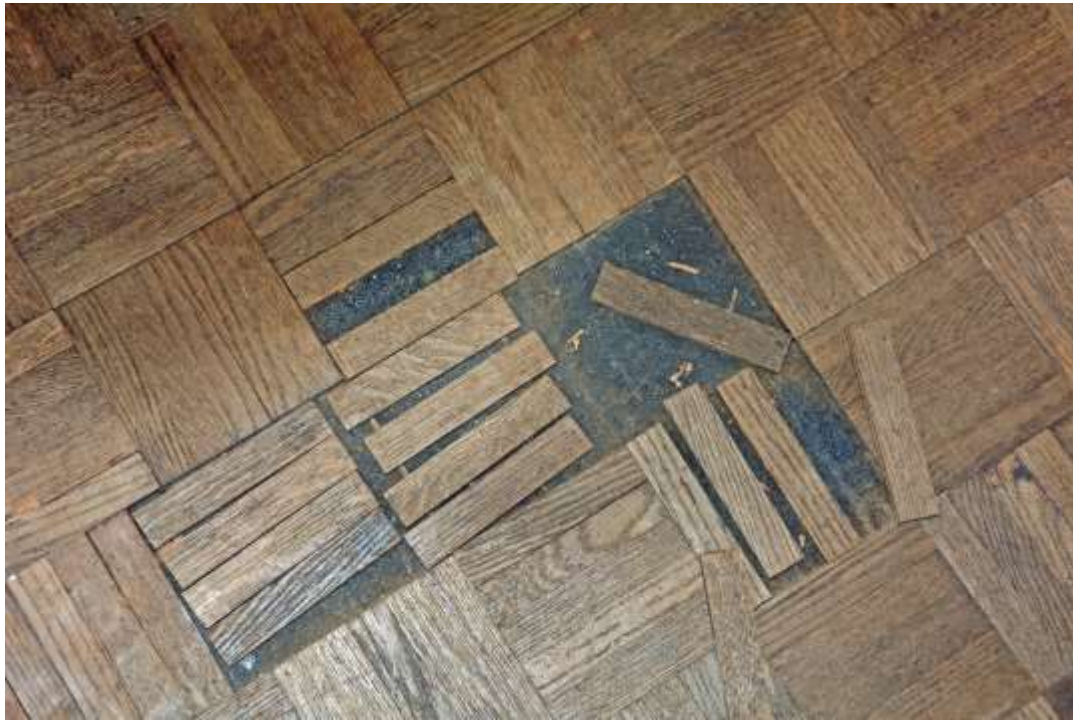
The existing flooring in the hallway is a modern parquet flooring laid in a style popular in the 1960s-1970s, with the wooden blocks quite consistent and factory made. It has been laid in a very common square based pattern, each with five segments, but is now completely loose in several areas – particularly around high traffic areas such as doorways. This can be observed in the form of both missing and loose segments, both have left the bitumen underlay exposed (Figures 122-123).

**Figure 122:** Floor condition within the hallway (Area B). Taken 01.11.24.

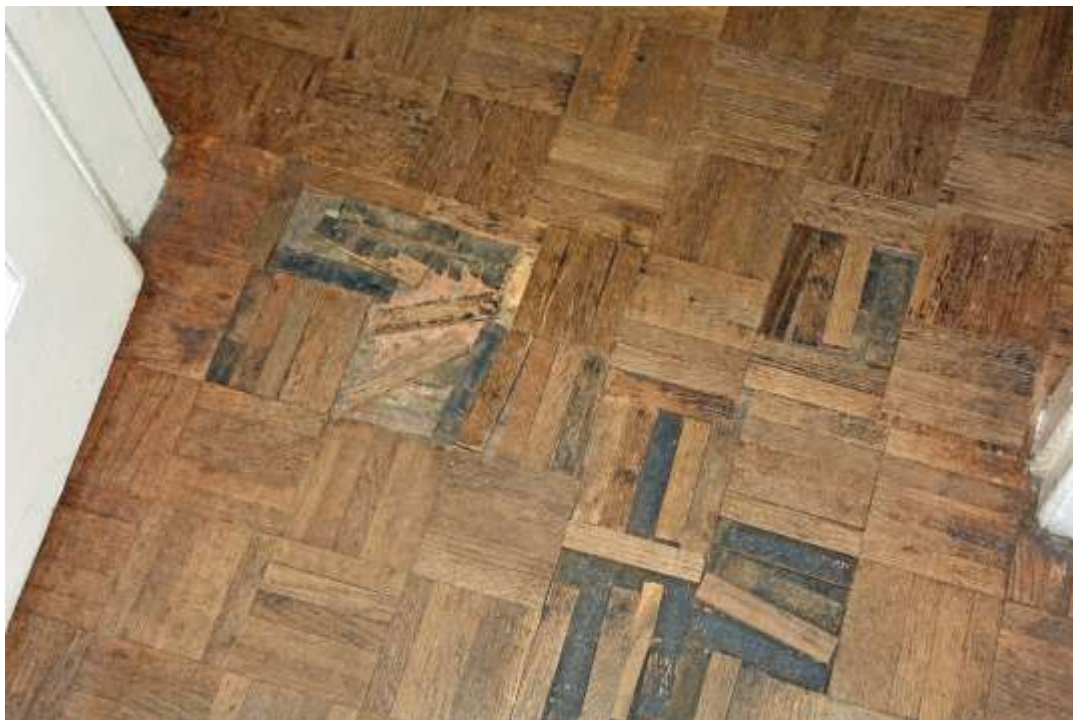
**Figure 123:** Floor condition within the hallway (Area B). Entrance to Area C. Taken 01.11.24.
