**“ST DUNSTAN’S COTTAGE”**  
**9 & 9a MUSWELL HILL, HARINGEY N10 3TH**

**HISTORIC BUILDING IMPACT ASSESSMENT**

Updated February 2026

COMPASS ARCHAEOLOGY LIMITED  
250 York Road, Battersea  
April 2025 / Updated February 2026  
Author: Gabriela Williams  
Amendments by Hannah Stralow Rees  
Telephone: 020 7801 9444  
E-mail: [mail@compassarchaeology.co.uk](mailto:mail@compassarchaeology.co.uk)  
Website: [www.compassarchaeology.co.uk](http://www.compassarchaeology.co.uk)  
©Compass Archaeology Ltd.

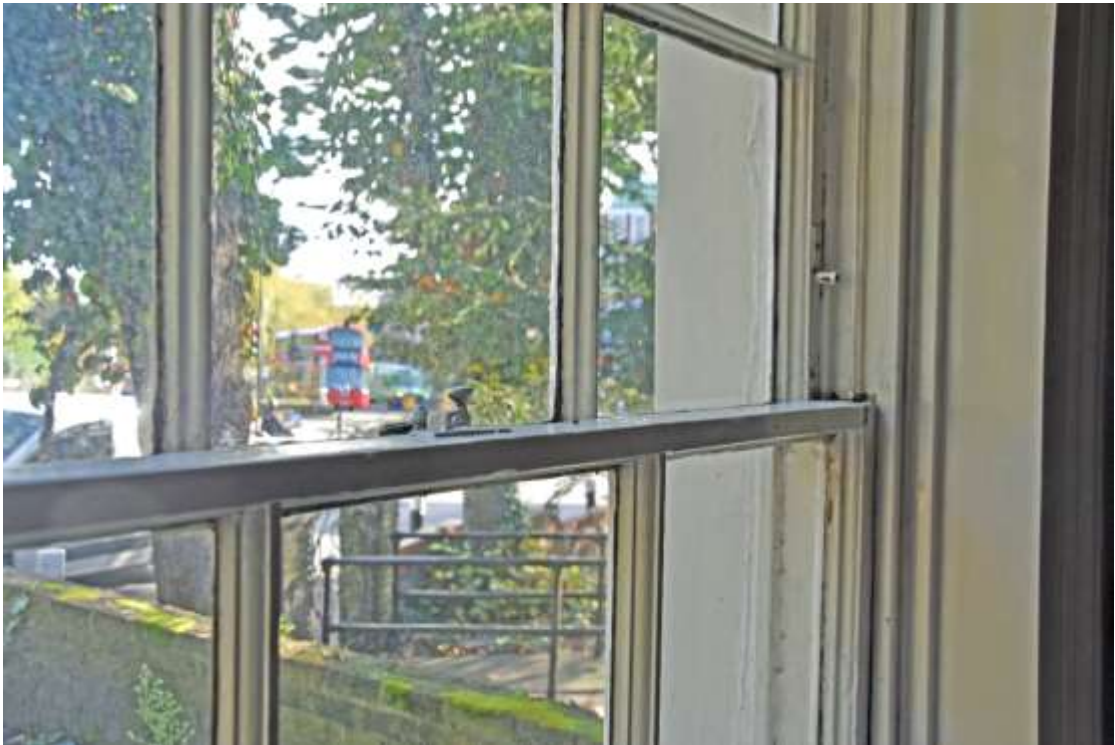
**Figure 136:** Detailing of window interior within Area C. Taken 22.10.24.

From the interior of the room it can be clearly observed that the glazing bars for the upper and lower sashes of the window differ (Figure 136). The upper sash has the thinner, lambs tongue style whilst the lower features Ovolo & Fillet glazing bars. The frame of the two sash panels is identical for both, meaning it is likely the lower sash was refurbished at some point with the glazing bars replaced. This window is operational and the hardware corresponding with a sash window is all *in situ* within the

frame. The fastener appears to be a quadrant sash fastener which has been painted during one of the repaints completed for the window frame and sashes (Figure 136). Due to the paint coverage, the metal utilised and its current condition cannot be assessed. The window frame has also had modern additions, specifically the addition of blinds with the fixtures for these to the top of the frame.

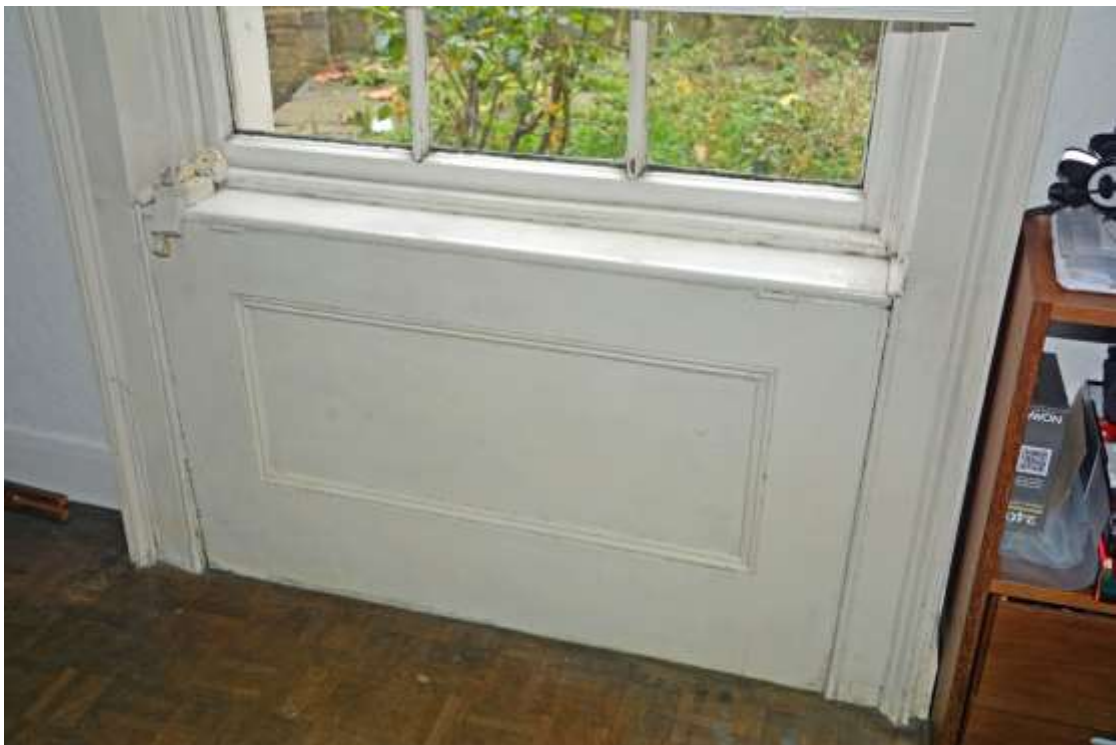
**Figure 137:** Shutter Box feature underlying window in Area C. Taken 01.11.24.

Underlying this window is an additional period feature, a panelled wooden box (Figure 137, previous) that is thought to be associated with shutters which could originally be pulled up to cover the window. It is unknown if the box still contains the shutters as it has been painted shut – although the hinges to open the box are still present. The railings for the shutters are believed to have been covered by modern wood, with additional wooden elements also added to prevent the box being opened. The same feature can be observed within the window of Area G but it is not present on any other windows within the residence. Shutters of this style were common in Georgian architecture as window curtains were not popularised until later in the 19<sup>th</sup> century.

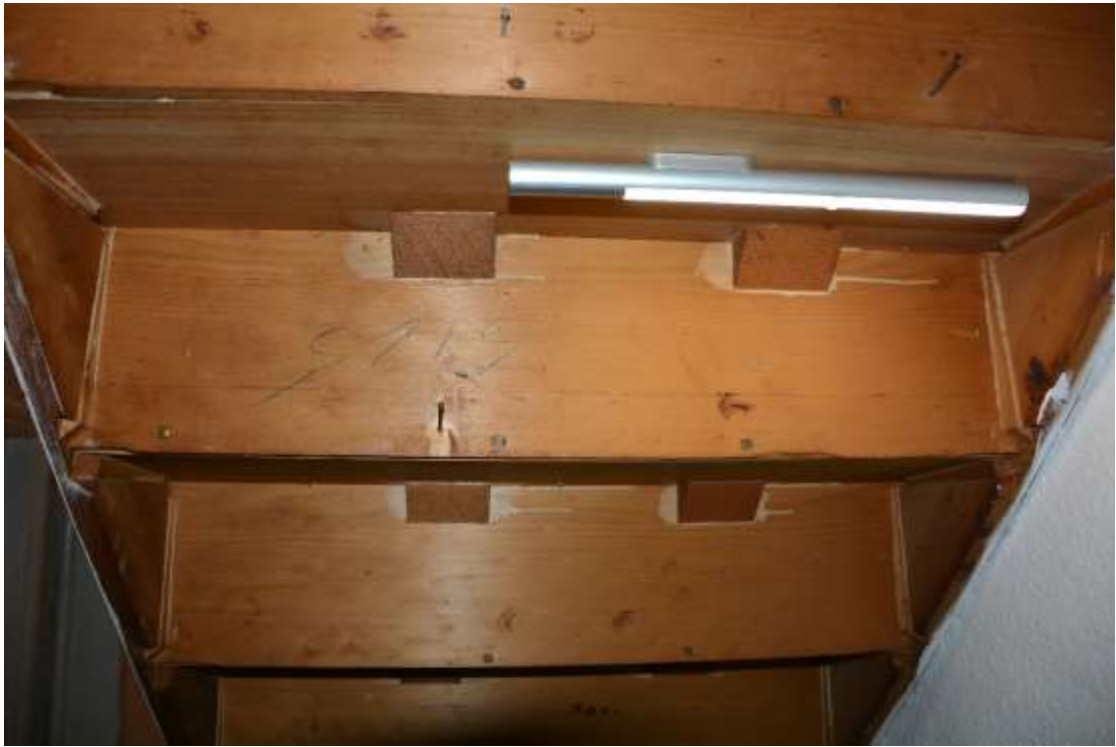
**Figure 140:** Underside of modern staircase in Area D. Taken 01.11.24.

The staircase is modern and is thought to have been installed when the main residence was restored from two separate flats into a single dwelling, probably in the 1960s. The wood utilised for the staircase is modern as are the staircase details (handrail and balusters).

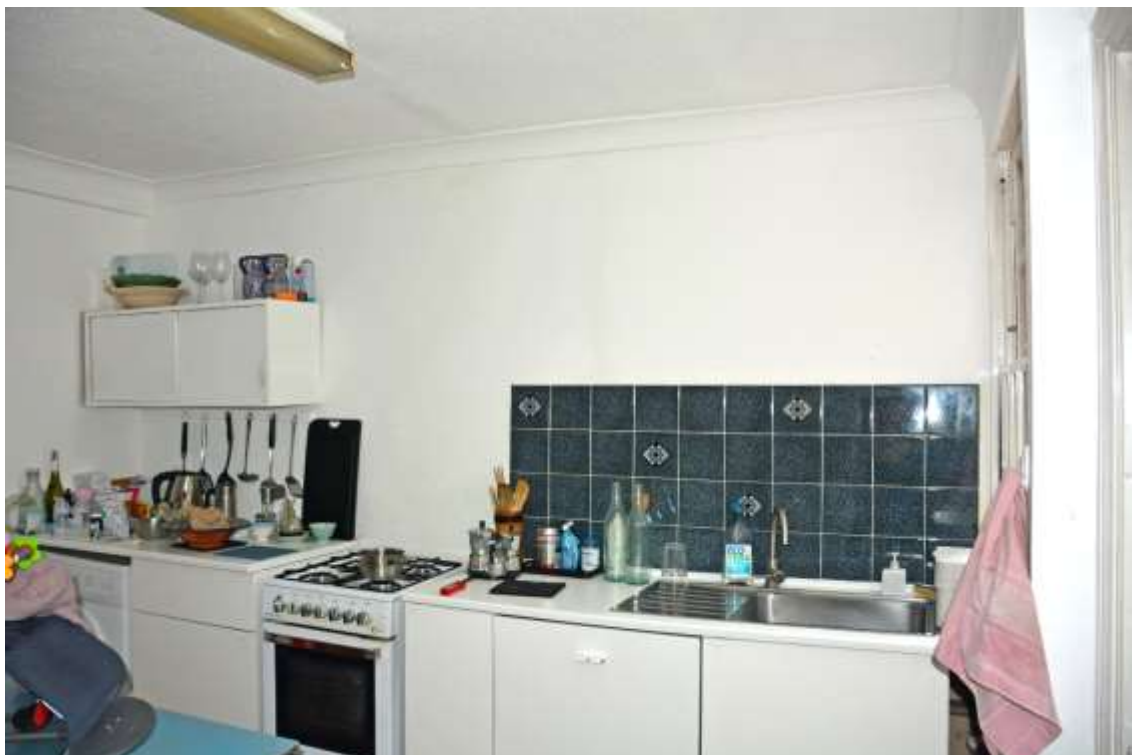
The kitchen is a modern installation with fitted units, a stainless steel sink and various associated fixtures. It measures approximately 3.5m in length and 3.25m in width. Originally, a fireplace (+ cooking range?) would have been present on the south wall, but the flue has been blocked. In its place are built in cupboards which provide additional storage for the kitchen and also house the central heating boiler for both 9 and 9a Muswell Hill. Coving is present in this room, although it is in a simple modern design which does not match either of those observed in Area B or Area C (Figure 142).

**Figure 141:** Overview photograph of Area E (kitchen), as viewed from doorway in Area D. Taken 01.11.24.

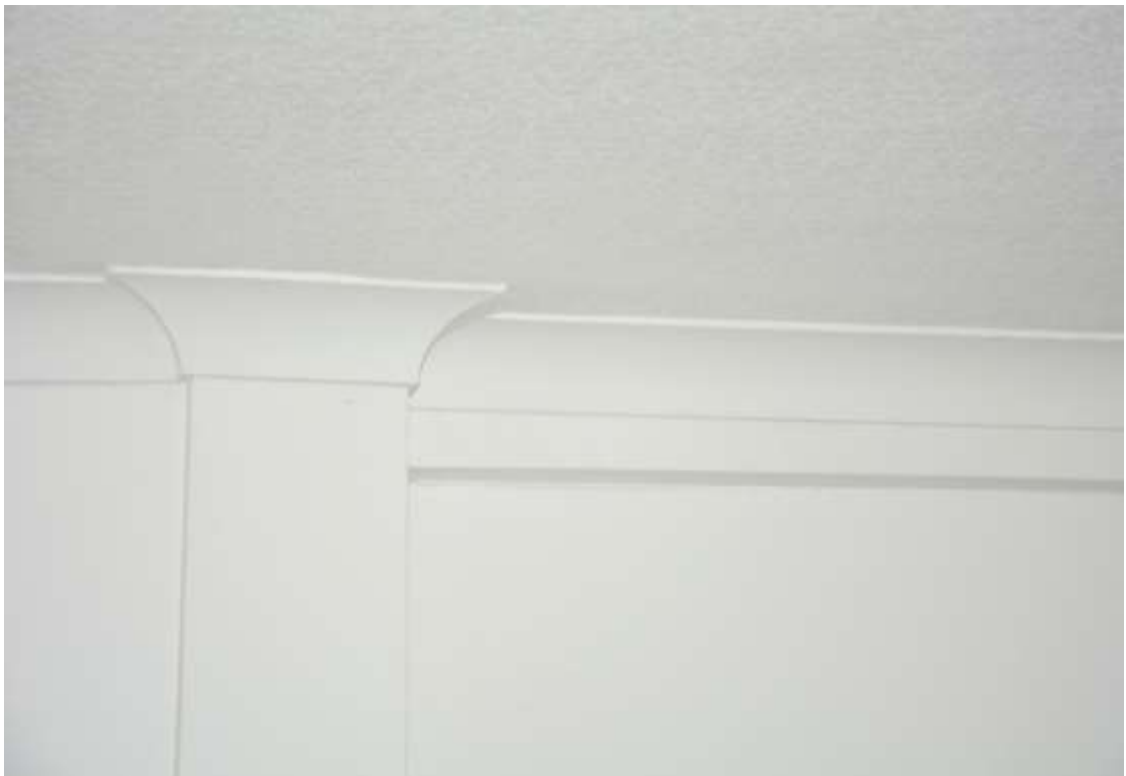
**Figure 142:** Detail Photograph of coving within Area E – southern wall. Taken 01.11.24.

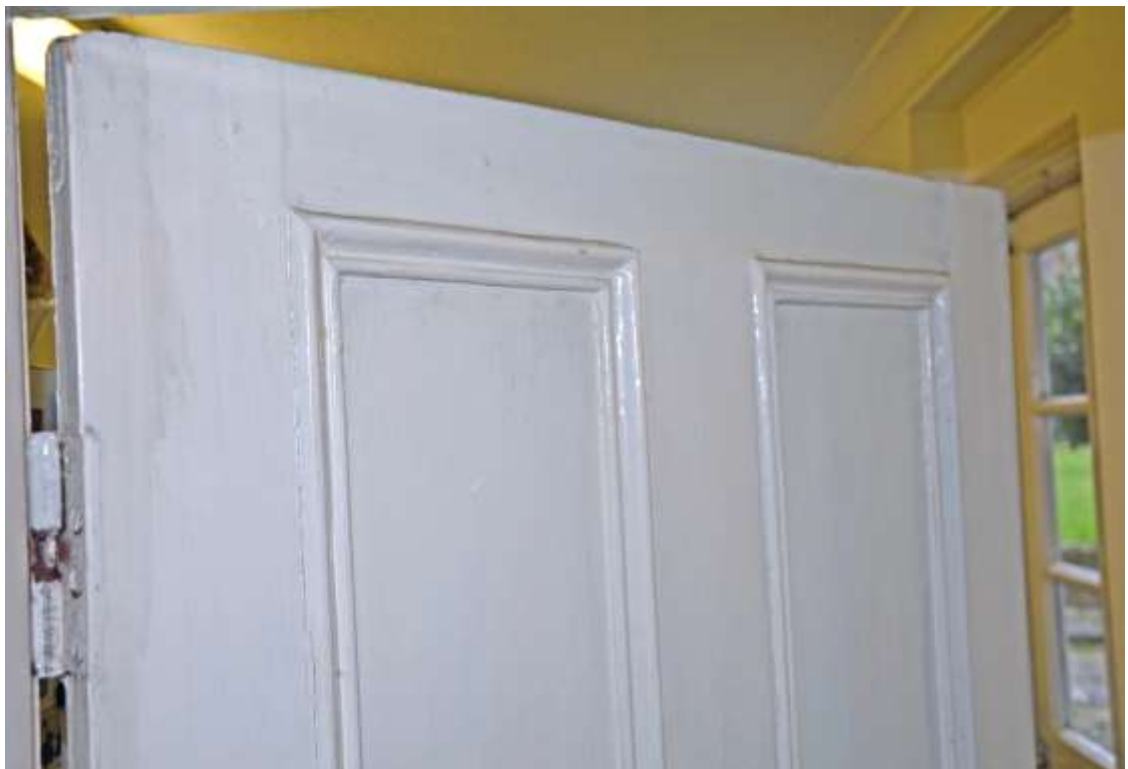
The skirting boards in this room are also Type 1, like those observed in Areas C and G, whilst the floor has a modern strip wood-effect covering. A white-painted, four panel wooden door with a ceramic handle door provides access from Area E. However, it differs from the remaining doors on the ground floor, most obviously with the moulded trim outlining the panels projecting from the surrounding woodwork (Figure 143).

**Figure 143:** Detail photograph of door providing access to Area E. Taken 11.12.24.

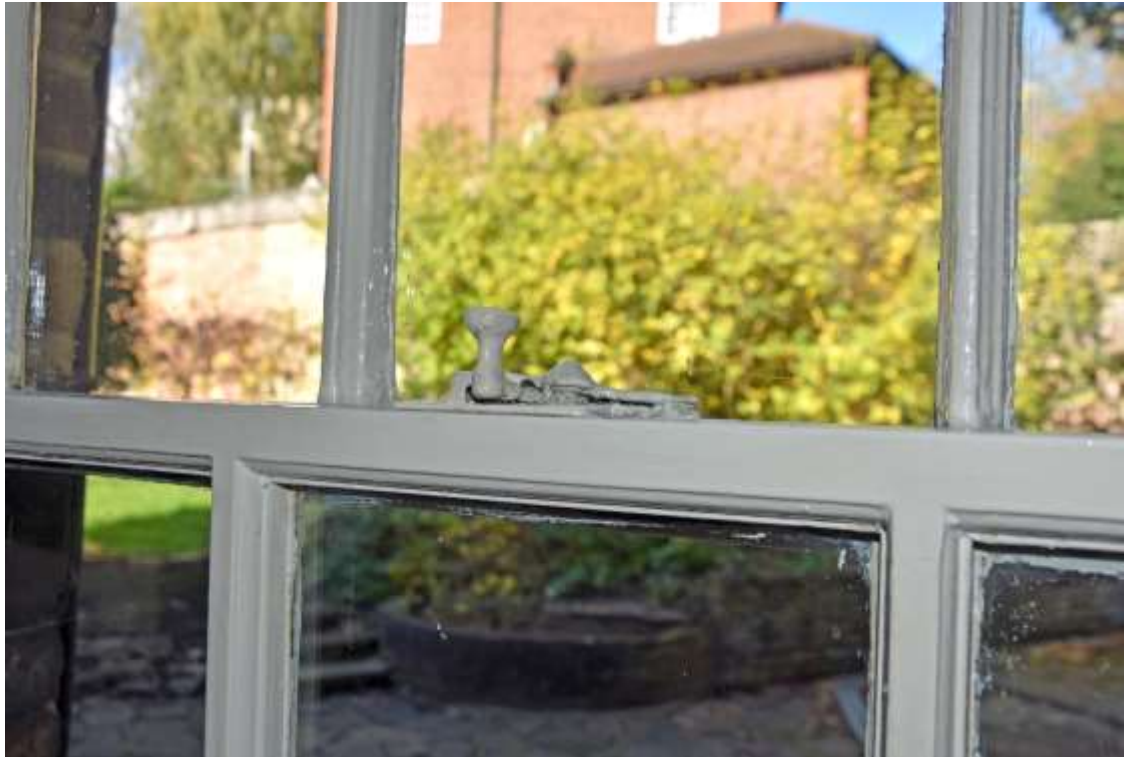
**Figure 144:** Detail photograph of window in Area E. Taken 22.10.24.

As previously mentioned, the window within Area E has two entirely different sashes. The upper sash is older in date and features the 19<sup>th</sup> Century Ovolo & Fillet style glazing bars with a matching frame (Figure 144). This sash also contains at least one pane of older glass. In comparison the lower sash is quite modern, both the glazing bars and surrounding frame. The fastener of this window appears to be the same quadrant sash fastener present in Area C, although it has been painted over so the metal and condition cannot be fully assessed. The external kitchen door is also entirely modern and is within a modern frame. Neither the window nor the door is thought to have existed in their current position in the original design, although there is likely to have been a door in this area to allow kitchen staff access to the exterior of the property without going through the main residence. It is possible that both – and in particular the window – would have been located on the western wall, prior to construction of the rear extension around 1860.

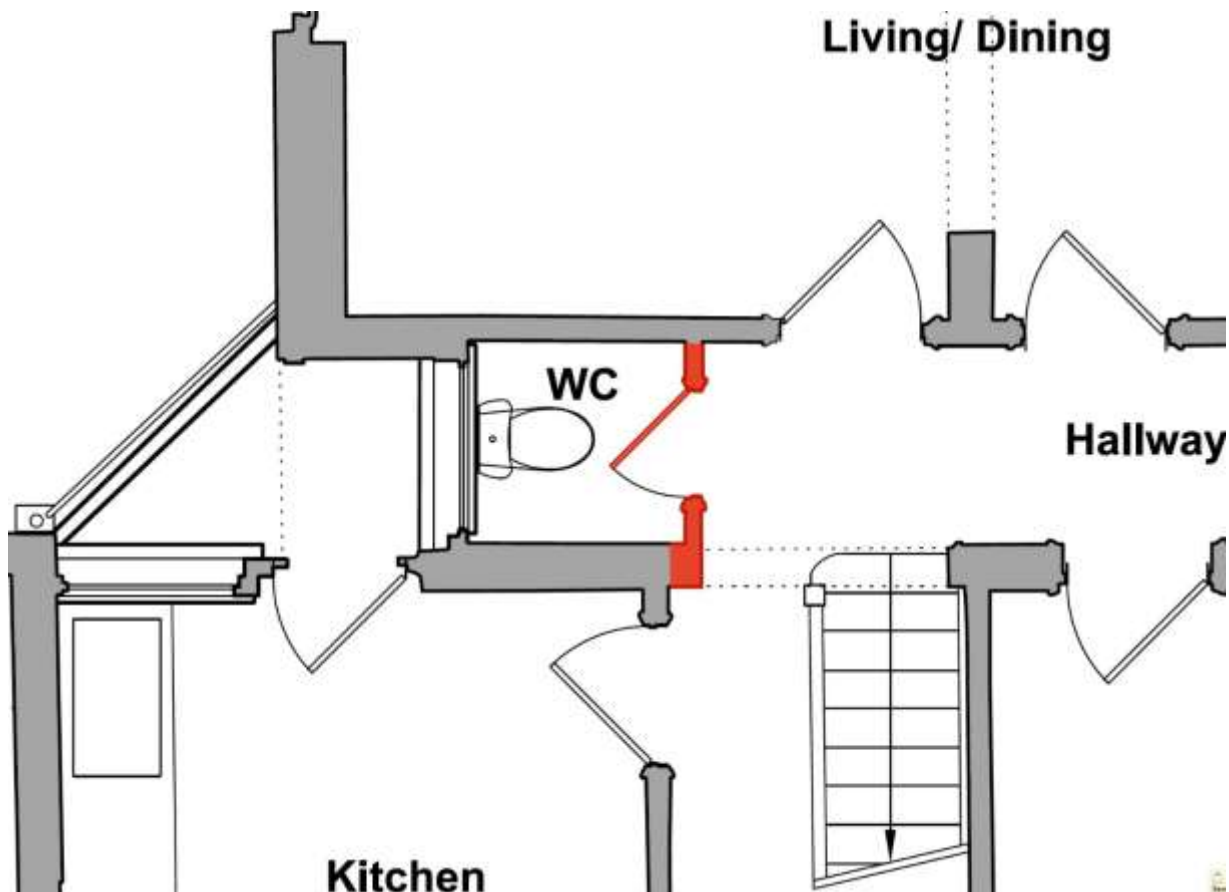
of Area F before following the room around to the west (the external wall) and then returning on the southern wall. The coving also has a distinct ending which can be seen on the south wall within Area F, stopping short of the present wall corner (Figure 147). The point at which the coving disappears is on a line with the existing kitchen wall to the south, and also marks the change west to east from a solid brick wall to a hollow stud wall. Originally, the hallway would have continued through to the rear of the property, but when the WC was installed the existing alcove was not large enough to fit the toilet with sufficient space in front (even to open the door), so the 'wall stub' was constructed in order to extend the space.

**Figure 145:** Detail from the ground floor plan, highlighting in red the stud wall and doorway inserted across the original front-to-back hallway so as to create a separate downstairs W.C

As can also be seen above, the building out of the stud wall retained just sufficient space to pass from the main hallway past the foot of the stairs and thence to the kitchen and cellar. Again it is clear that this would not be part of the original design.

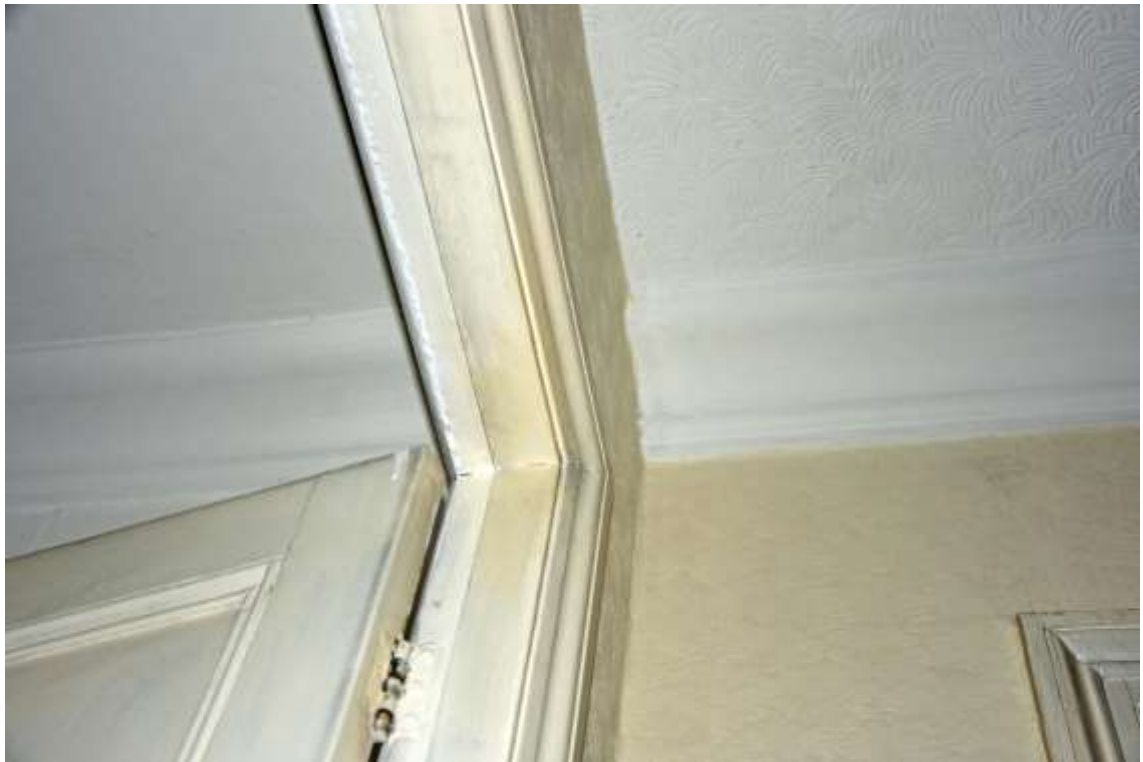
Area F is a small, more or less square space located at the far end of the hallway (Area B) and directly in line with the front door of the residence. The doorway to this space is narrower than those previously discussed, whilst the space itself is occupied by a downstairs WC featuring just a toilet and a window. The wall separating Areas F and B is a stud wall and is not original to the residence (*cf.* Figure 145). This can be determined definitively due to the coving on the northern wall of Area B continuing through the stud wall into Area F (Figure 146). It then continues along the north wall

**Figure 146:** Detail photograph showing the continuation of the coving on the northern wall from Area B (right) into Area F (left). Taken 22.10.24.

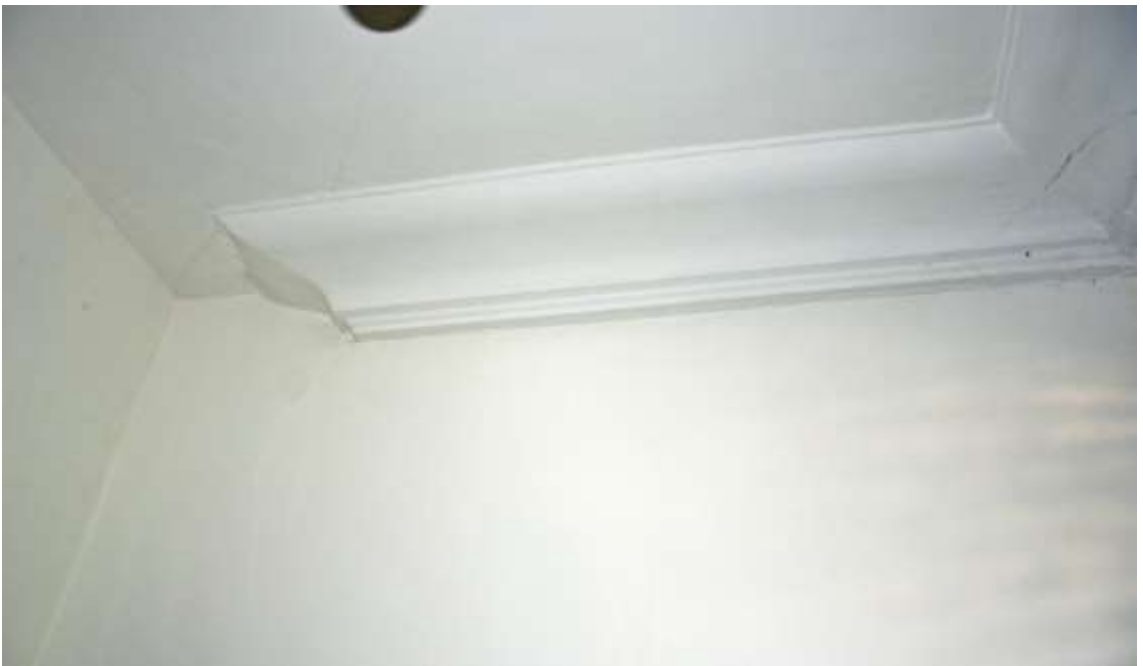
**Figure 147:** Photograph of coving on southern wall of Area F. Taken 22.10.24.

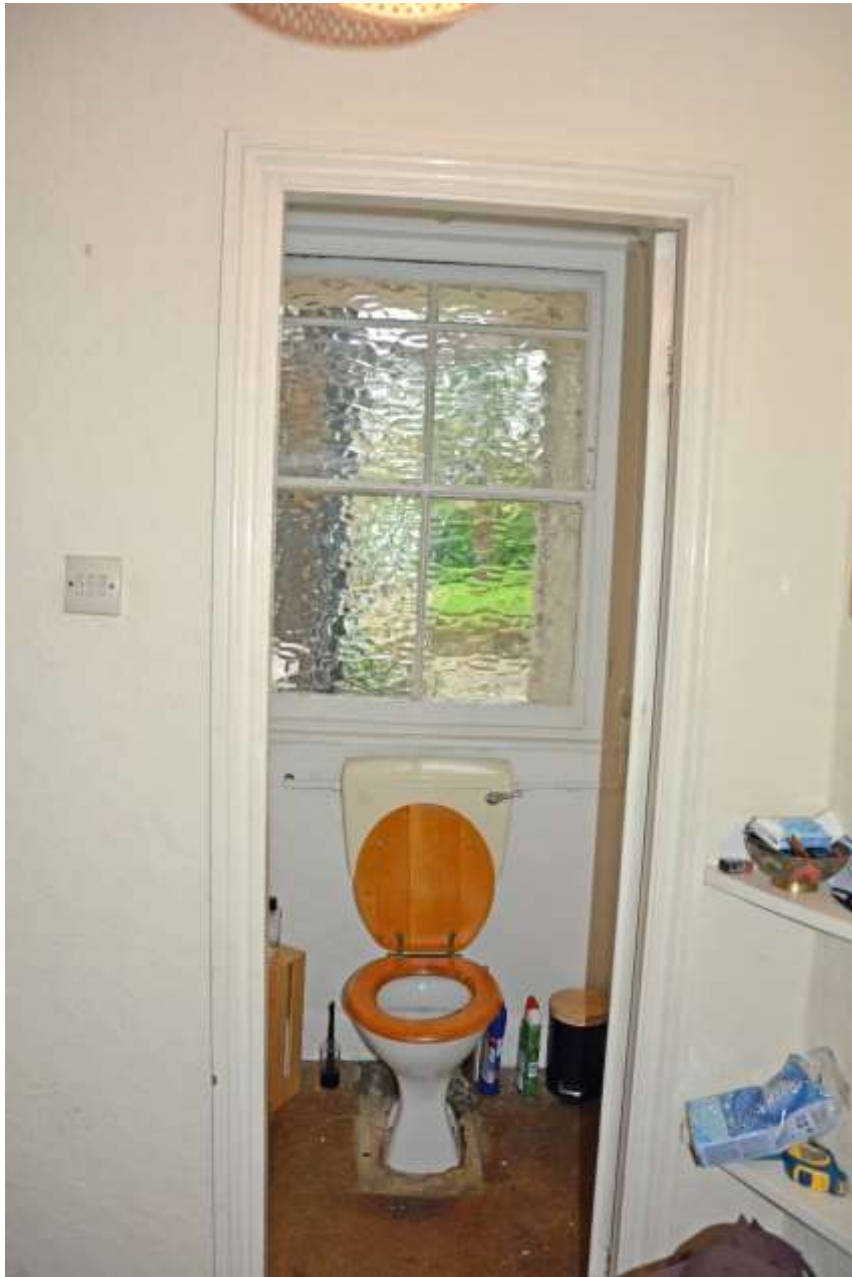
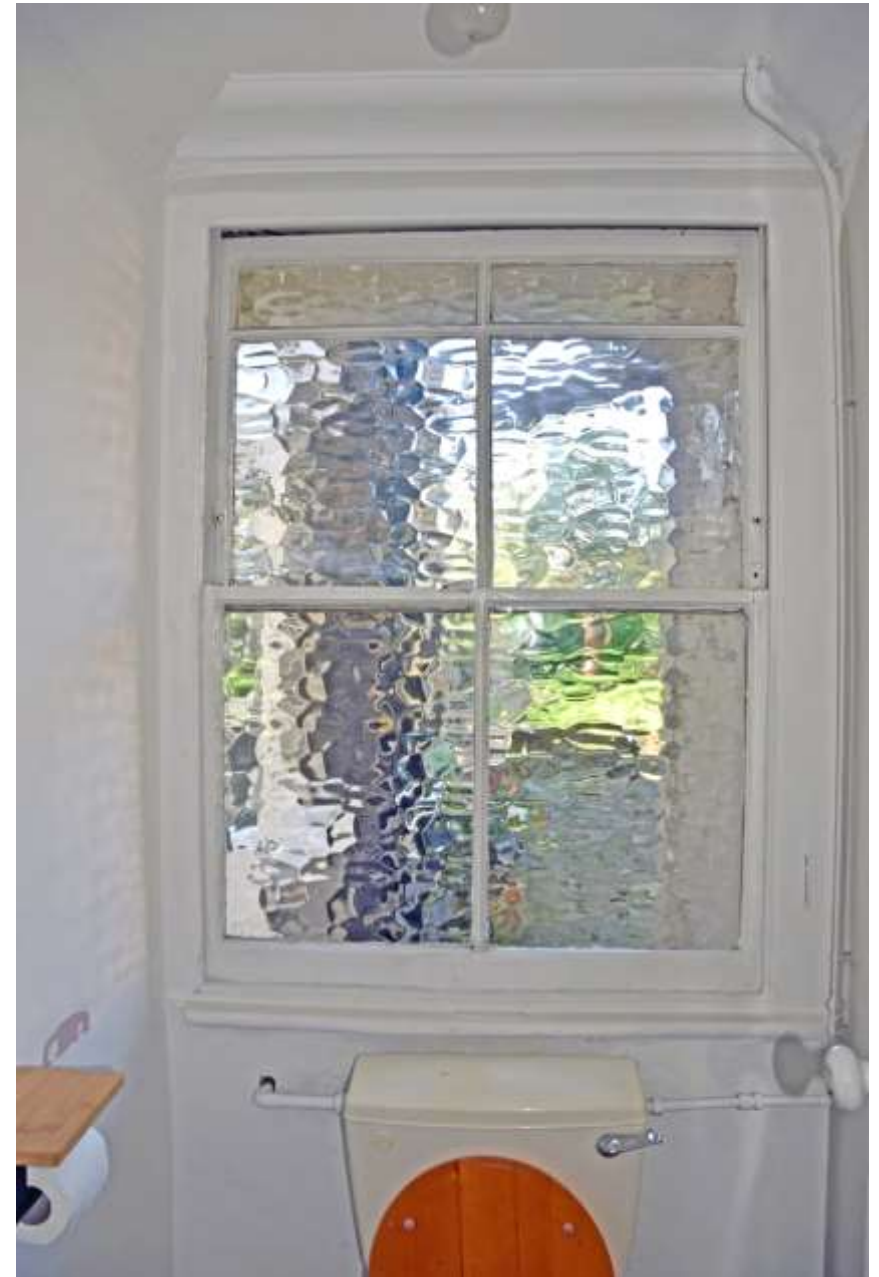
The main feature present within Area F is a large window occupying the upper part of the western wall (figs 148a & 148b). The exterior of this window has been discussed in detail in Section 6.5.5 and is clearly not original to the house. The window itself is a Victorian sash window design which has been replaced with modern textured glass. The framing of the window is modern, with additional woodwork to install the window into the wall. It is not believed that a window originally existed in this location: it is much more likely that there was an external door here, providing a clear access route from the front to rear of the residence and directly into the garden.

**Figure 148a:** Overview photograph of Area F. Taken 01.11.24

**Figure 148b:** Detailed photograph of the window in Area F. Taken 22.10.24.

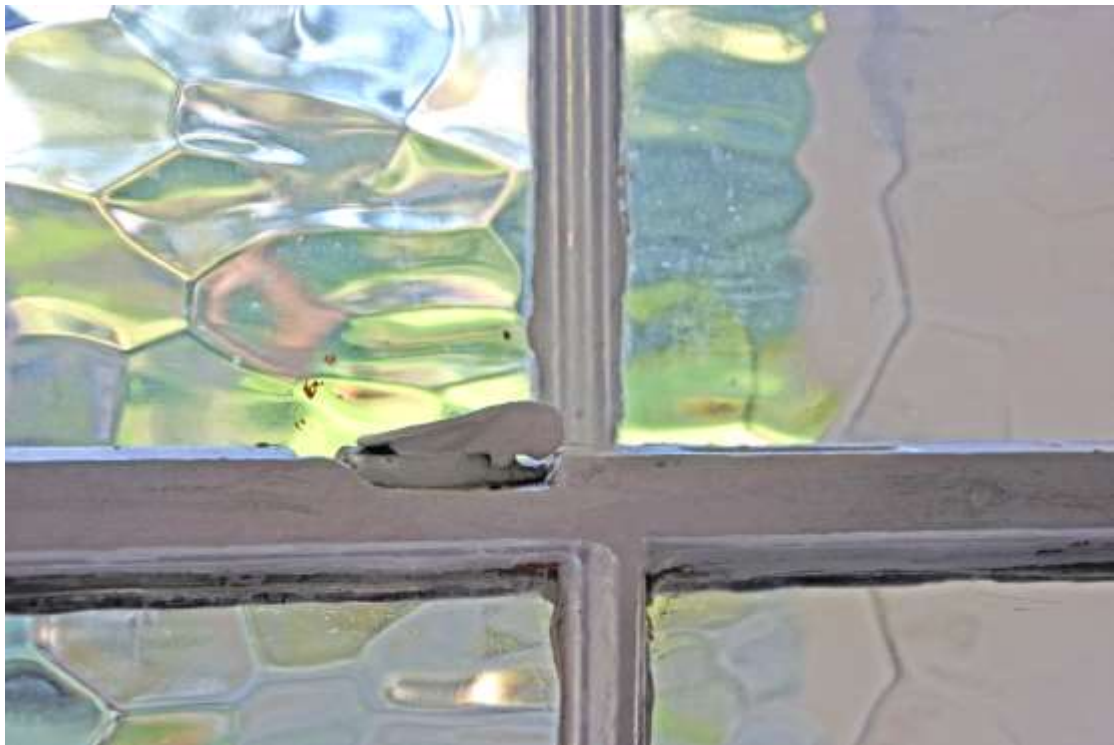
The window hardware in this area differed from the quadrant sash fasteners present in Areas C and E. Instead a 'Fitch' sash fastener (popularised c.1900) that features a conch shaped pulley has been used (Figure 149).

**Figure 149:** Detail Photograph of 'Fitch' sash fastener in Area F. Taken 22.10.24.

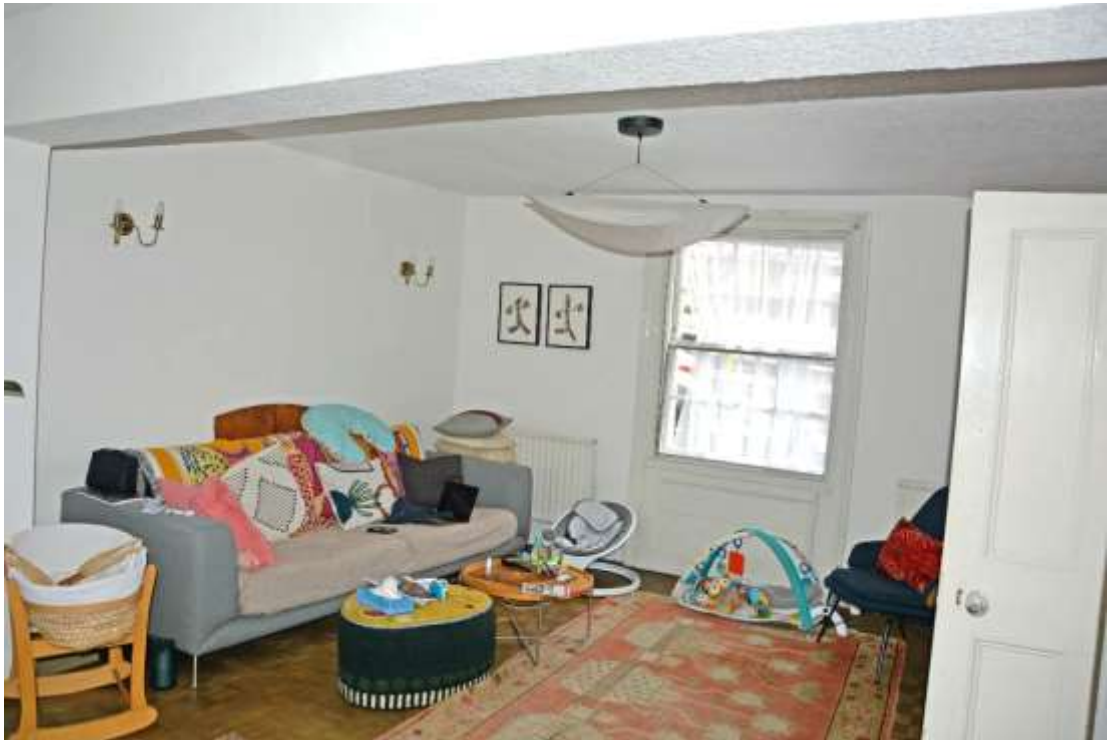
**Figure 151:** Overview Photograph of Area G, facing east towards Muswell Hill. Taken 01.11.24.

Area G has two chimneys, one for each of the previous rooms. The fireplace in the eastern room has been blocked and the remaining aperture converted into a storage space (See Figure 151, partially obscured by sofa). In contrast, the fireplace in the

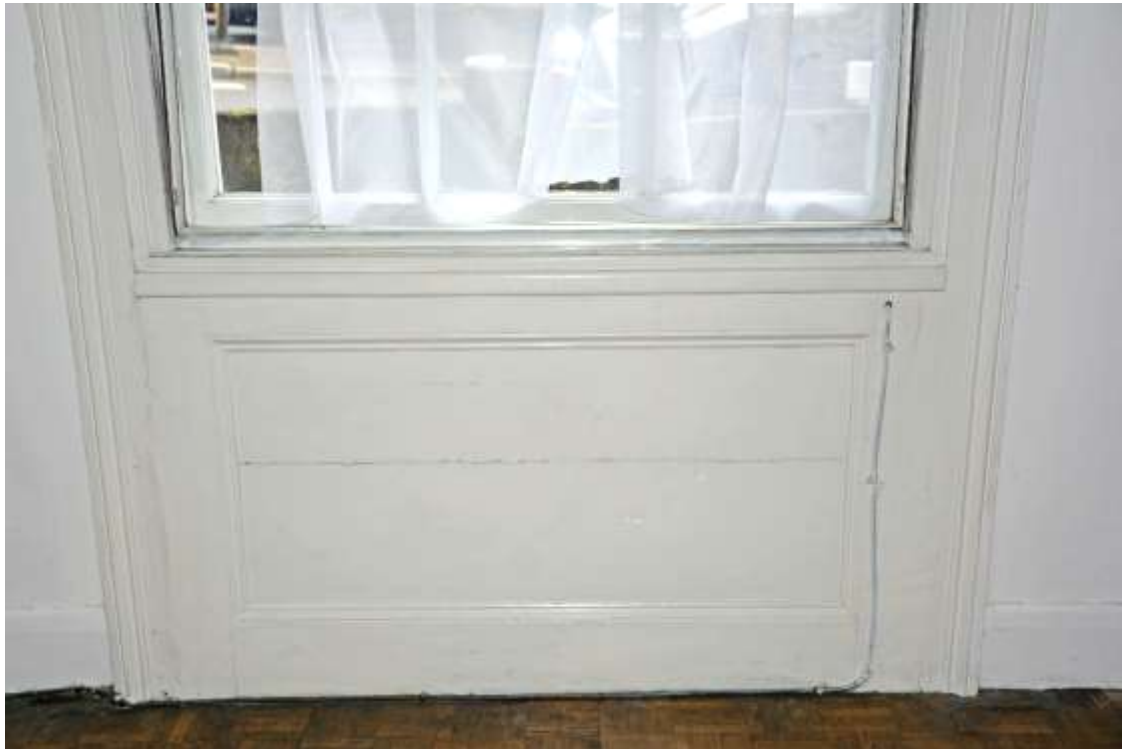
Several additional features are present within Area G. The first of these features is the window on the eastern wall, the exterior of which has been discussed in Section 6.3.7. Both window sashes have been replaced with Georgian Style modern reproductions, featuring a modernised version of the Ovolo & Fillet design. As discussed in Section 6.11.2, the frame containing the sash window does not project into Area G in the same way as in Area C due to the greater thickness here of the external (eastern) wall. The window also features the same underlying box panel as Area C, which is thought to have contained sash window shutters that could be pulled up (Figure 152). The box in this area has been heavily painted and additional wooden panelling has been added, rendering it inaccessible so that the presence of the shutters could not be confirmed. The hinges for this box have been removed or covered. The sash fastener for the window itself is the same ‘Fitch’ style as in Area F.

**Figure 152:** Detail Photograph of sash window shutter box on the eastern wall of Area G. Taken 01.11.24.

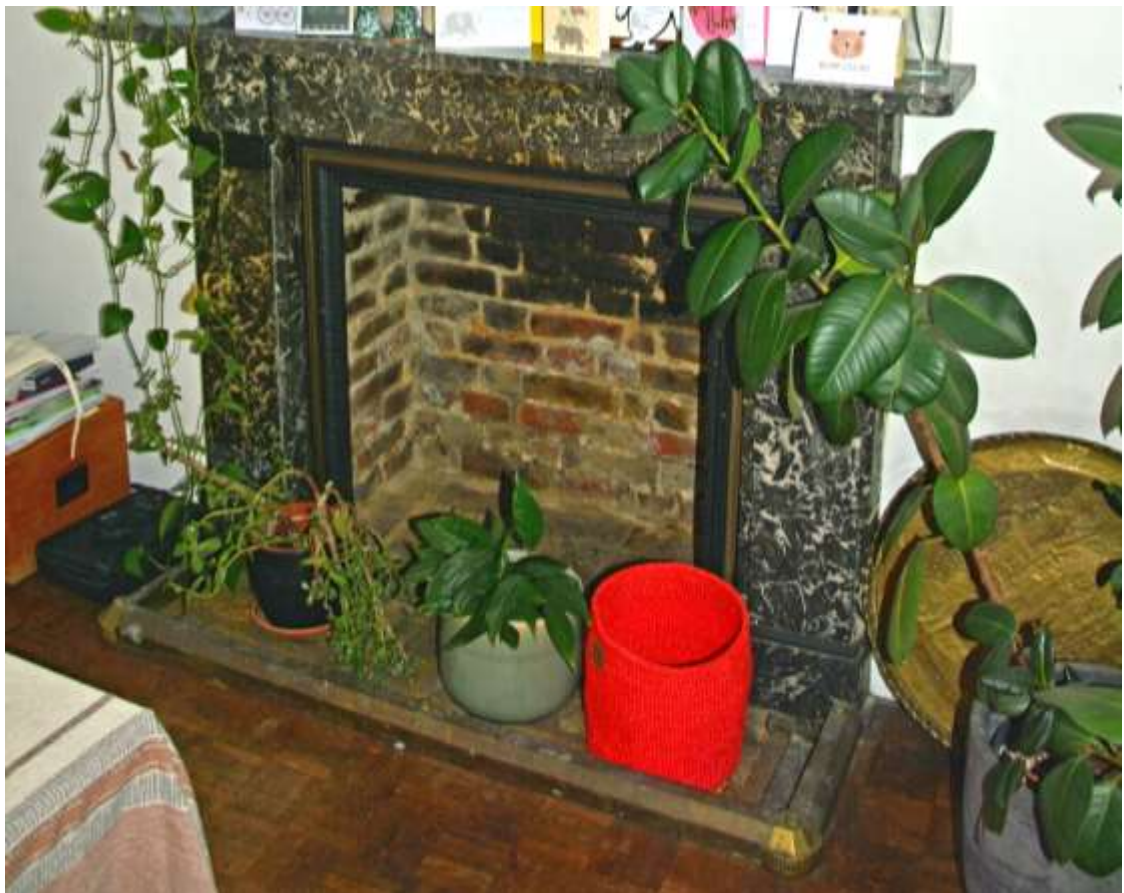
**Figure 153:** Photograph of the fireplace in the western section of Area G. Taken 01.11.24.

western room is open and still has its surround. The fireplace surround is in the same Victorian ‘flat’ style shape as the one in Area C; and is not thought to be original to the house, although the design varies significantly (Figure 153, previous). The fireplace surround in Area G is black marble with yellow and white inclusions; it also features an additional decorative trim which is black with gold detailing. The walls and top of the fireplace itself are exposed brickwork with some evidence of soot /burning associated with past usage. The hearth also features a surrounding fender creating a clear boundary between the brick flooring of the feature and the parquet flooring of the room.

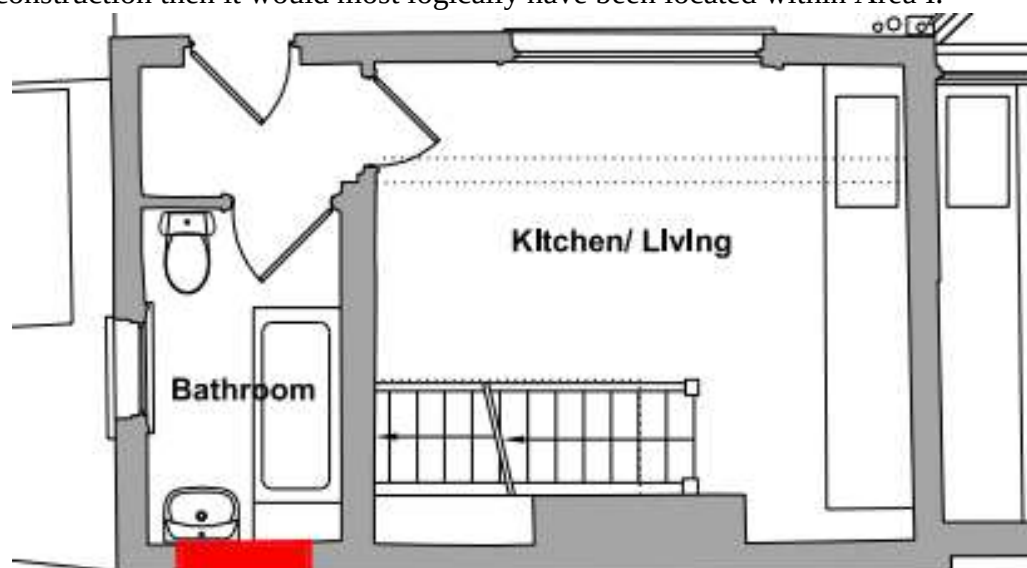
The next space within the rear residence is a downstairs bathroom (Area I) which contains a panelled bath, pedestal wash hand basin and WC. The room measures 2.67m by 1.75m. As mentioned above, the eastern wall of the bathroom is 280mm thick which matches the surrounding external walls. The only notable feature within the room is the window on the western wall – the exterior of which is discussed in Section 6.5.6. The window may form a later insertion rather than an original feature; however, it is thought that a window was previously located on the southern wall of the bathroom and was later blocked up (Figure 154). The staircase for 9a Muswell Hill is also a modern insertion (Section 6.11.9), but it is thought that if a staircase existed within the original construction then it would most logically have been located within Area I.

**Figure 154:** Ground floor plan of 9a Muswell Hill, with blocked window marked in red.

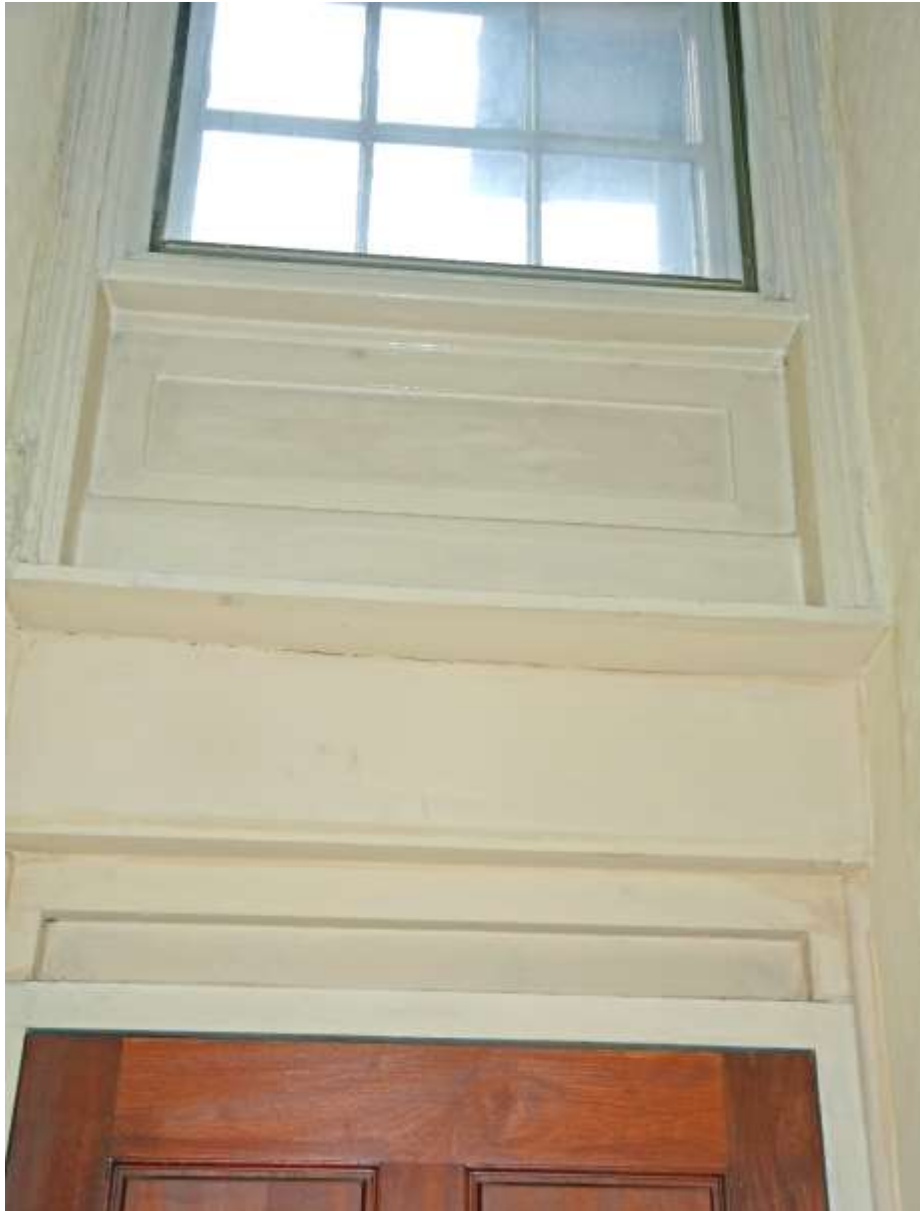
The first space to be considered within the first floor of the main residence is Area K. The eastern end of Area K is occupied by a double-height space approximately 1.7m in length, overlying the primary entrance to the residence (Section 6.3.8). Above the front door is a mixture of panelling, likely to have been installed in several phases (Figure 156). The lower section probably corresponds to the location of an original rectangular transom or fanlight – a standard feature in properties of this type and date. Moreover, it is unlikely that the double-height space is an original feature, so an opening would have been required to bring some light into the lower hallway.

**Figure 156:** Photograph of panelling within the double height void in the eastern section of Area K.

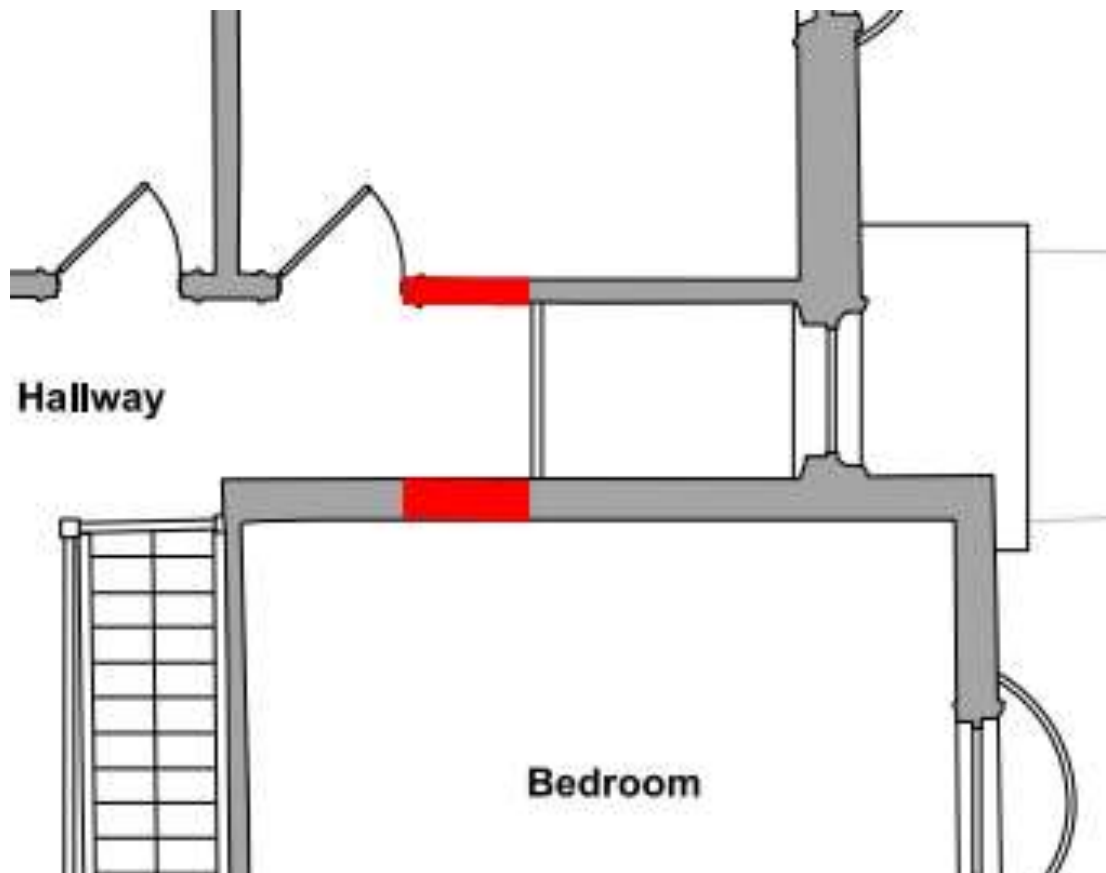
Additional evidence for the double-height space not being an original feature can be found on the first floor in Area K. Inspection of the walls framing Area K on its northern and southern sides, around the junction between the double-height space and the *in situ* floor to the west, has revealed what are evidently two blocked doorways. One of these, the doorway into Area Q, has been moved a short distance to west; the

other original opening into Area L has been relocated at the top of the staircase. The approximate location of these blocked openings is indicated on Figure 157, although it is possible that the original doors and frames were repurposed in their new locations.

**Figure 157:** Original doorway positions within the first floor, marked in red.

The proximity of the original doorway placements to the double-height space makes it very likely that if a void was present in the original design of the house it was shorter in length – in fact the original door position probably slightly overlap this feature. However, it is more probable that no void was present and this feature was added at a later date.

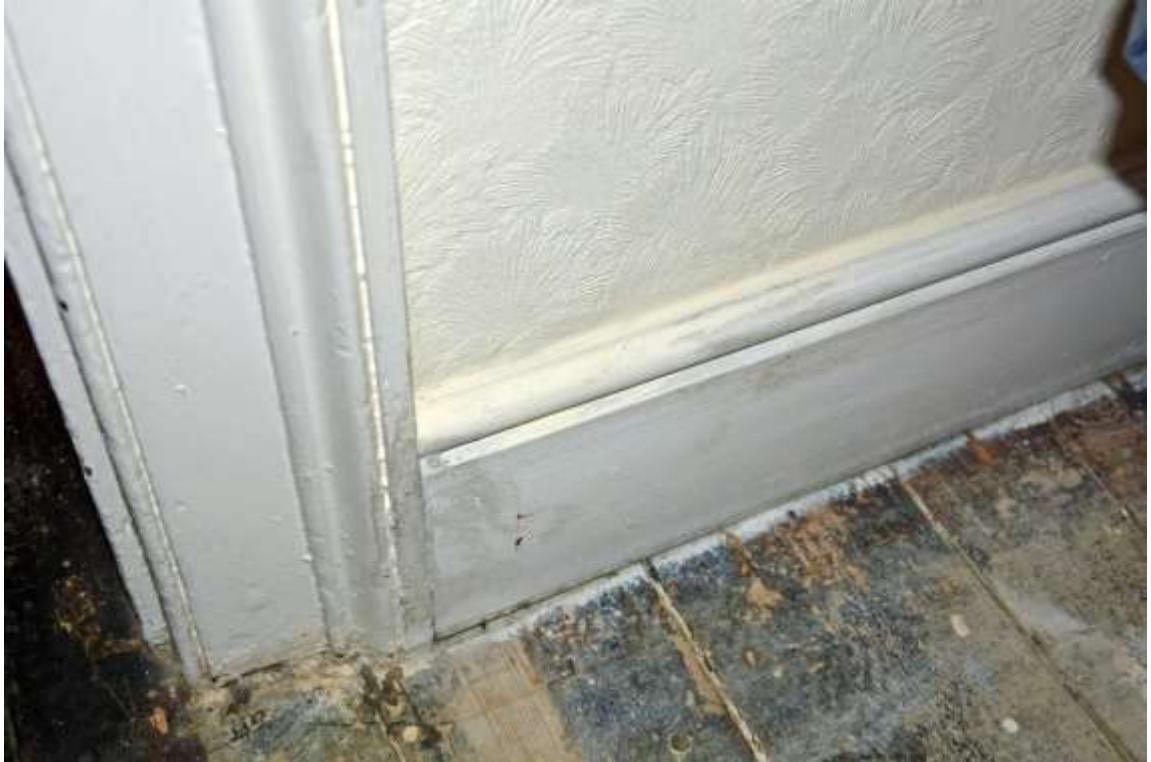
Area K has also been covered entirely in textured wallpaper – both the walls and ceiling – as observed across the ground floor of the residence. No coving is present in Area K, although there are skirting boards. These vary slightly in form and moulding from north to south of Area K (Type 5), but it is likely that the former – and possibly both – are historic in date, but not original (see Appendix I).

**Figure 158:** Detail Photograph of skirting boards in Area K (on shared wall with Area Q. Taken 11.12.24.

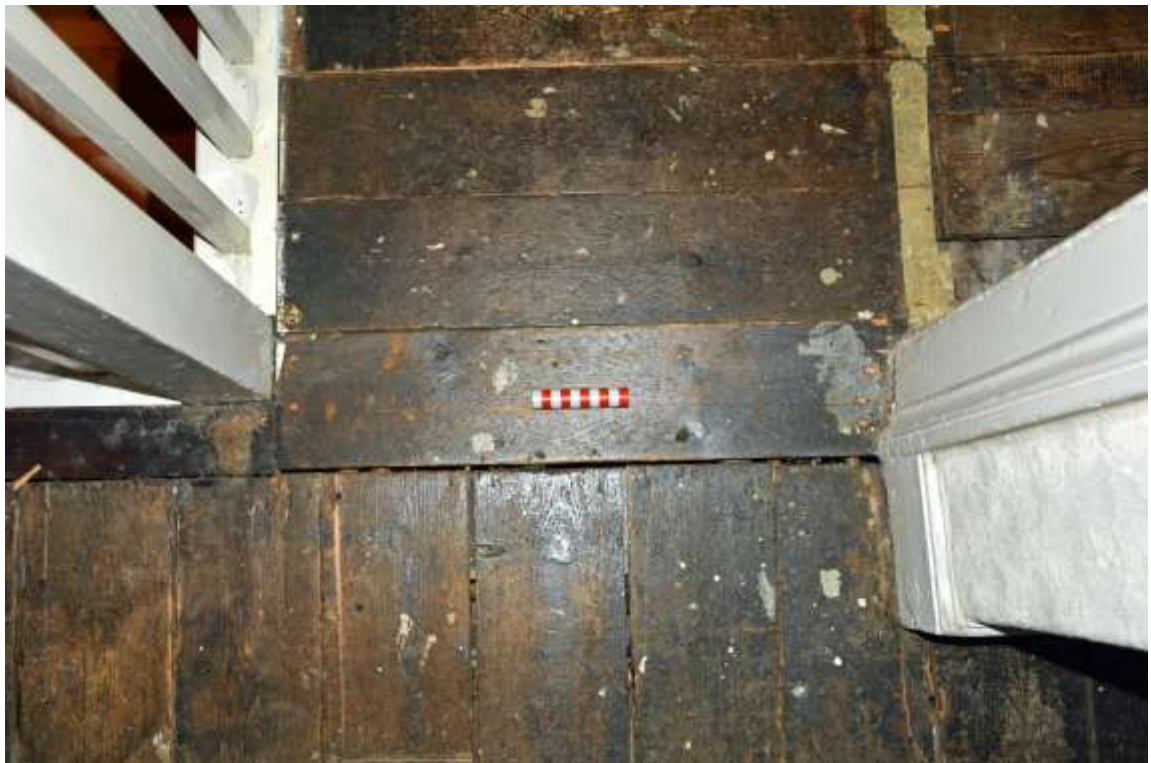
**Figure 159:** Detail Photograph of wood flooring between Area K (bottom) and Area M (top). 10cm scale Taken 11.12.24.

The flooring in this area is exposed wooden boarding which in places is somewhat uneven. The boards are 155-160mm in width and have been laid across the hallway (S-N) and into Areas P and Q. However, the direction of the floorboards (& hence also

underlying joists) changes at the junction between the main first floor hallway (Area K) and the section leading off to the south (Area M). This distinction also applies to the rooms in the southern part of the property, with boards also laid east to west (Areas L & O), whereas throughout Areas P and Q the boards are also laid to match Area K. The difference in the flooring can be clearly observed in Figure 159. It is thought that these boards were laid during one of the reconfigurations of the floorplan (& also stairs) to/from separate flats and are therefore not original to the house.
