**“ST DUNSTAN’S COTTAGE”**  
**9 & 9a MUSWELL HILL, HARINGEY N10 3TH**

**HISTORIC BUILDING IMPACT ASSESSMENT**

Updated February 2026

COMPASS ARCHAEOLOGY LIMITED  
250 York Road, Battersea  
April 2025 / Updated February 2026  
Author: Gabriela Williams  
Amendments by Hannah Stralow Rees  
Telephone: 020 7801 9444  
E-mail: [mail@compassarchaeology.co.uk](mailto:mail@compassarchaeology.co.uk)  
Website: [www.compassarchaeology.co.uk](http://www.compassarchaeology.co.uk)  
©Compass Archaeology Ltd.

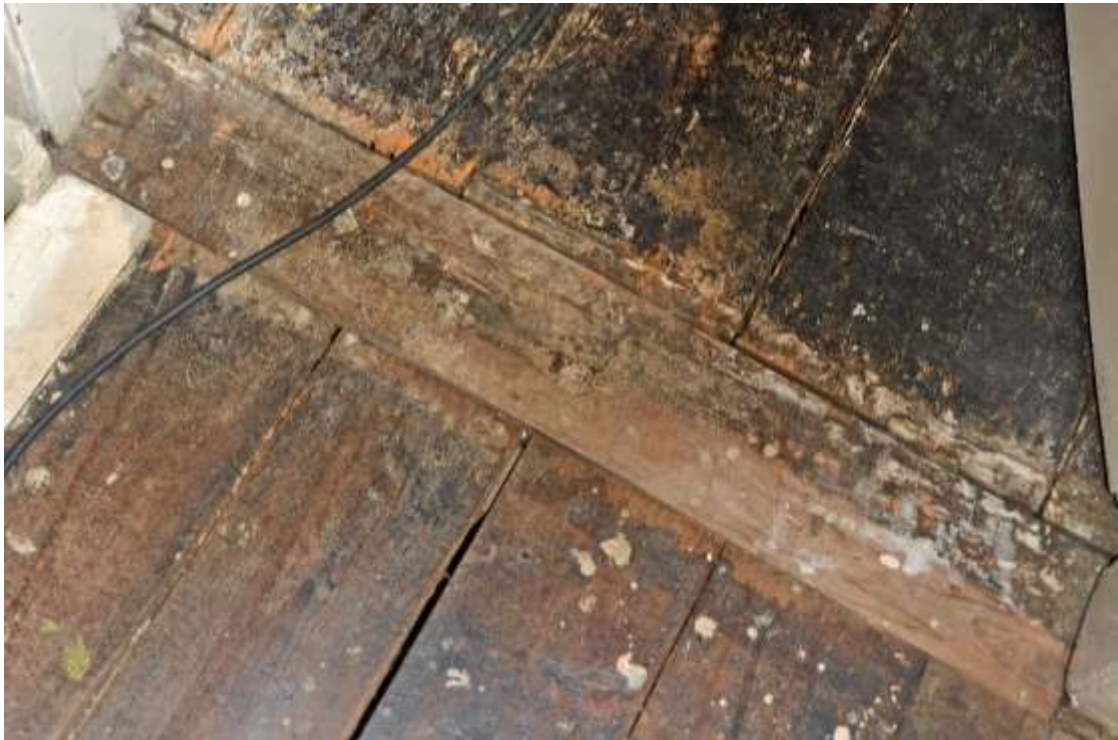
Upon entering Area L the first observable feature is an abnormality in the doorway, which evidently relates to the doorway having been moved from its original location on the northern wall of Area L (see above 6.12.1 & Figure 157). Where the wall has been knocked through to allow for the new entranceway a single wooden plank been added to fill the area which would previously have been walling (Figure 161). Markings on the wider floorboards just within the entrance to Area L would also appear to correspond with the original skirting boards which would have framed the wall on either side. Additionally, this threshold design between Area M and Area L does not match those seen in other openings, including Area P and Area O.

**Figure 161:** Detail Photograph of entrance to Area L (with wider floorboards top right). Taken 01.11.24.

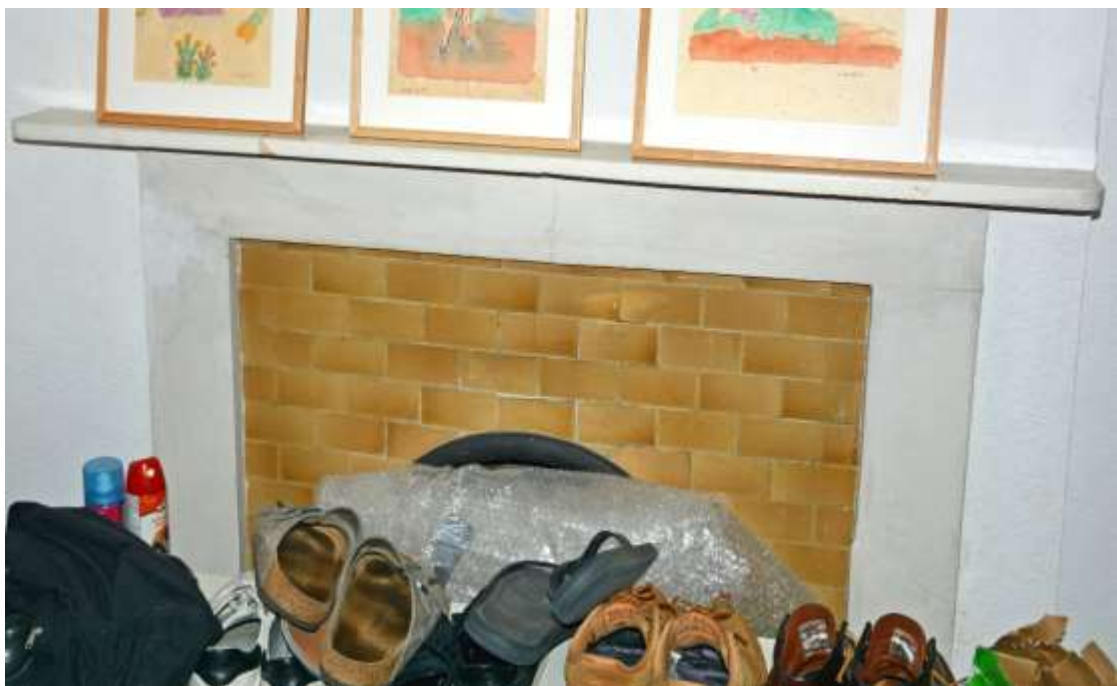
The next prominent feature within Area L is the fireplace, although no longer operational. The fireplace consists of a simple wooden frame which has been repainted several times, surrounding a yellow-gold tiled surface. The tiles are a fairly modern art-deco style design, and the fireplace is approximately dated to the 1930s.

**Figure 163:** Detail Photograph of fireplace within Area L. Taken 01.11.24.

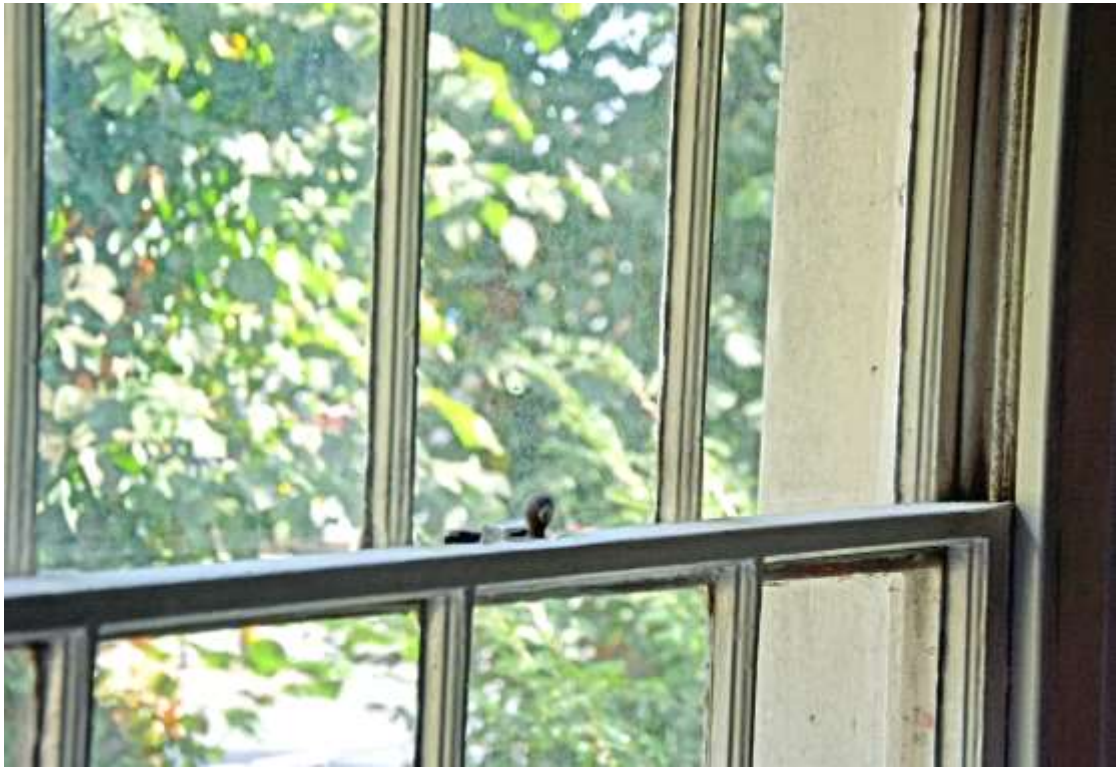
The final feature within Area L is the window on its eastern wall, the exterior of which has been discussed in detail in Section 6.3.4. The window appears not to be original to the house as it does not match any of the other windows on the front elevation of the building. On inspection of the interior the window was also seen to have Ovolo & Fillet glazing bars consistent with a later 19<sup>th</sup> to early 20<sup>th</sup> century date, though the upper and lower sashes of the window are the same and thus have not been replaced separately. There is no box for associated sash window shutters under this window, although they were observed in the corresponding windows on the ground floor (Areas C and G). The sash hardware is still present and the sash fastener is the same style as those observed in areas C, E, and K. The door in Area L matches the other doors seen within the first floor, but with the addition of a thin external plywood panel which obscures the four panel design of the door.

**Figure 164:** Detail photograph of window in Area L. Taken 22.10.24.

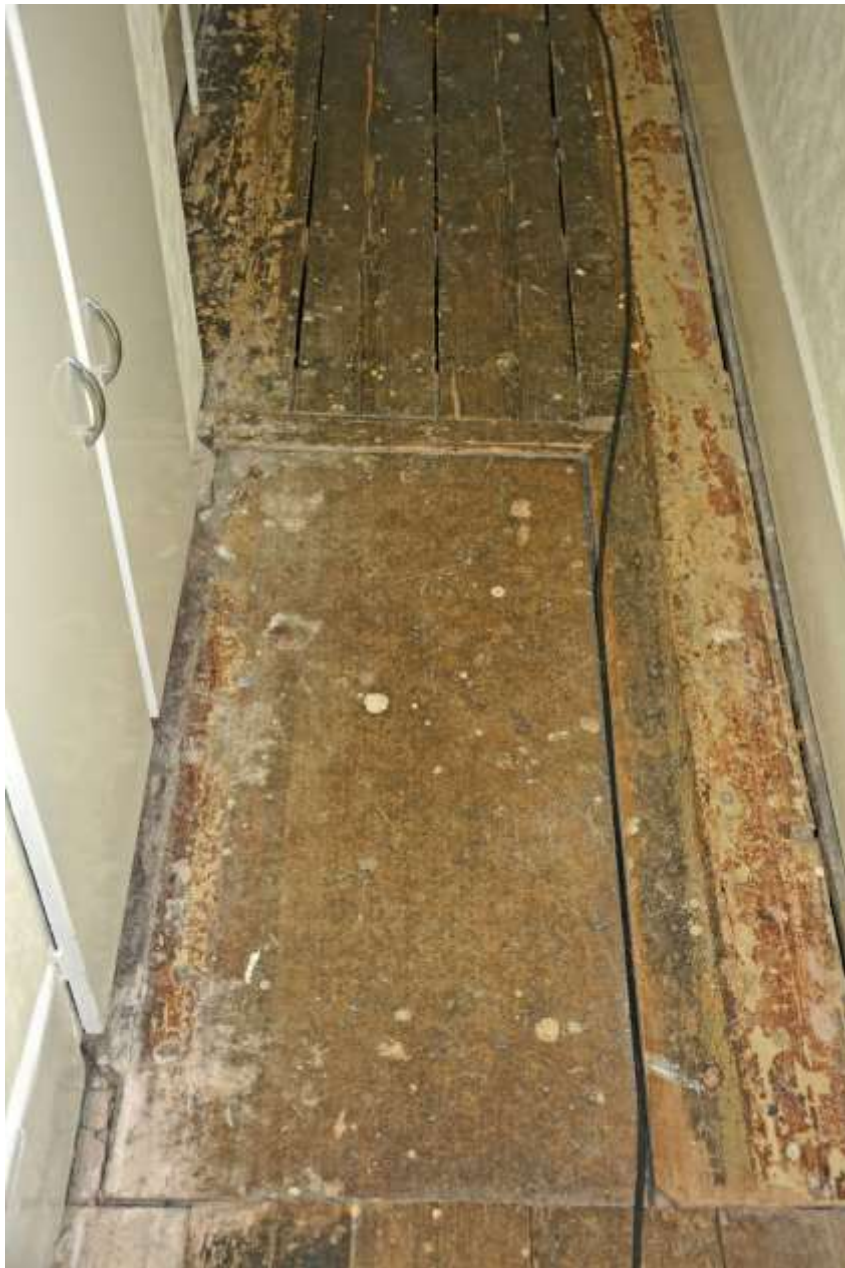
This final section of passageway has an additional feature in the form of a blocked fireplace – betraying its original role as the southern continuation of what is now Area O (*cf.* 6.12.5). The fireplace itself has been converted into a storage cupboard with wooden panelling and doors added to completely box in the opening. A difference in the flooring can be observed in this area (Figure 165), although the original hearth appears to have been replaced at a later date – presumably to create an even/level surface prior to carpeting. With the exception of the door to Area N, the doors and their frames are thought to be older in dating (possibly original). However, the doors have been refurbished and only feature modern hardware, with holes for touch plates and similar ceramic door knobs as observed on the ground floor.

**Figure 165:** Detail Photograph of hallway flooring around former fireplace/hearth. Taken 01.11.24.

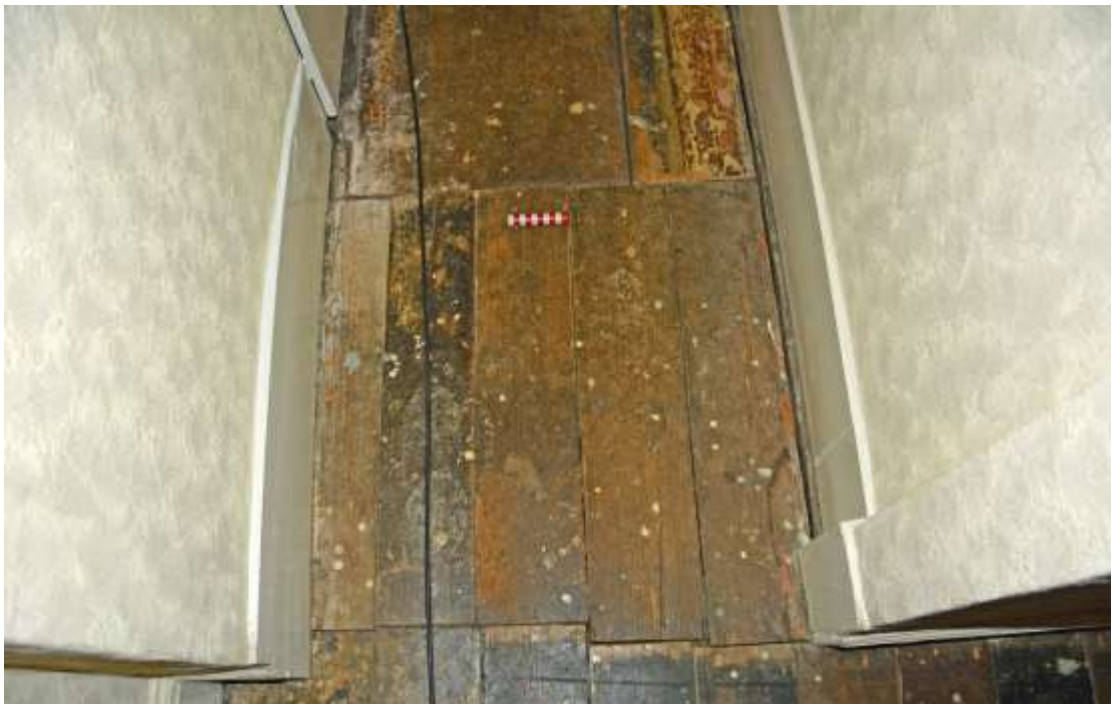
The flooring in Area M generally comprises narrower (& therefore secondary) boards finished with a dark stain, and which run east-west as mentioned in Section 6.12.1. To the west Area M leads to Area N, which is within the area of the rear extension – and which is thought to have originally formed part of one large room. Evidence of this can be observed in the flooring at the junction of Areas M and N, with a clear divide in the floorboards at the entrance to Area N (Figure 169). It is quite likely that the doorway itself was cut through the wall sometime after the construction of the extension, probably at the same time as the adjacent passageway (Area M) was created. The entirety of the floorboards within the hallway leading to Area N also appear to have been patch-worked together, as can be clearly seen in Figure 170.

**Figure 170:** Detail Photograph of flooring in Area M leading to Area N (top). Taken 11.12.24.

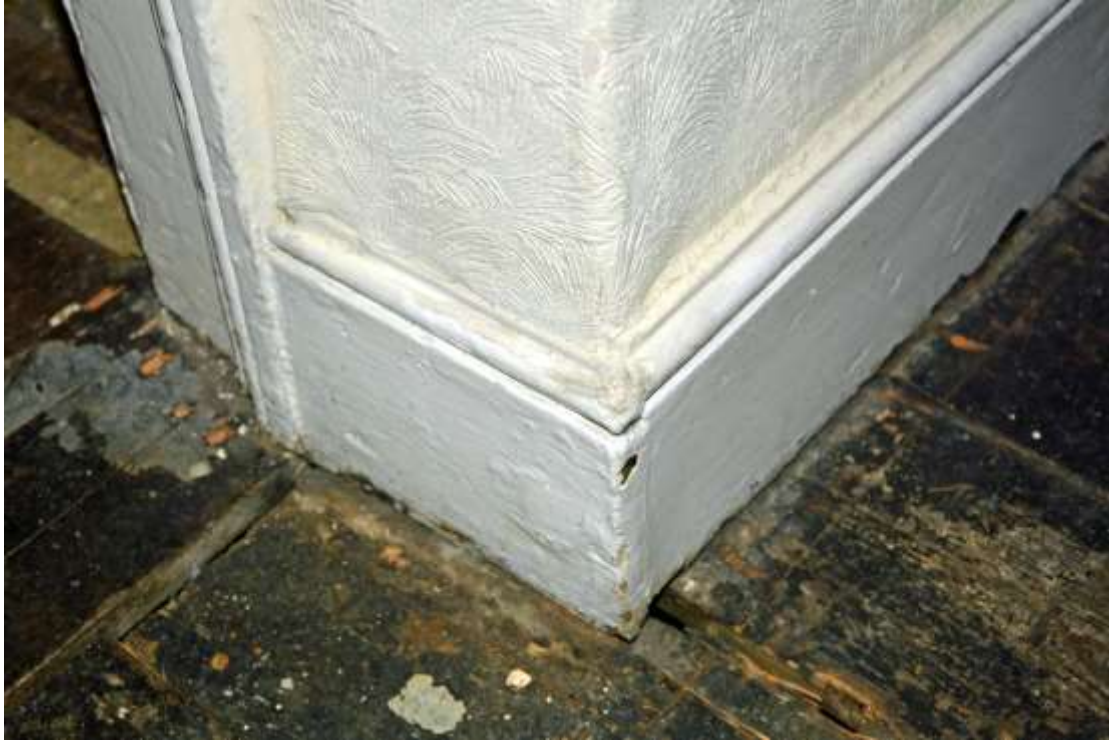
The hallway (Area M) has been entirely covered (walls and ceiling) in textured wallpaper in the same style as the remainder of the residence, and there is no coving here. However, skirting boards are present throughout Area M: the passageway leading to Area N features Type 6 skirting (See Figure 169, previous), whilst the remainder of Area M has Type 8 skirting (Figure 171). It is not likely that either type is original to the house, but both are believed to be historic.

**Figure 171:** Detail Photograph of skirting boards in Area M. Taken 11.12.24.

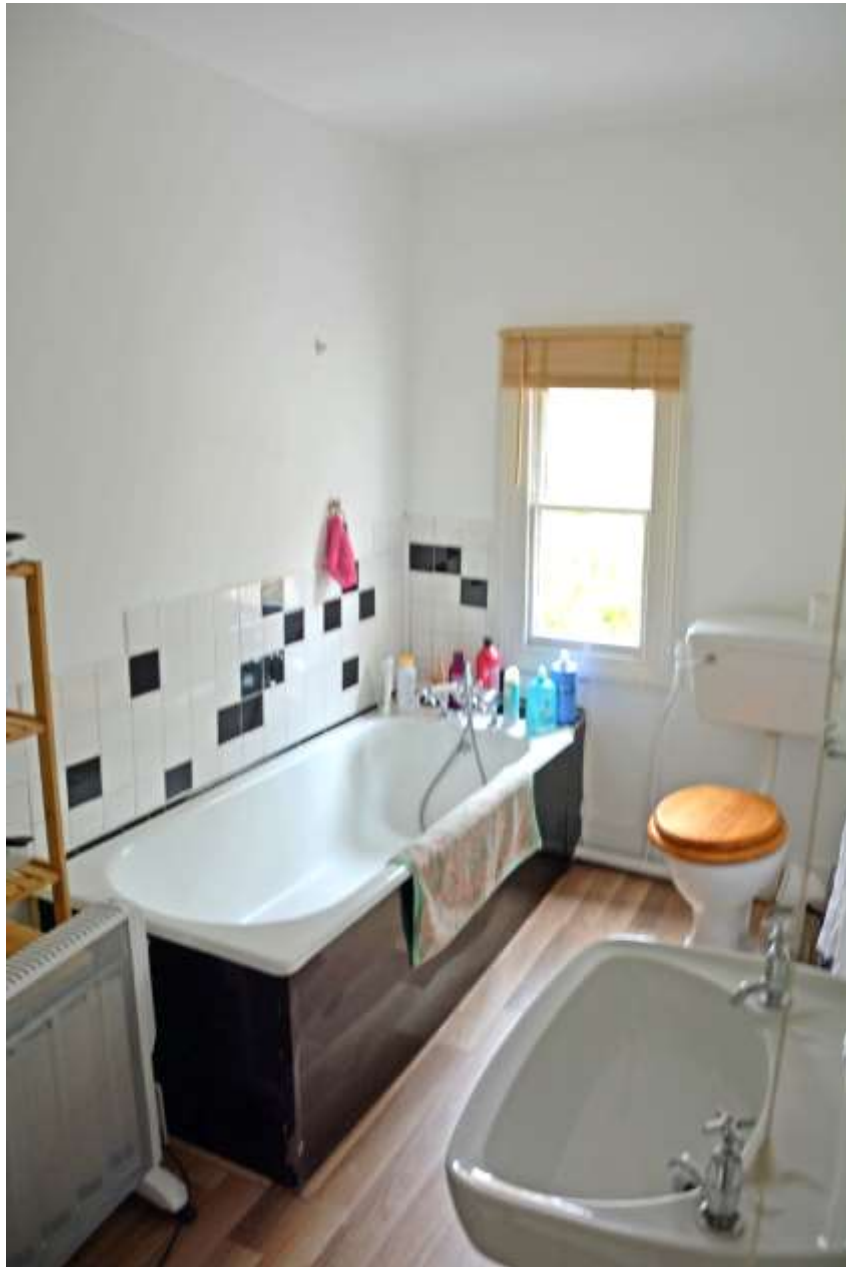
Area N is the main family bathroom for the principle residence (Figure 172, Overleaf). It measures 3.78m in length and 1.83m in width and is rectangular in plan. It is occupied by a full bathroom unit including a panelled bath, pedestal hand basin and WC. The door to Area N (as seen in Figure 166) does not match the style of any of the other doors in the residence and is clearly a modern replacement – including a modern textured glass pane in its upper section intended to provide privacy corresponding with Area N's use as a bathroom. The space itself is occupied by modern additions to the residence, with its western wall being a partition subdividing what would originally have been the upper floor of the rear extension, 9a Muswell Hill. Area N also contains an access hatch in the ceiling to the loft space (Section 6.13), and a built-in cupboard in its south western corner for the hot water tank. Except at the entrance the flooring in this area has been covered with a modern wood-style laminate; whilst the walls have been partially tiled with the remaining surfaces painted.

**Figure 172:** Overview Photograph of Area N. Taken 01.11.24.

| <b>INTERNAL – HOUSE (first floor)</b> | | | |
|---|---|---|---|
| Area N (6.12.4) | Replace sanitary ware to existing bathroom | Modern bathroom located within subdivision of the c 1860s extension, not original to the building. | The existing bathroom units are modern so their removal will not result in any loss of historic fabric. |

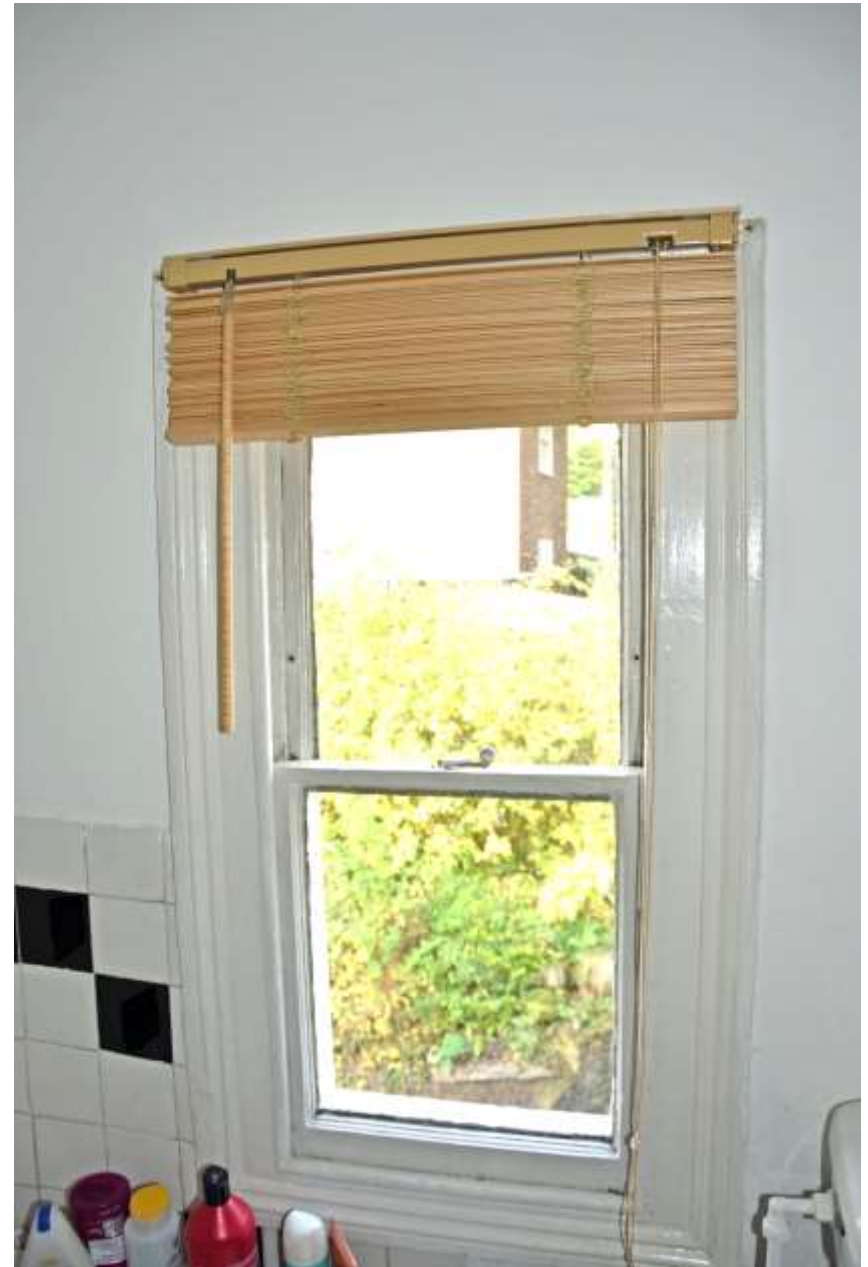
The only remaining feature within Area N is a window, the exterior of which has been discussed in Section 6.4.6. It is a fairly modern Victorian-style window, with modern framing as observed during the inspection (Figure 173 overleaf). It has sash fasteners which are in the same style as those observed in Areas C, E, K, and L. The window aperture itself is thought not to be original to the extension, but probably inserted through a solid wall at the same time as Area N itself was subdivided.

**Figure 173:** Detail Photograph of window in Area N. Taken 01.11.24.

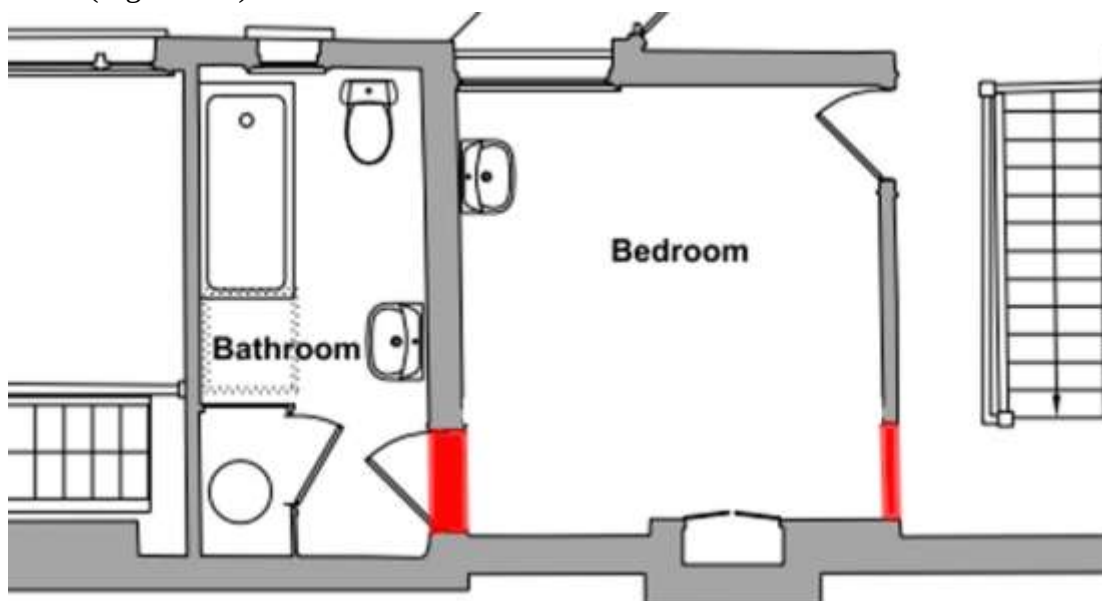
However, the current sizing of Area O does not represent the room's original boundaries – as clearly indicated by the blocked fireplace within what is now part of Area M. The southern wall of Area O is a partition wall, added during a later phase of construction to create a passageway to Area N: this development would also have involved knocking through the wall to create a doorway into Area N (which was

**Figure 175:** Probable original floor plan for Area O. Doorways blocked in red and partition wall removed.

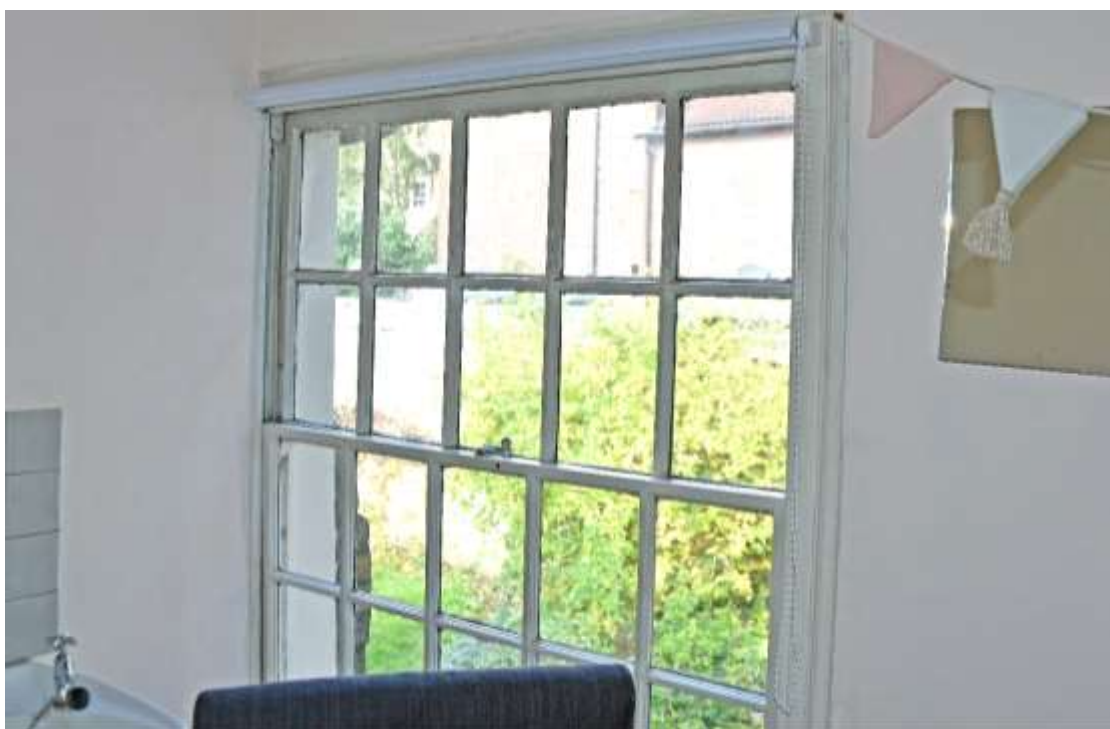
**Figure 176:** Photograph of window in Area O. Taken 22.10.24.

The only feature which exists within the room at present is the window, the exterior of which is discussed as Section 6.4.5. The window is a Georgian-style 10 over 10 sash, although it appears largely modern in construction – particularly the glazing bars, which are of a more angular style associated with the mid-later 20<sup>th</sup> century (Figure 176). However, the upper sash frame does have horns which are typical of mid-later Victorian design, so parts of the window may be earlier – but certainly not original. The sash fastener used here is the same quadrant style which is common throughout the residence, and like other fasteners has been repainted several times. The location of the window aperture itself is also not thought to be original: it is not known where the

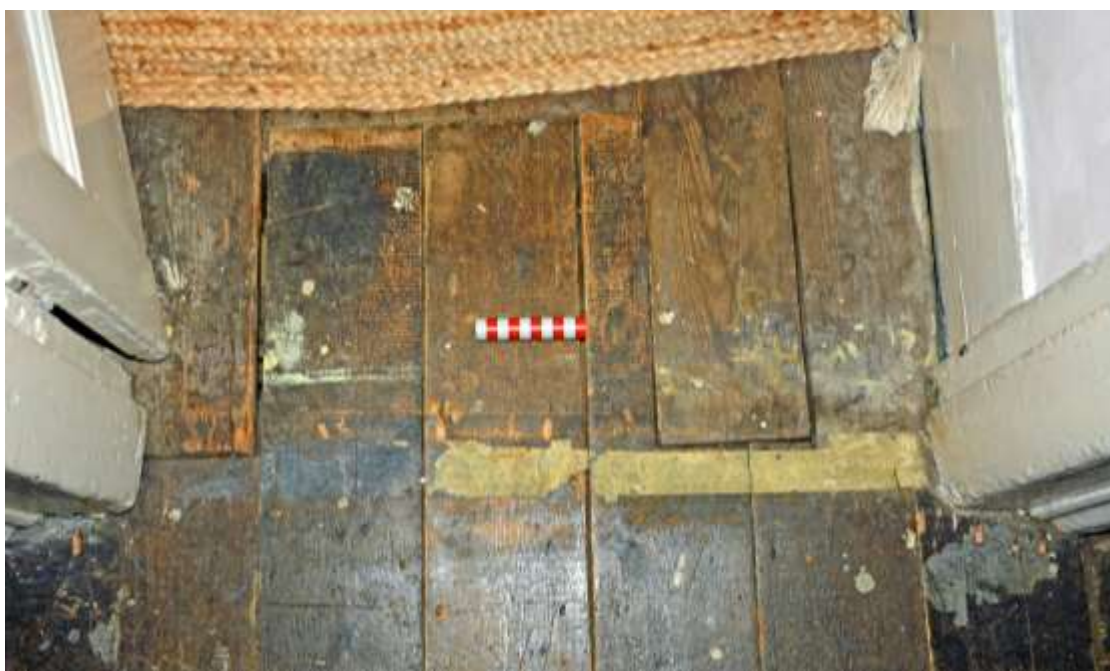
The flooring in Area O included a range of board sizes - the majority wide panels 200-220mm in width that match those observed from Areas A and L. These boards can be seen in Figure 177. The remainder of the room was boarded with much narrower 140mm wide boards, in a pattern that appears to correspond with later repairs. This included a 1.4m by 0.98m area to the left of the doorway and an approximately 0.44m wide area spanning the right-hand side of the room. These repairs are particularly noticeable in the entrance to Area O, with clearly cut-out sections filled by replacement boarding (Figure 178).

**Figure 178:** Detail Photograph of flooring within the entrance to Area O. Thinner floorboards visible to the right. Taken 11.12.24.

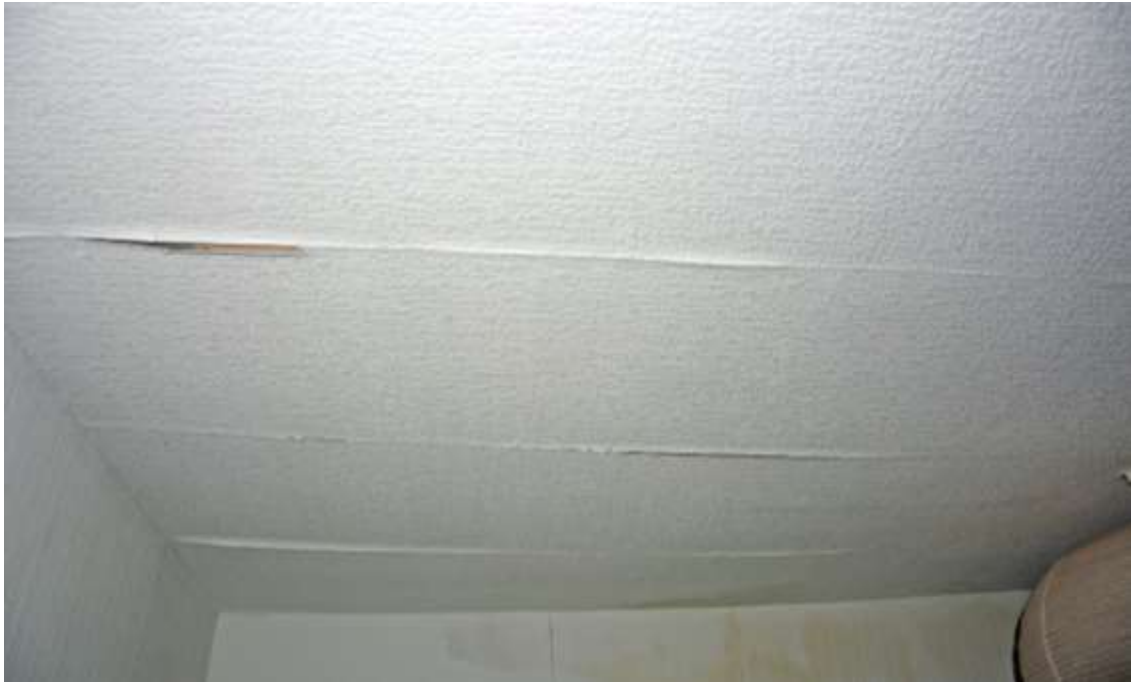
The walls and ceiling have been wallpapered with a textured design, as elsewhere in the residence. The ceiling wallpaper in this room is peeling significantly (Figure 181).

**Figure 181:** Detail Photograph of condition of ceiling wallpaper in Area P. Taken 01.11.24.

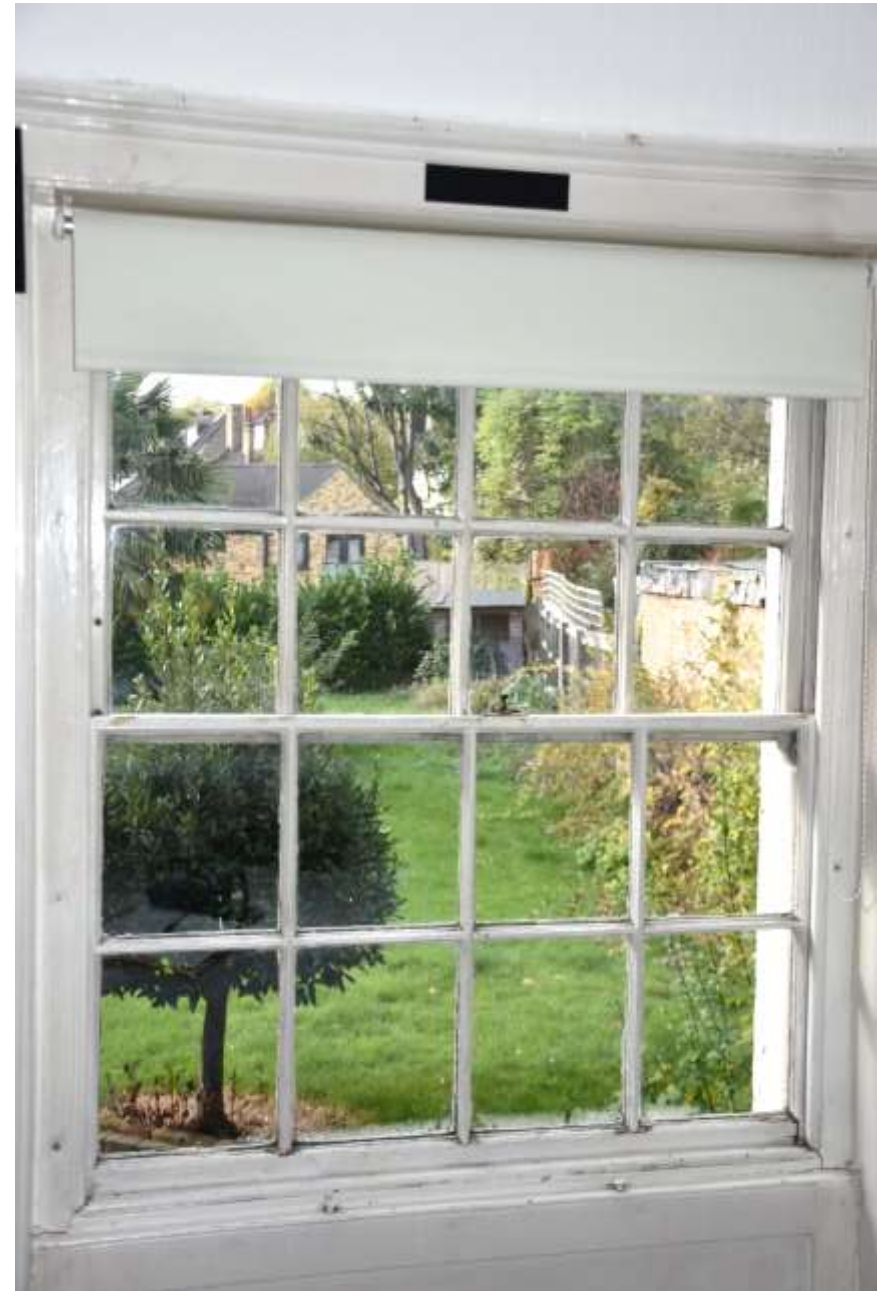
**Figure 184:** Detail of window within Area P. Taken 01.11.24.

The final feature present within Area P is a window, which is a Georgian style 8 over 8 sash window (Figure 184, Previous). The exterior of this window has been considered in detail in Section 6.5.3. As previously noted, the upper and lower sashes differ, with the upper sash having been replaced with a modernised version. However, the surround to the window appears to be original, although no facilities for a shutter are present. The sash fastener has been replaced more recently than others in the residence and is polished brass in a modern design.

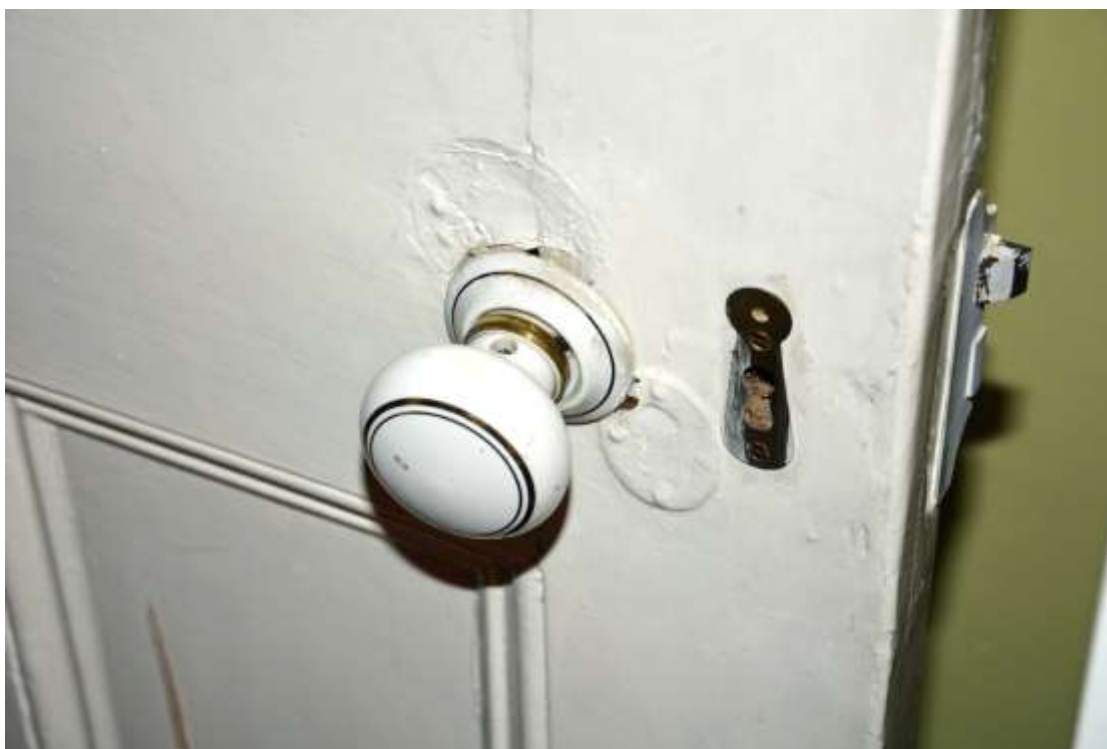
does not feature the same floral design as observed elsewhere in the residence. Moreover, the door has been refurbished with modern hardware, although the positioning of the original handle and lock can be clearly observed (Figure 188). It is thought that the doors for areas C, G, O and Q are older in date, although it is not possible to confirm that they are original to the construction of the residence.

**Figure 188:** Detail of Area Q door, with old hardware positioning visible. Taken 11.12.24.

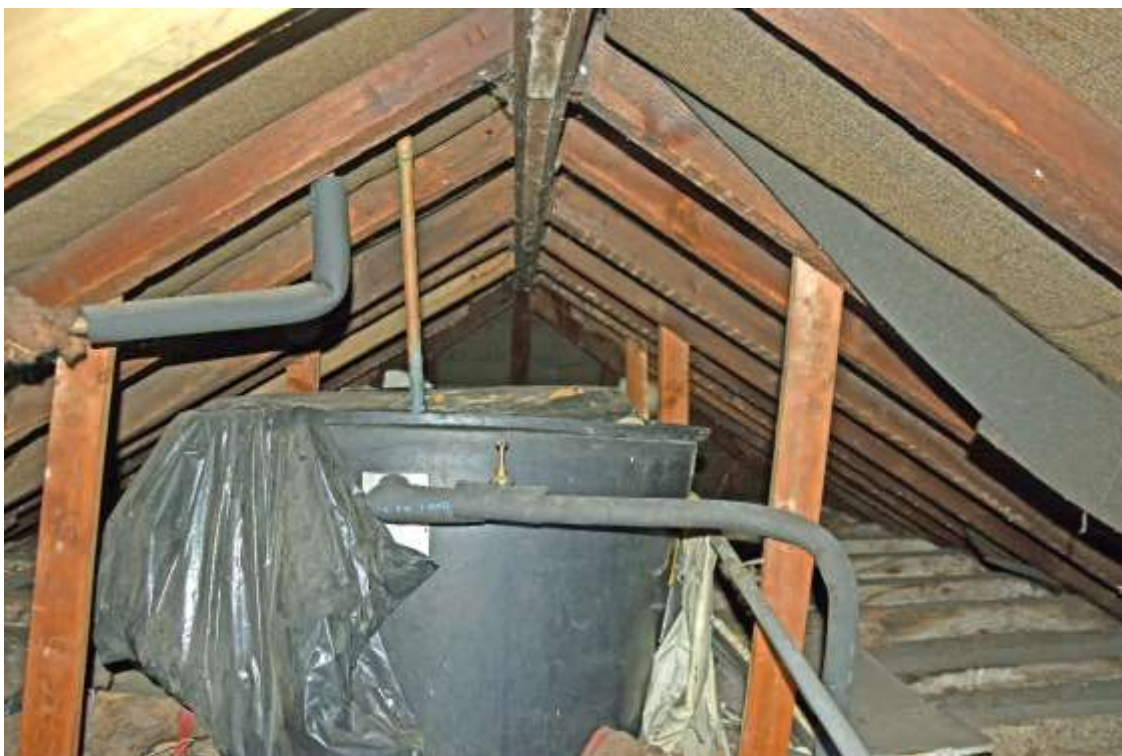
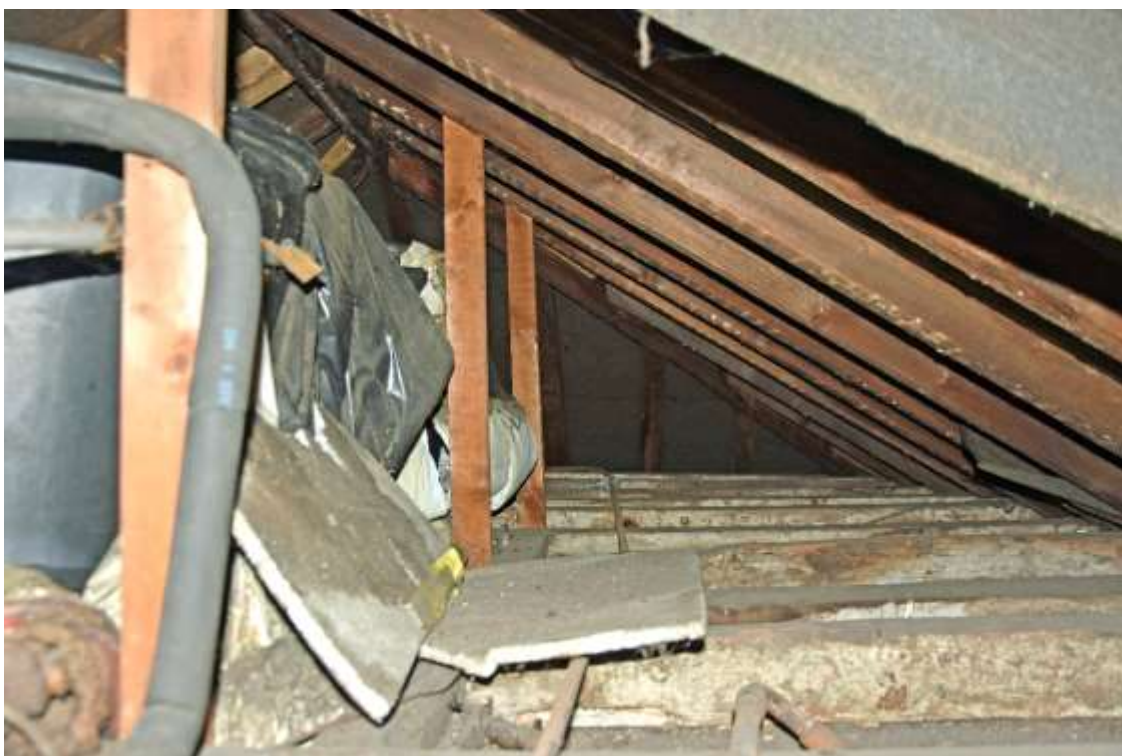
The loft forms a large open space, exposing the internal roof structure. It was inspected from one position (through the hatch in the bathroom), in particular for any features relating to differing construction of 9 and 9a Muswell Hill and for the latter forming a later extension. There was significant evidence on both these levels, and also for some much more recent repair works – the latter including replacement of some rafters and also modern felt sarking within the area over no 9a. (Figures 189 & 190 overleaf).

**Figure 189:** Overview of loft overlying 9a Muswell Hill, looking west. Taken 22.10.24.

The roof as a whole formed a simple rafter construction. Within the area over 9a this included some reused timber – most obviously evidenced by the presence of plaster ‘stripes’ on their surface caused by previous lath & plaster attachments, whilst many of the joists appear to have been painted or limewashed (Figures 189 & 190) – perhaps both being derived from some other site where demolition was taking place.

**Figure 190:** Detail of loft overlying 9a Muswell Hill, looking west. Taken 22.10.24.

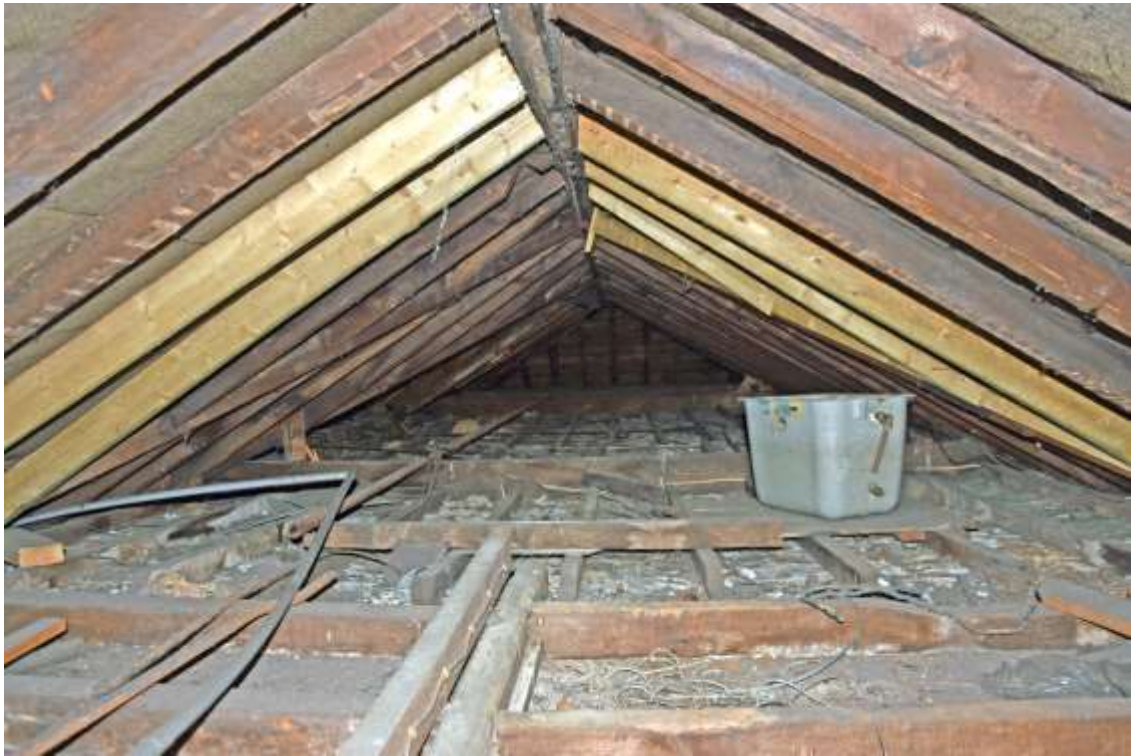
A handful of rafters at the eastern end of the extension roof and close to the junction with the original build had also been replaced fairly recently (Figure 191) – possibly

the result of previous water ingress at the junction of the two separate builds.

**Figure 191:** Overview photograph of loft for main residence, facing east. Taken 22.10.24.

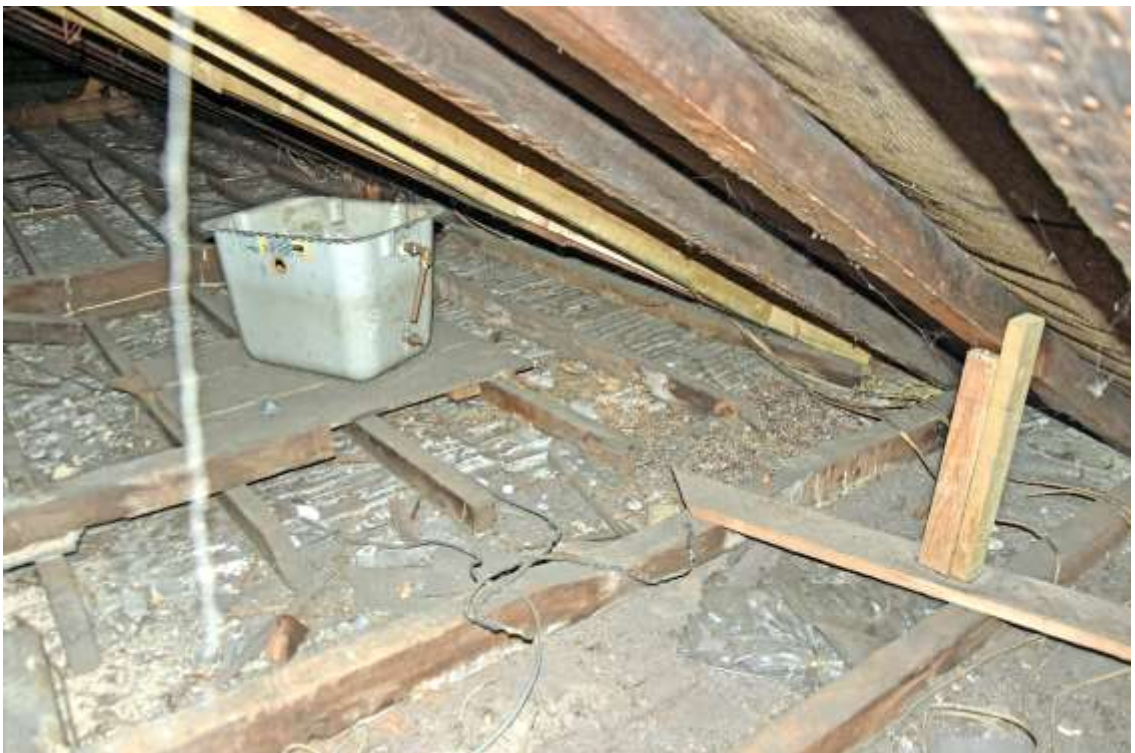
**Figure 192:** Detail photograph of boundary between the residences, facing south-east. Taken 22.10.24.

The boundary of the original roofing for 9 Muswell Hill could be clearly seen, adjoining the clearly later extension works over no. 9a (Figures 191, 192). The longitudinal (E-W) ceiling joists here – to which the underlying lath & plaster ceiling is attached – end abruptly, with many featuring a c 35° cut corresponding to the slope of the overlying roof. These cuts thus indicate the boundary of the roof, and would have been immediately above the soffits. Moreover, on close inspection it can be seen that the raking hip rafters that would have formed the corners of the original roof are still in position – probably clearest on the left-hand side of Figure 191.
