# SIR FREDERICK MESSER - SEVEN SISTERS

## LANDSCAPE MANAGEMENT PLAN

**Sir Frederick Messer Estate,  
Haringey – BS 5837:2012  
Arboricultural Report and  
Impact Assessment  
Oobe Ltd**

**Report Title:** Sir Frederick Messer Estate, Haringey – BS 5837:2012  
Arboricultural Report and Impact Assessment

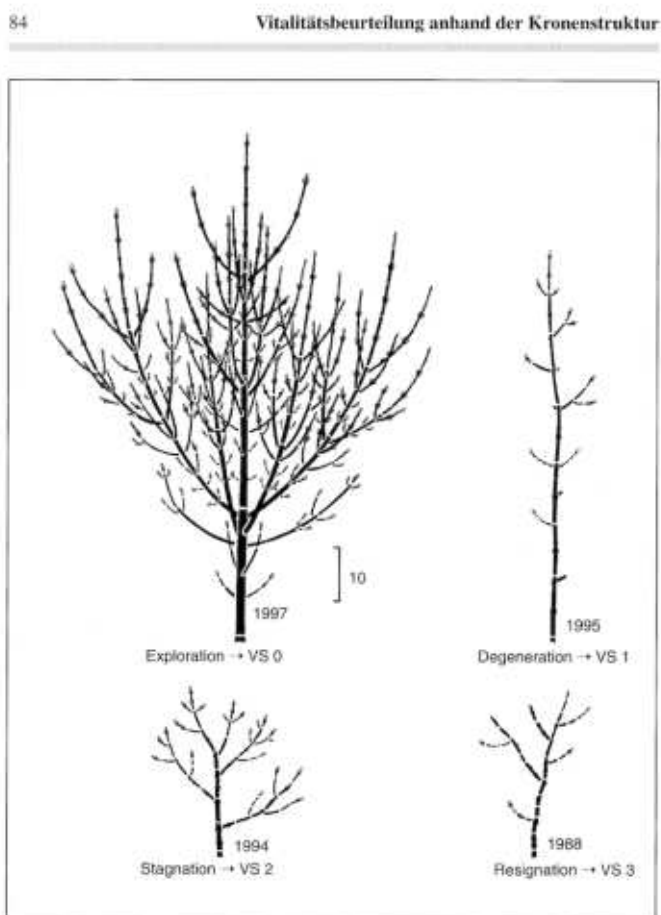
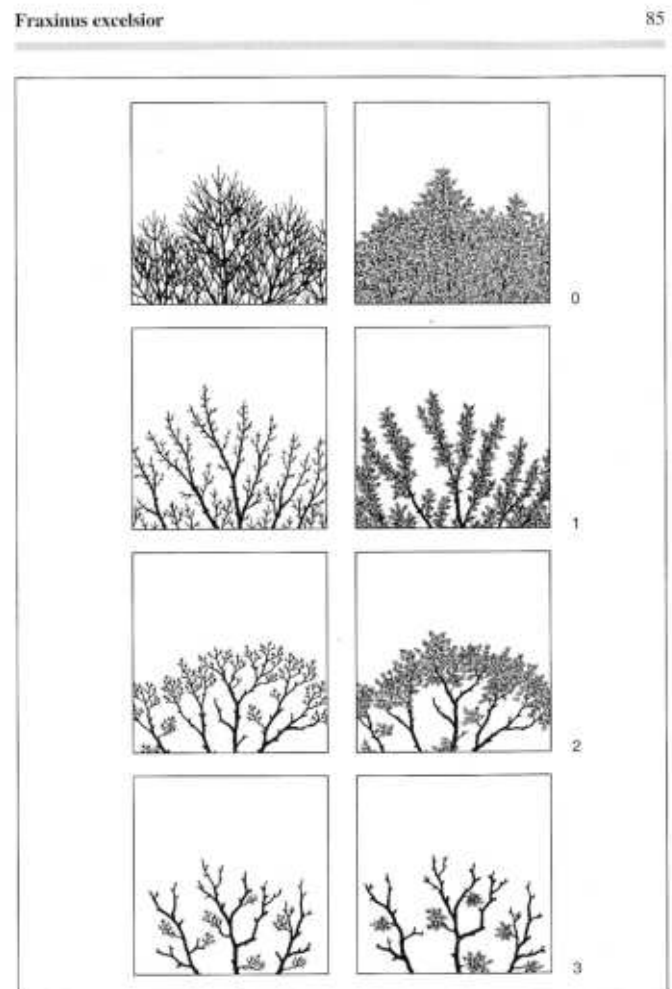
- Vitality class 3: In considerably damaged or declining trees of the crowns finally fall apart by the breaking off of larger branches and the dieback of whole crown parts. The tree seems to consist only of more or less surplus sub-crowns, dispersed randomly in the airspace and forming whip-like structures. The treetop is often dying back or is already dead, because the treetop shoots grew in the retraction phase.

These 4 vitality classes are shown below for Ash.
