# Tree Condition Report

## & Management Recommendations

26 Queens Avenue  
Muswell Hill  
London  
N10 3NR

**Dated**  
27<sup>th</sup> October 2025

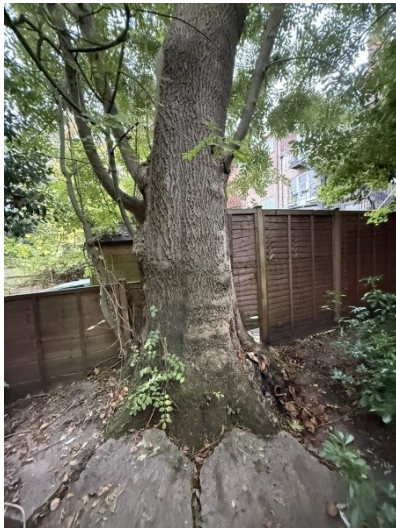
Photo 10. T002

| Ref. | Other Reference | Life Stage | Species | Height | DBH (cm) | North | East | South | West | Photo | Location & Targets | Survey Notes | Inspection Limitations | Physiological Condition | Structural Condition | Recommended Works | Priority | Inspect Frequency (yrs) | Safety Category |
|---|---|---|---|---|---|---|---|---|---|---|---|---|---|---|---|---|---|---|---|
| T002 | | Veteran | Horse chestnut ( <i>Aesculus hippocastanum</i> ) | 19 | 141 | 8 | 10 | 12 | 8 | | Garden tree.<br>Target - dwelling.<br>Target - gardens. | High ecological value<br><br>Defects:<br>Significant decay and cavities to stem and scaffold limbs (good wound wood) extensive decay to removed limb and main stem at c.1.5m . occasional significant tear wounds. Occasional minor symptoms of chestnut canker (bleeds). | None | Fair | Fair | Reduce overall height by 3m and radial spread by 1.5 to 2m | Moderate | 1-5 | 2 |

- 2.1.10. Given a dwelling is within the target zone of the tree, a balance must be struck between retaining important habitat features and reducing the likelihood of stem/limb failure. Therefore, to reduce the lever arm forces acting on the various defects within the stem and scaffold limbs, a 3m reduction in overall height and 1.5m to 2m reduction in radial spread is recommended.

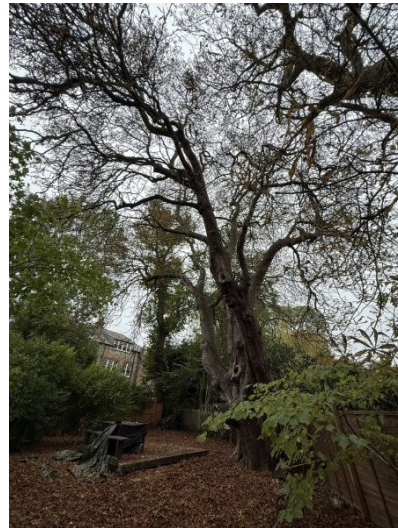
- 2.1.8. T002 is a horse chestnut located to the rear of the garden. Potential targets include the surrounding gardens and an adjacent dwelling. T002 as high ecological value, with multiple cavities, woodpecker holes and tear wounds with exposed heartwood (see photos 11 to 16). These are important habitat features but do represent potential defects within the structure of the tree/tree parts.

Photo 11. T002 (cavity good wound wood)
