# Site Investigation Report

195580.1.USI

Auger were commissioned by Crawford & Co to undertake a site investigation and CCTV inspection of the underground drainage within the area of concern (AOC) at the property.

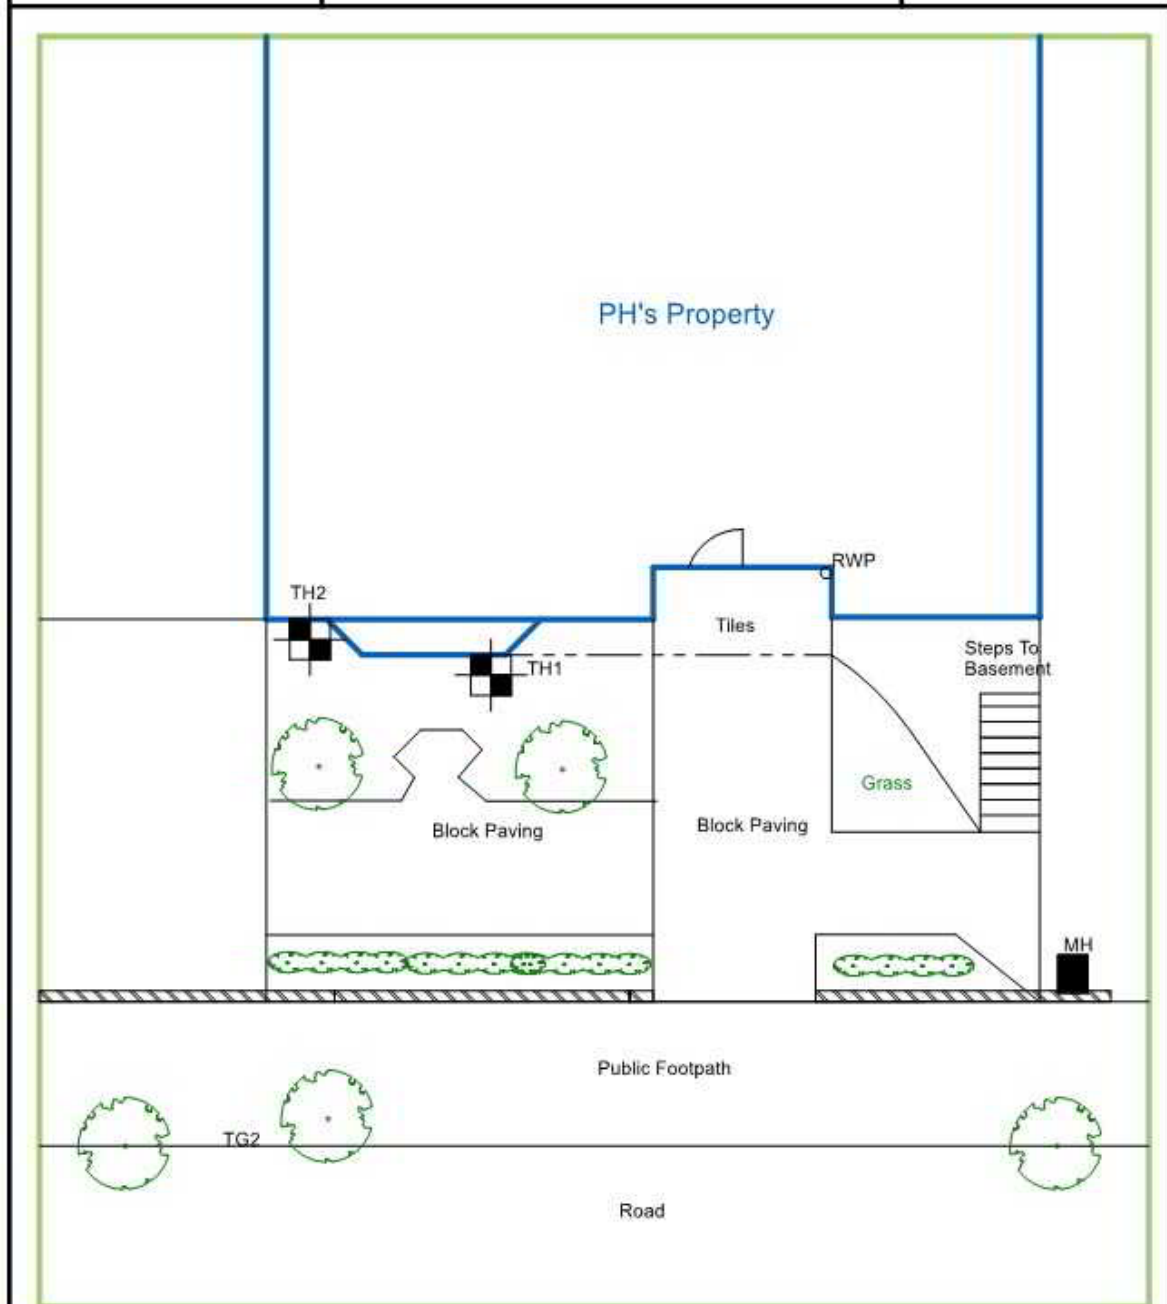
## FRONT OF PROPERTY

No CCTV survey of the underground drainage was undertaken whilst on site because there is no drainage within the area of concern, the rainwater pipe runs away from the area.
