# Earlsmead Primary School – Condition Survey Report

London Borough of Haringey

February 2026

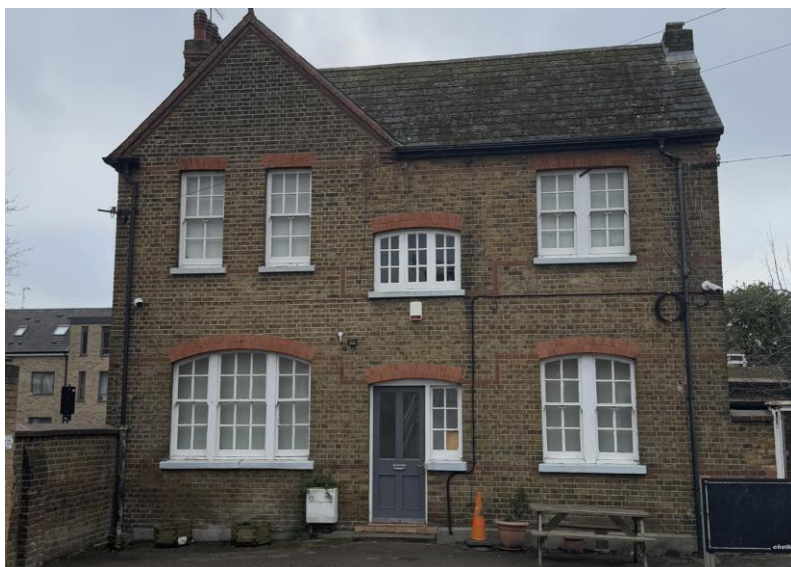
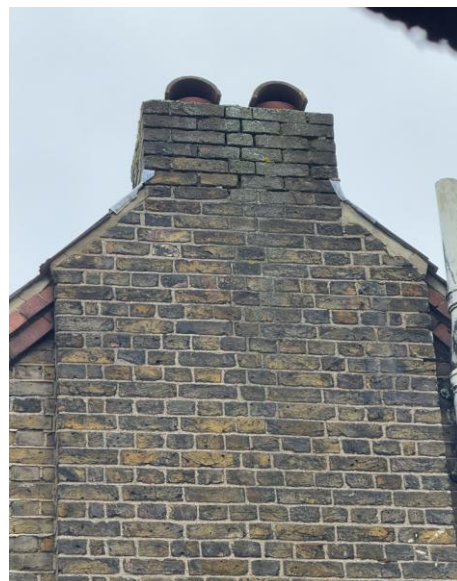
Care takers house

The guttering and downpipes should be repaired and replaced. There is evidence of splitting and cracking to 2nr cast iron downpipes, which is causing efflorescence to the brickwork. The timber fascia board should be replaced as this is exhibiting early signs of timber decay where visible. Whilst roofs are being replaced all associated repairs to chimneystacks and parapet walls should be undertaken.

Typically, the repairs involve re-pointing, brickwork replacement, helibar stitch repair where cracking is evident, blown render to the Southern elevation.

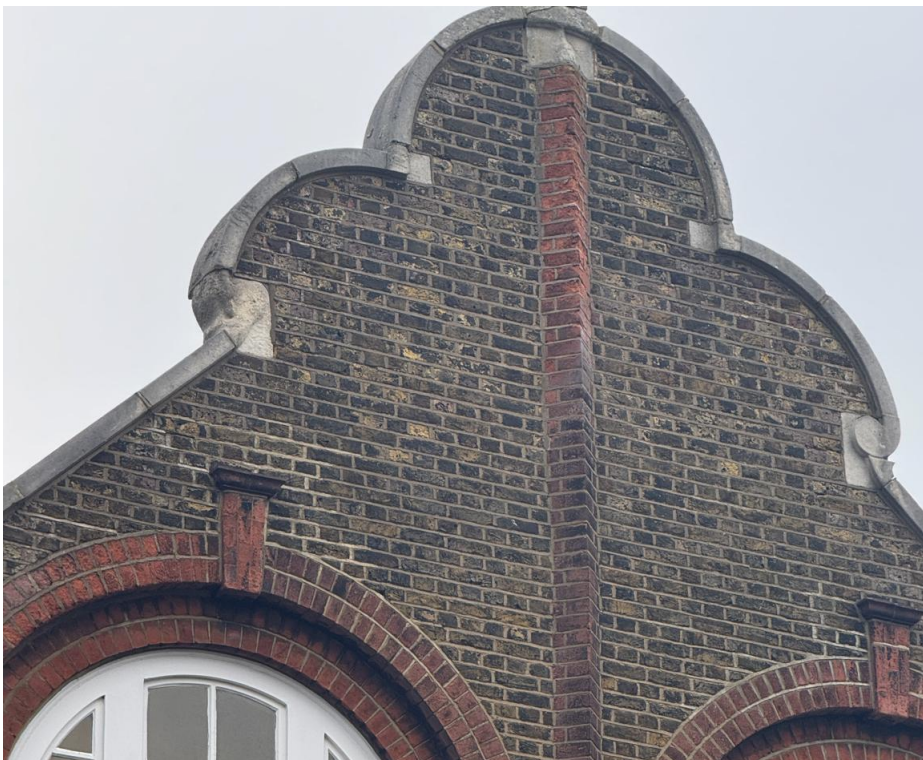
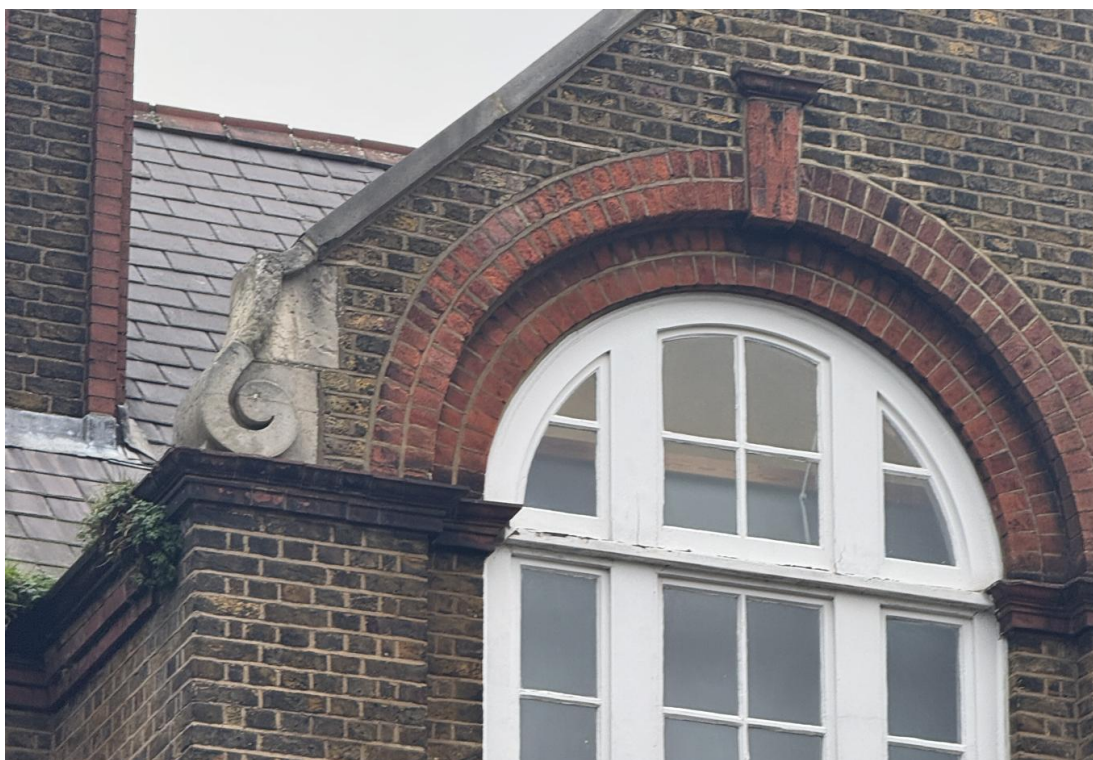
Front elevation stonework details

To the front elevation of the building (West Elevation) there are 2nr apex's which are raised parapets with stone projecting copings, supported on brickwork. Additional ornate stone corbel projections have been provided; we noted that several of the ornate stones were damaged and may require stone mason repairs.

Each apex is capped with a raised stone ball finial. The parapet walls are in a fair condition, with no significant defects. Minor defective pointing to copings and exposed sections of brickwork which require repairs.

Repairs to the stonework, including stone cills, ornate copings and decorative corbel projections, will be carried out using established conservation techniques to ensure the long-term preservation of the original fabric. Deteriorated or delaminated areas will first be carefully assessed, with loose or unstable material removed by hand using non-abrasive tools. Where minor losses are present, these will be reinstated using a compatible lime-based repair mortar, colour-matched and tooled to blend with the existing stone. Where elements are beyond repair, they will be replaced on a like-for-like basis using matching natural stone, cut and profiled to replicate the original detailing. All works will be undertaken by experienced conservation masons, ensuring that the repaired elements remain structurally sound, visually consistent and fully in keeping with the character and significance of the building, in line with Haringey's heritage expectations.

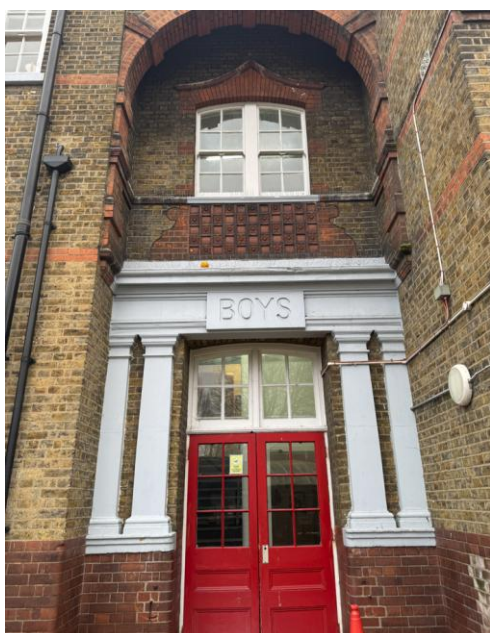
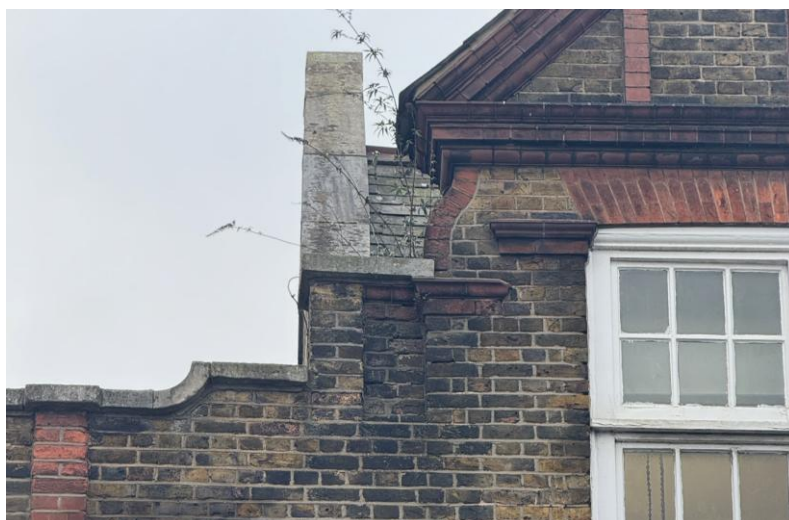
External decorations to rendered finishes and concrete banding are in a reasonable condition. However, we recommend that further decorative works are to be completed in conjunction with the repairs identified to the rendered finishes. There are some stone structural works required as per below photo.

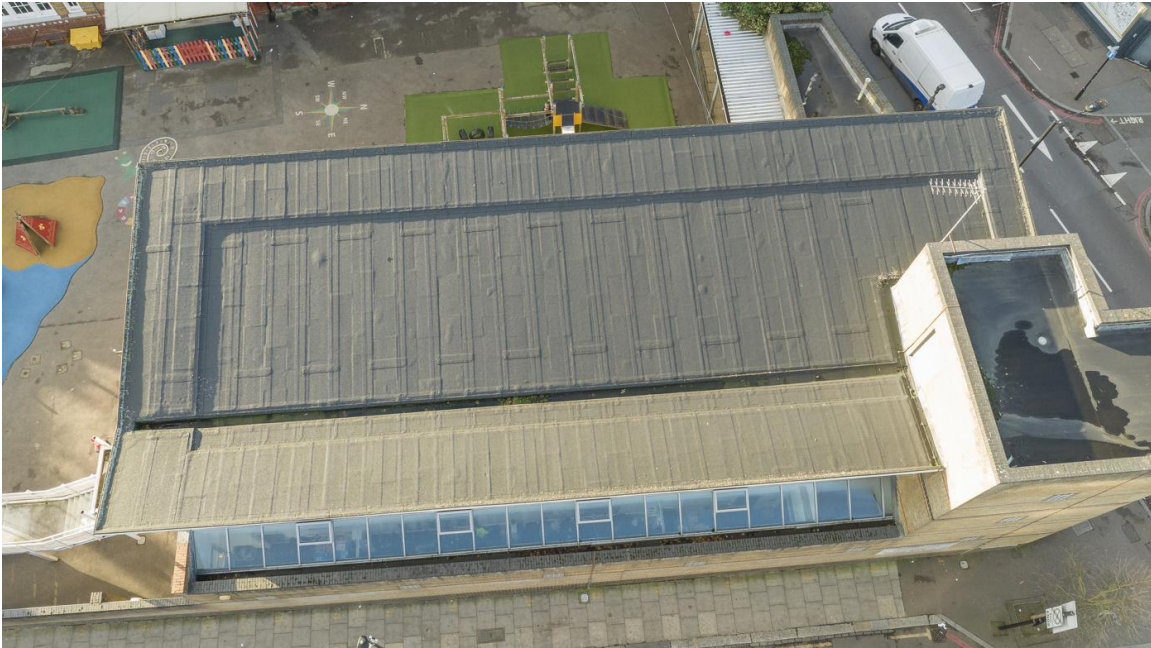
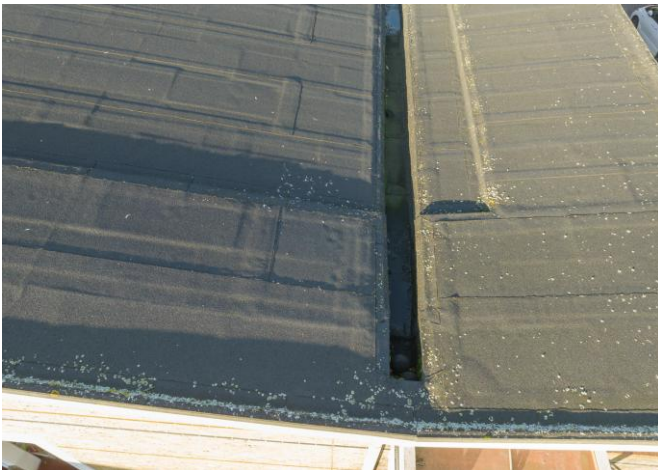
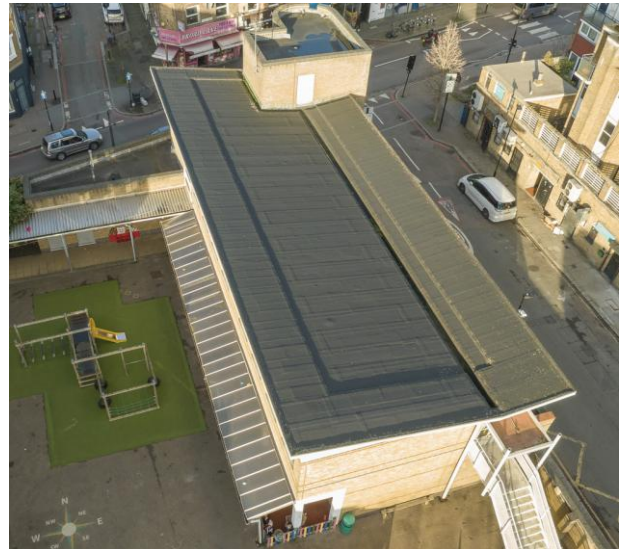
In summary the roof and associated details are in a fair condition but recommend that replacement is undertaken to prevent further deterioration of the building fabric were evidence of trapped moisture. We have highlighted a list of repair options which will provide some longevity to the roof covering.

Our recommendation would be to replace the roof and all associated details including rainwater goods and upgrade the thermal performance to at least the latest building regulations. We assume that this provision will require a temporary roof to protect the existing building fabric.
