# The Mulberry Primary School – Condition Survey Report

London Borough of Haringey

March 2026

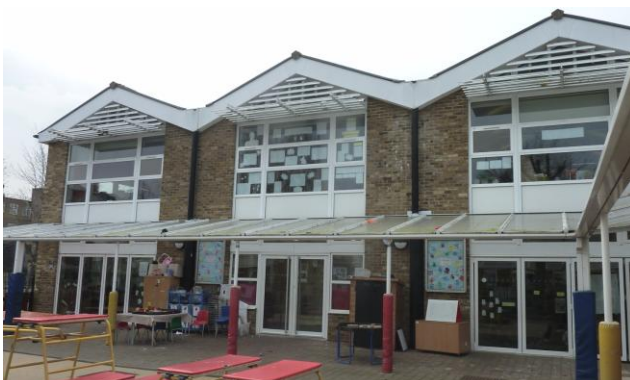
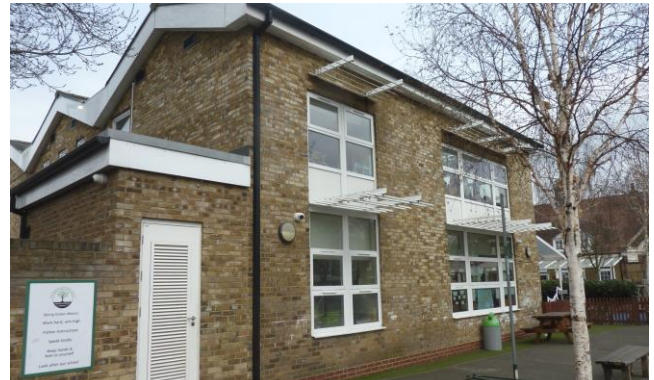
This building was of more recent construction and in reasonably good condition for its age. Minor repairs are required to the roof and external windows and doors would benefit with easing and adjusting for correct operation.

The external walls of the rear nursery block are of brick cavity construction. These walls are upright and in sound condition, with no significant defects.

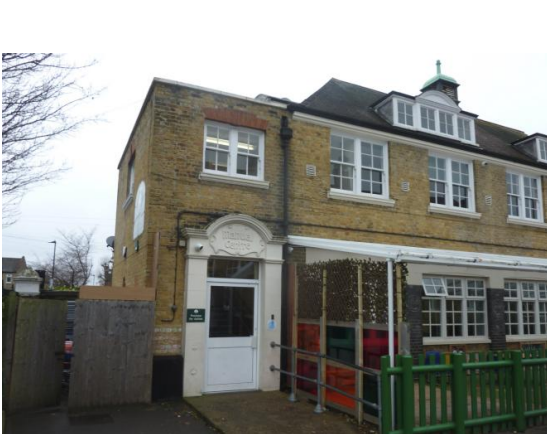
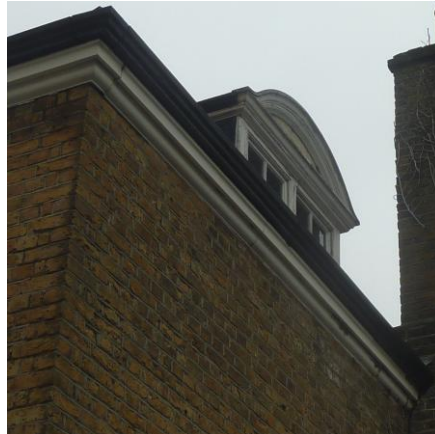
### Block C

There are decorated stone corbels supporting the guttering to the main roof, decorated stone lintels to ground floor windows and stone cills to windows.

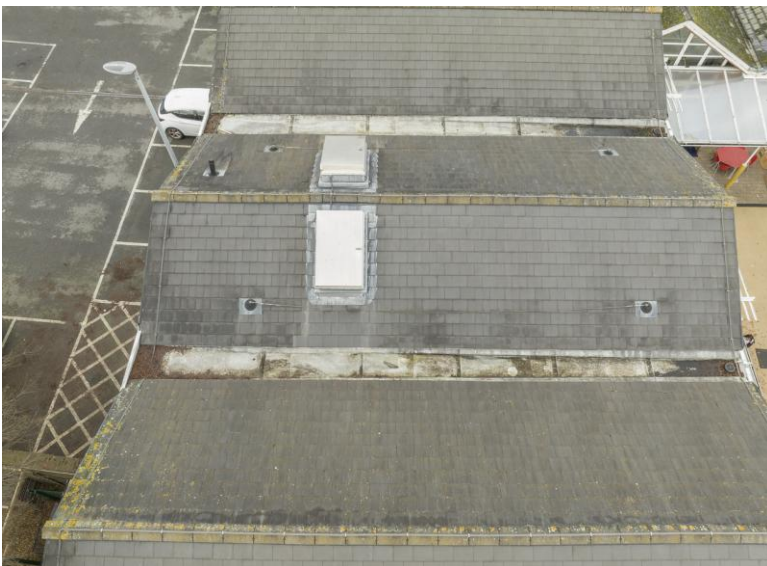
Block E

Gutters and downpipes comprise aluminium powder coated, fixed to uPVC fascia and gutters. No significant defect apparent.

No works appear apparent.
