# Schedule of Condition

Queen Street  
Tottenham  
London  
N17 8HZ

February 2026

**Reference** P2023-0756

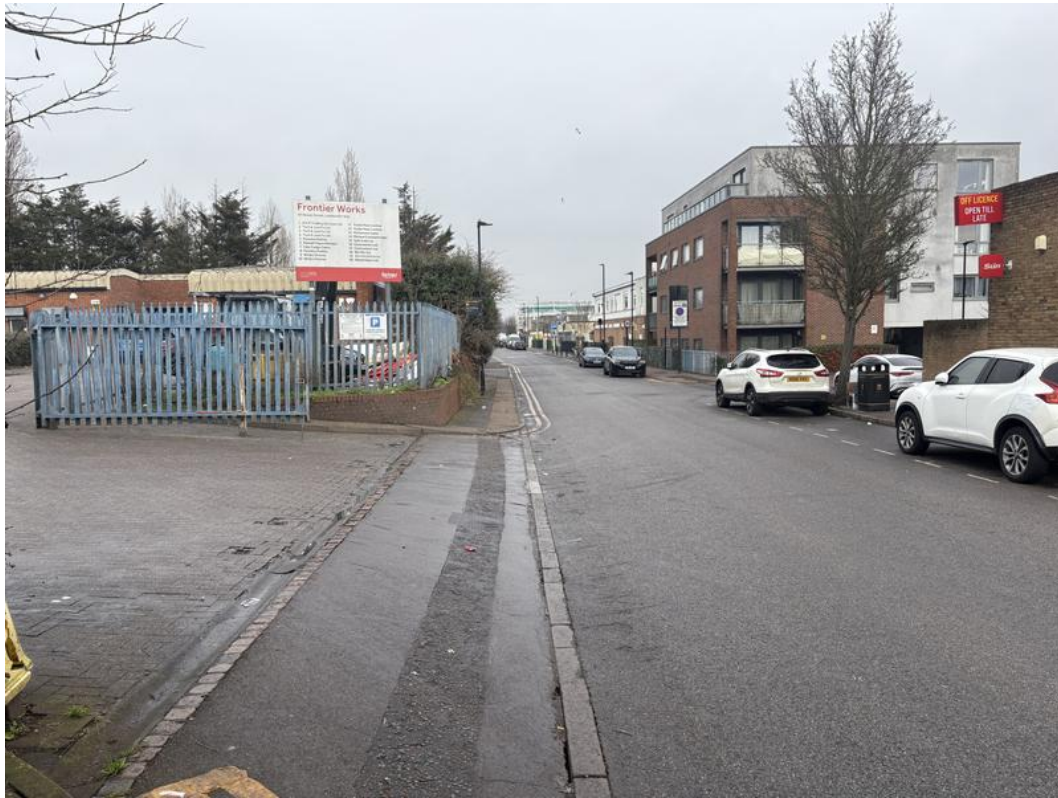
Photograph 1

| Location | Element | Condition | Photographs | Photo No. |
|---|---|---|---|---|
| Zone 1 | Generally | | | Photos [ 1 - 3 ] |

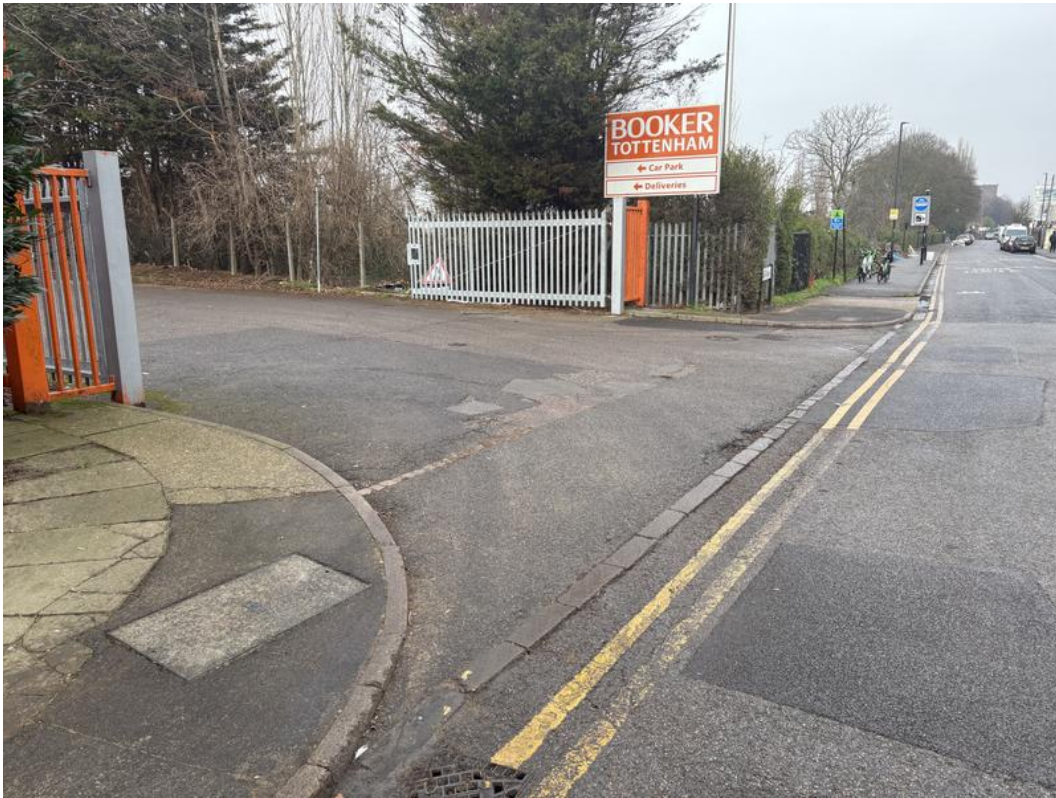
Photograph 17

| Location | Element | Condition | Photographs | Photo No. |
|---|---|---|---|---|
| Zone 2 | Generally | | | Photos [ 17 - 18 ] |
