**Project:** 26\_5837\_02\_49  
**Site:** 63 Sheldon Avenue, London, N6 4NH  
**Client:** Hamid Ipakchi

| Report Type: | Arboricultural Impact Assessment & Method Statement |
| Site Address: | 63 Sheldon Avenue, London, N6 4NH |

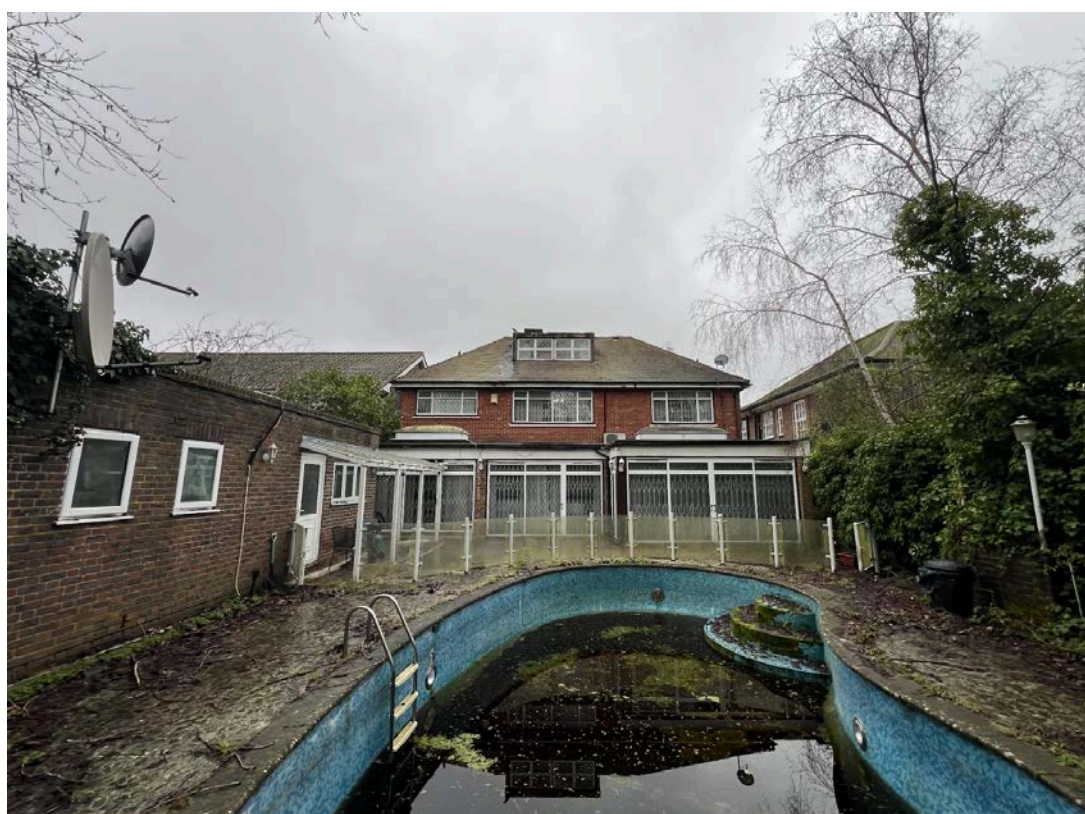
*Photographic plate showing the rear of 63. (ROAVR, 2026)*

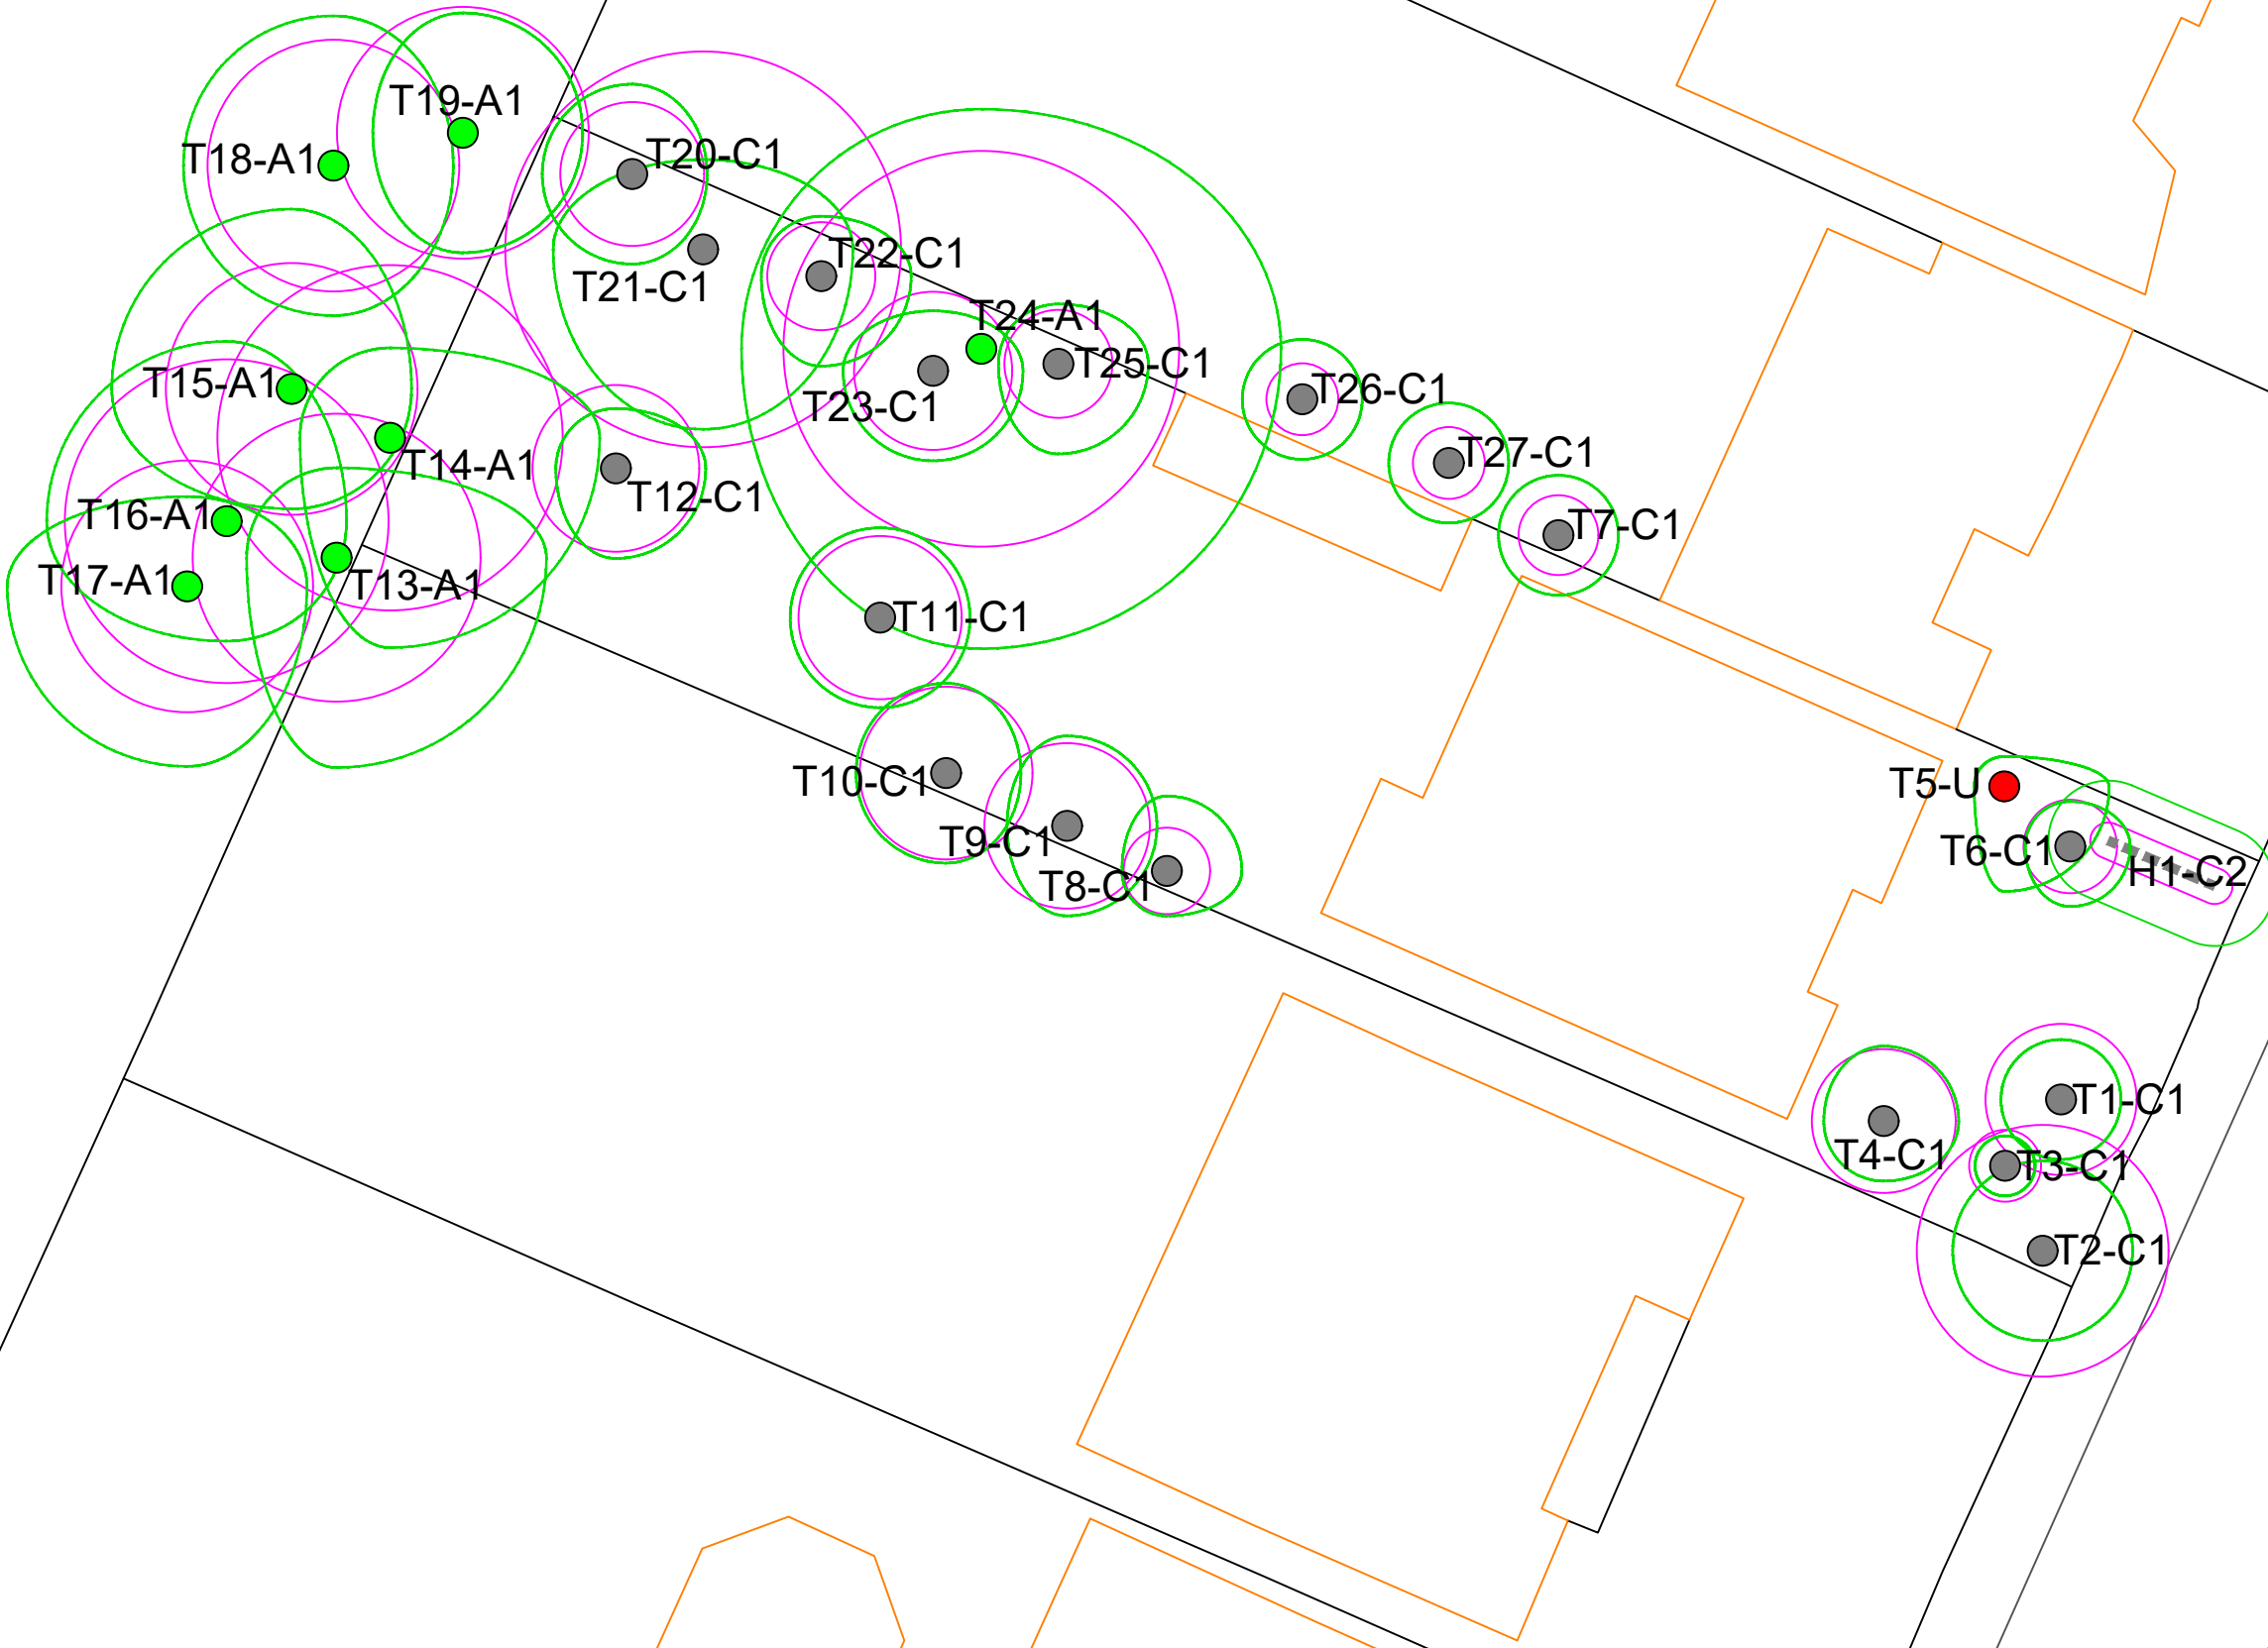
Within the application site, the majority of trees are categorised as C1, representing trees of low quality with a life expectancy of at least 10 years. These include Elder (T1), multiple Lawson Cypress specimens (T2–T4, T20–T21), Cherry Laurel (T6–T7), Silver Birch (T8–T10), Apple (T11–T12), Prunus species (T22–T23, T25), Cotoneaster (T26) and Hawthorn (T27). These trees are generally in fair condition. A number are affected by ivy or dense undergrowth, which restricted full stem inspection at the time of survey. Several specimens are located within hard surfaced areas or raised beds, which may influence long-term rooting conditions. No specific management works are currently recommended for these trees.

T5 (Lawson Cypress) is categorised as U. The tree is dead, windblown and exhibits stem decay, fungal brackets and significant deadwood. It has a life expectancy of less than 10 years and is unsuitable for retention.

A number of large off-site trees make a strong contribution to local amenity. T13–T19 (Common Oak) and T24 (Grey Poplar) are categorised as A1. These trees are in good condition with an estimated life expectancy of 40+ years. Although undergrowth restricted detailed stem inspection, no significant defects were identified from ground level. These trees provide high public amenity value and form a prominent landscape feature.

T7 is located off site behind a wooden boundary fence. There is a minor RPA encroachment associated with the proposed bin and cycle store. Given its off-site position and separation by fencing, the impact is limited. Works within the notional RPA must be carried out sensitively to avoid root damage.

T9 is in direct conflict with the proposed basement structure and will require removal. The scale and depth of excavation associated with the basement precludes its retention. T10 will be subject to a minor root protection area encroachment, but can be retained with careful hand excavation. The excavation method must avoid over excavation or battering back to prevent root damage to retained trees.

T24 is a high quality tree and forms a significant constraint. There is minor RPA encroachment associated with the proposed basement, but can be retained with careful hand excavation. The excavation method must avoid over excavation or battering back to prevent root damage to retained trees.
