# Cooke Fawcett Architects

## 28 Wood Lane, N6 5UB Condition Survey-Rev A (Windows Only) 23.03.2025

CF\_225\_REP\_Condition-Survey-RevA

## 5. Windows

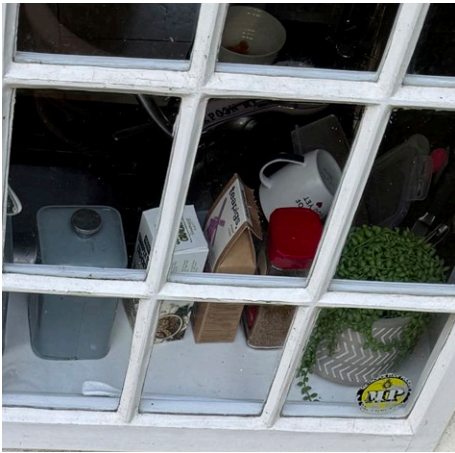
Paintwork chipped and split

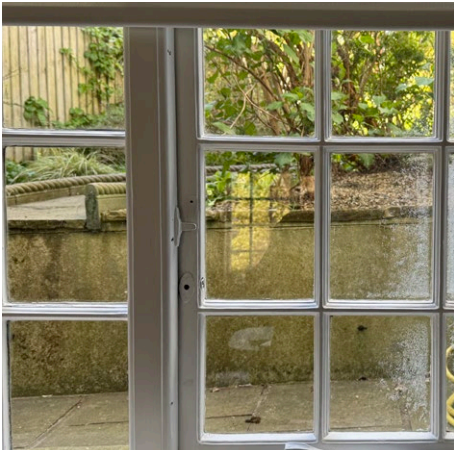
Some chips in paintwork and missing handle

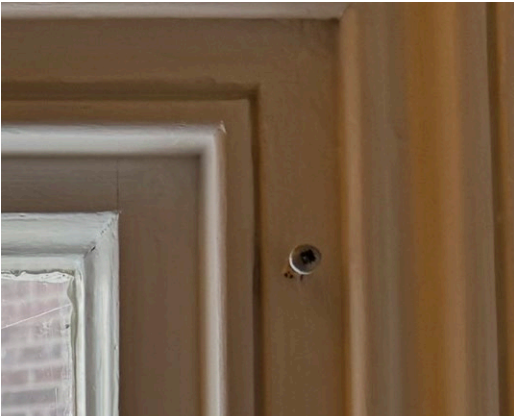
Screw drilled into frame

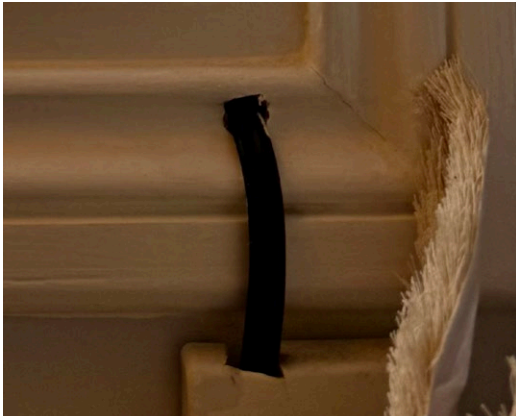
Hole in frame made for cable

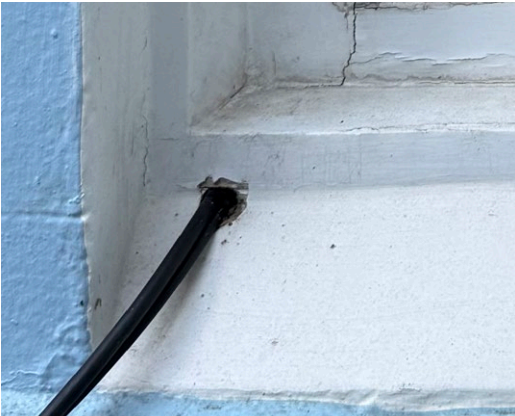
Cable entry through external plaster moulding

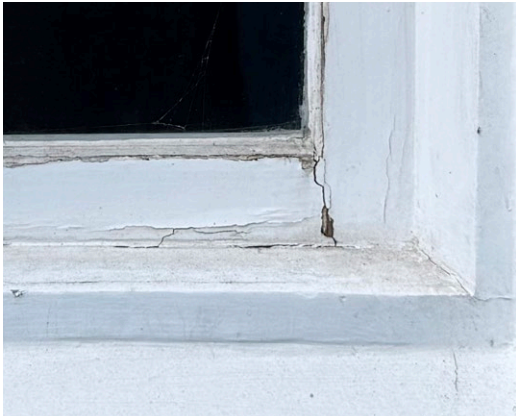
Signs of paint cracking and signs of timber rotting

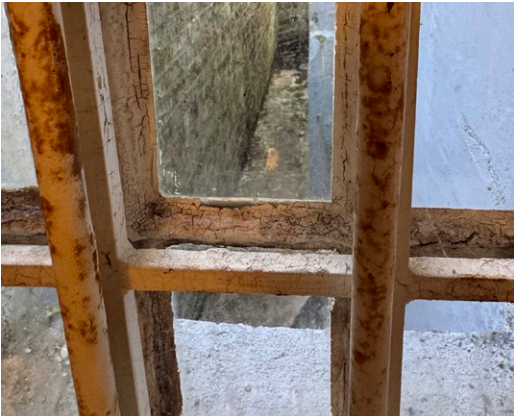
Significant sign of rusting, cracking and rotting

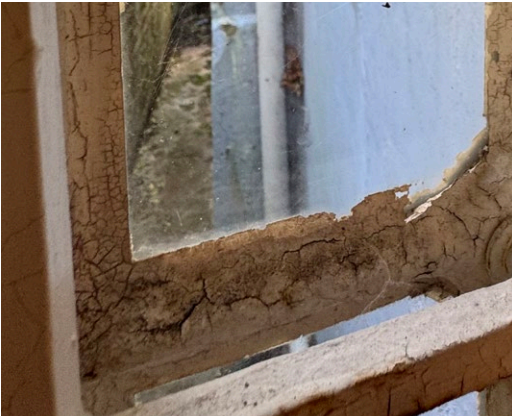
Significant signs of flaking, rotting and rusting

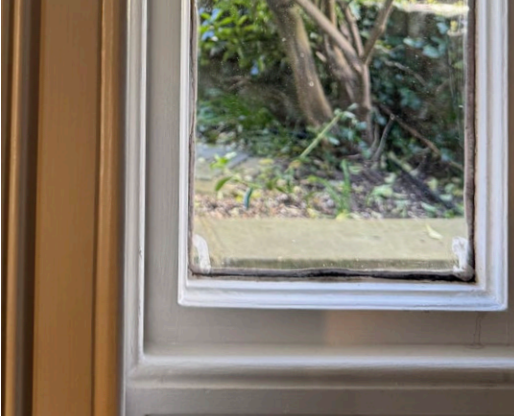
Signs of black mould on bottom rail of sills

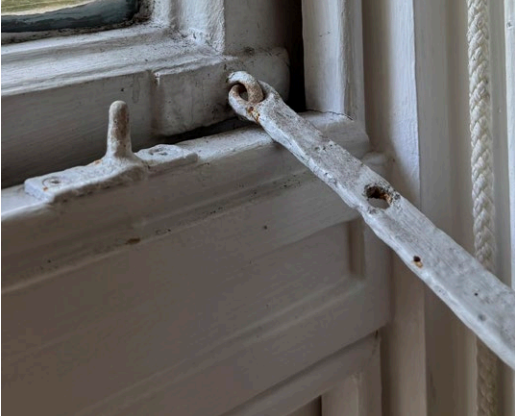
Window stay for top right casement not operable and casement not fully closable

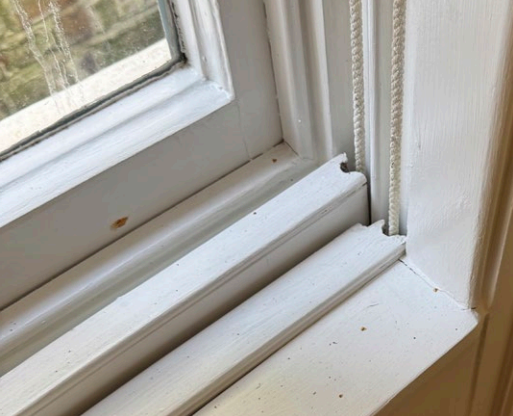
Vertical sliding shutters operable, some signs of cracking and splitting in paintwork

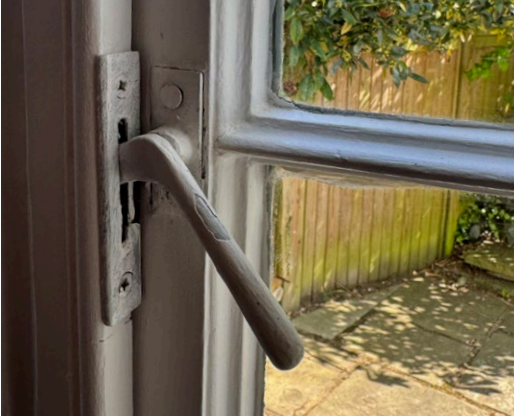
Steel handle painted over poorly with chips and flaking of paintwork

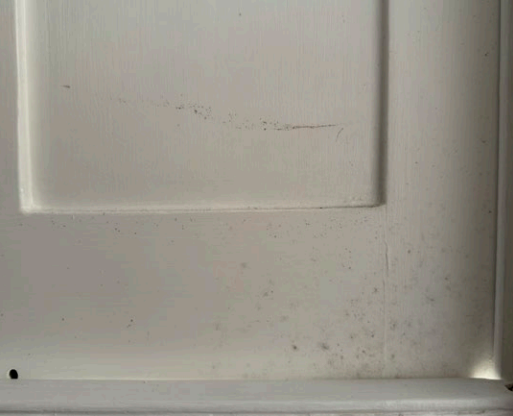
Vertical sliding shutters operable with signs of mould on timber panels

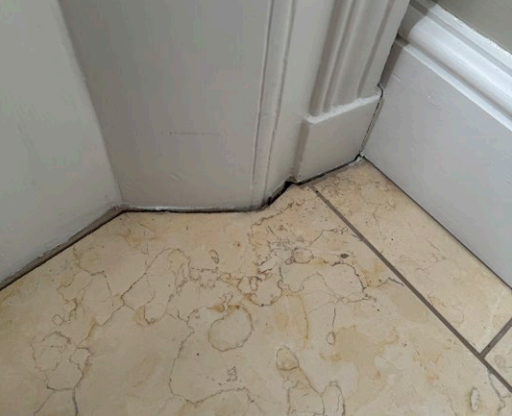
Evidence showing floor tiles covering decorative wood casing extending below floor level

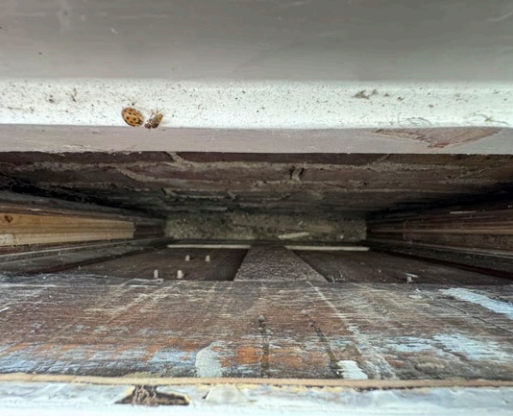
15cm discrepancy between bottom of timber shutter casing and floor level -rubble present at base.

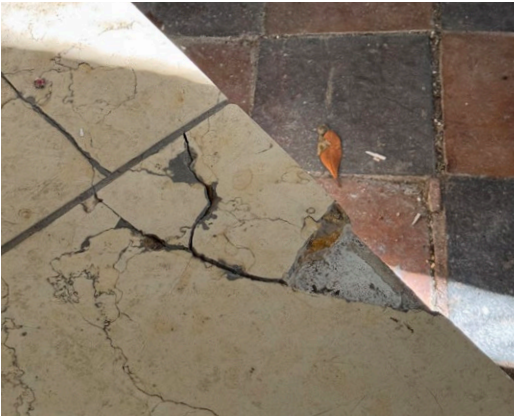
Tiles cracked and chipped away in door opening

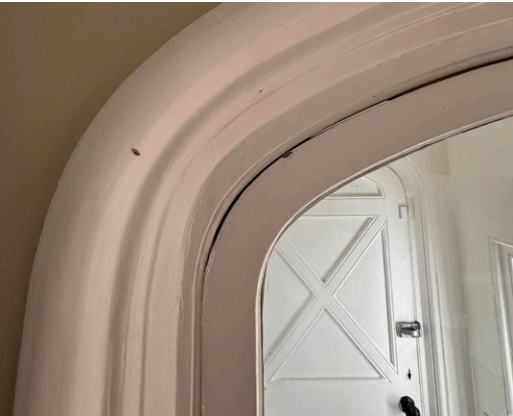
Chips in paintwork on internal frame

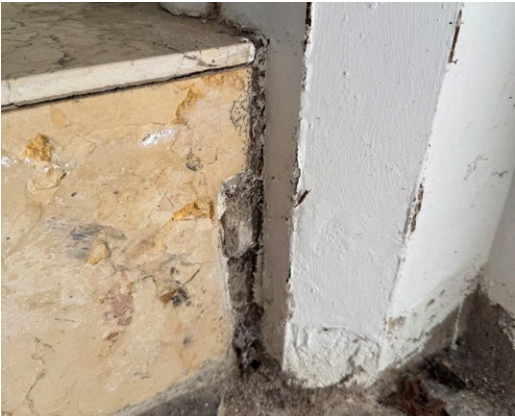
Signs of rotting on inner post (jamb)

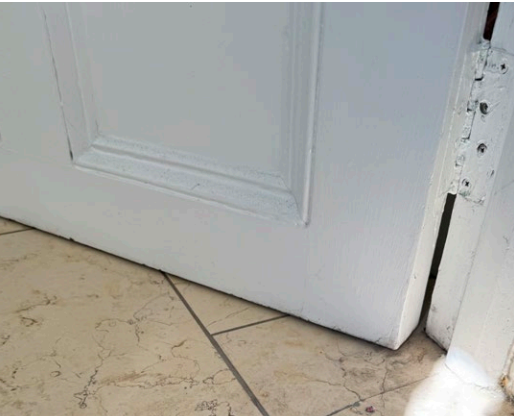
Scuff marks and chips in paintwork

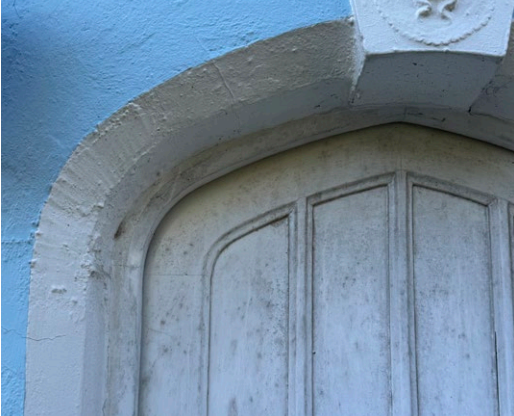
Signs of weathering on top portion of door

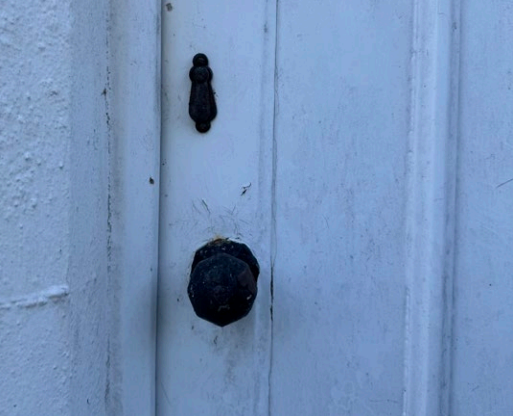
Rusting and cracking around door handle difficult to operate

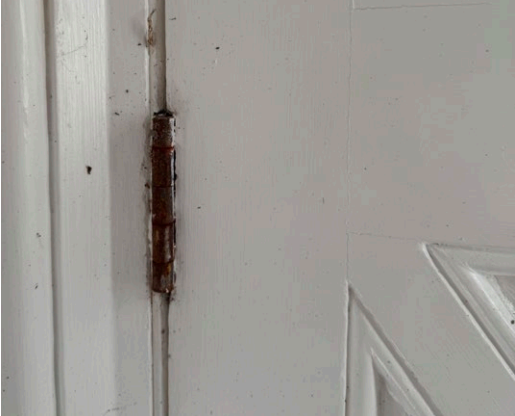
Signs of rusting on hinges and insects present around door

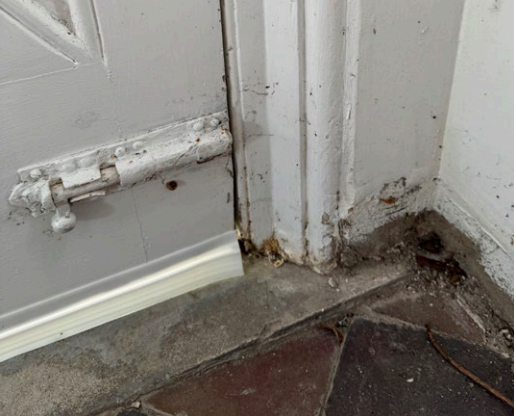
Signs of rotting where door frame meets ground, paintwork flaking and chipped

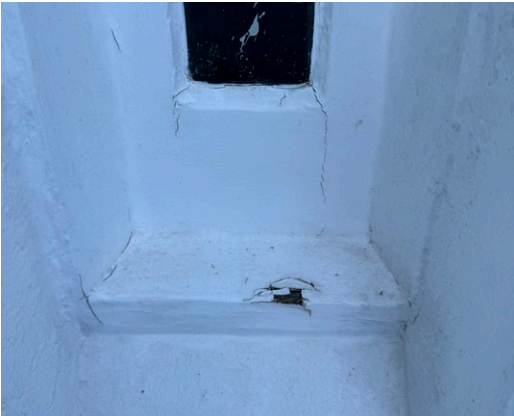
South West window: Chips and cracks in paintwork, signs of rotting in wood frame below paint

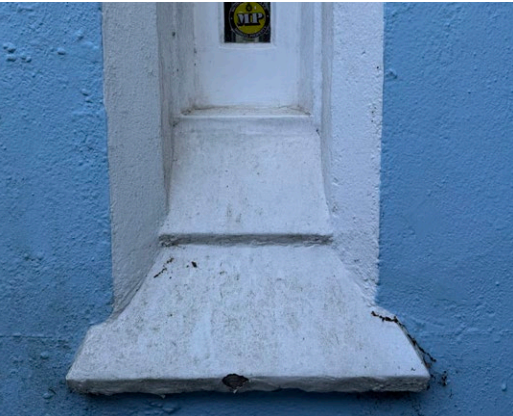
North East Window: Signs of weathering on decorative moulding around window

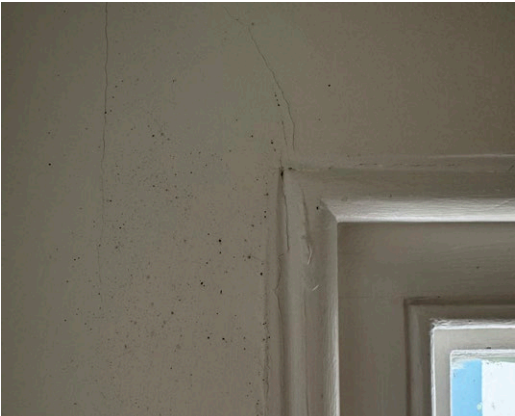
South West Window: Black mould around interior decorative moulding

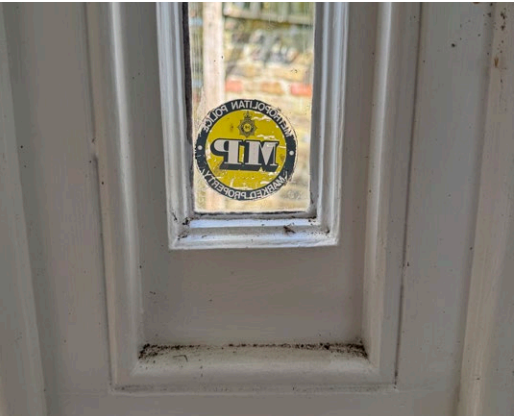
North East Window: dirt, insects and cobwebs on sill, manufacturer sticker on glass

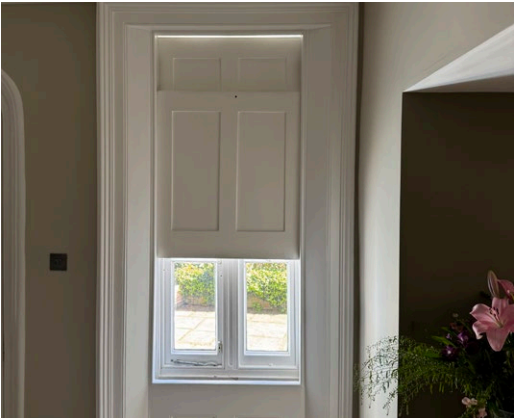
Vertical shutters operable with visible rope pulley system

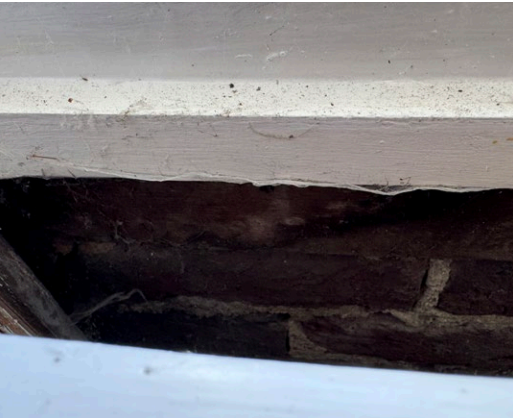
Signs of insects, weathering to paintwork

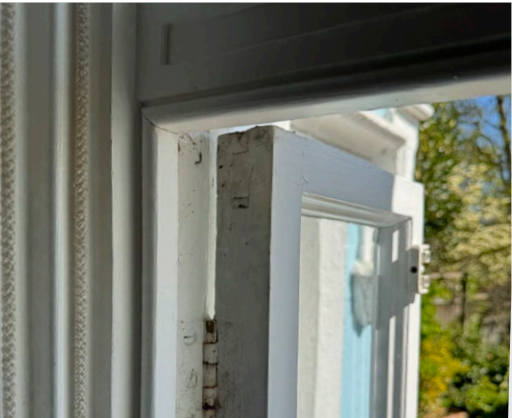
Splits in paintwork and rusting present on white painted hinges

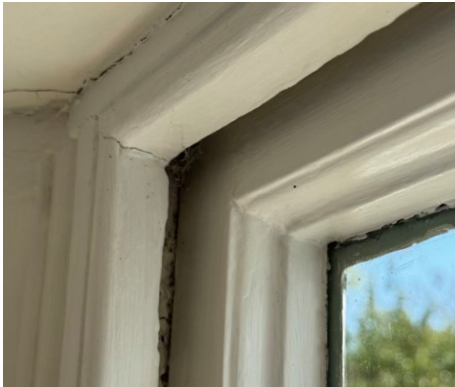
Casement not fully closable

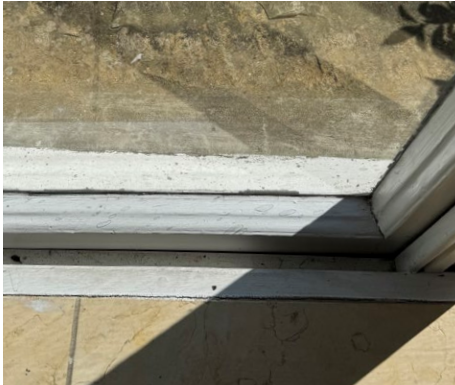
Window sill finished below floor level

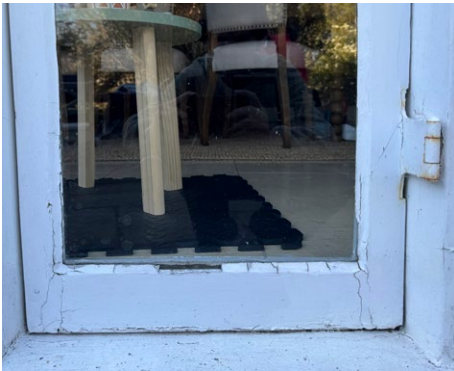
Cracks and splits in paintwork on external frames, rust on hinges

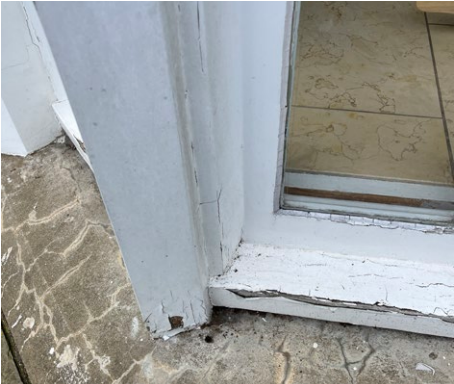
Damage to post and cill

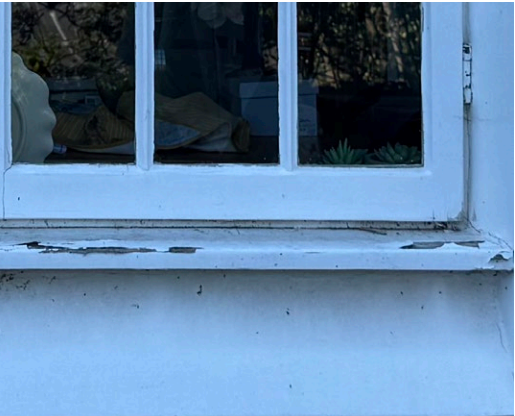
Chips and cracking in paintwork leaving exposed timber on bottom sill

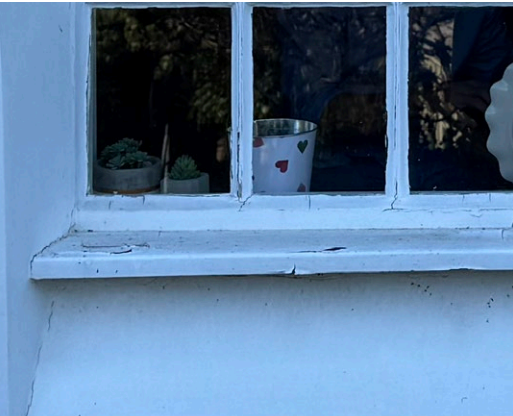
Signs of rotting on bottom rail

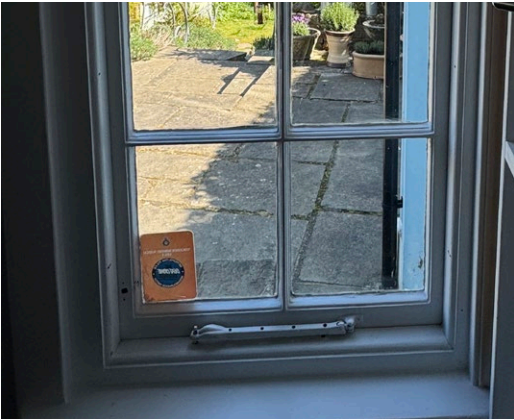
Chips in paintwork and screw/nail holes present on the frame

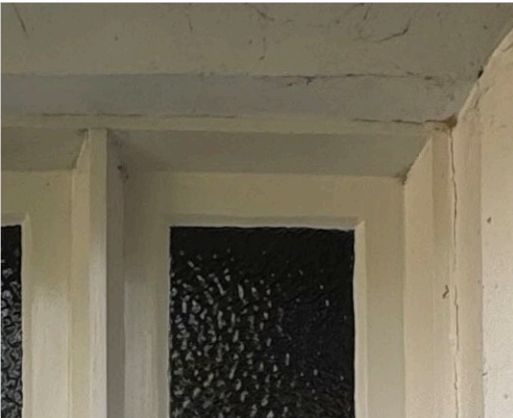
Signs of cobwebs, splitting and cracking of paintwork around frame

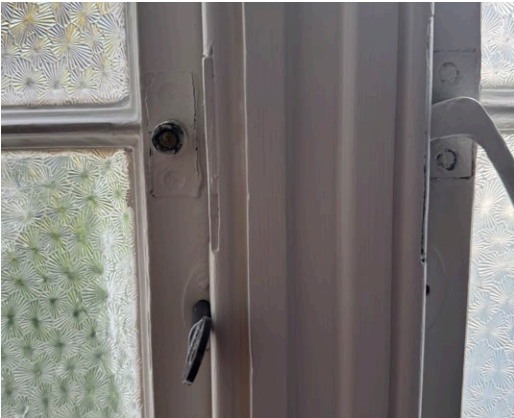
Missing handle to left casement, chips in paintwork

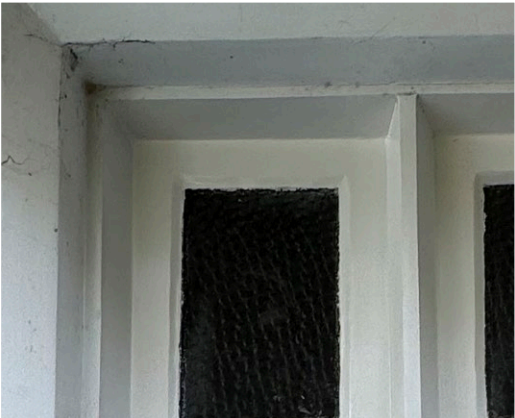
Signs of cracking and dirt build up on plaster moulding around frames

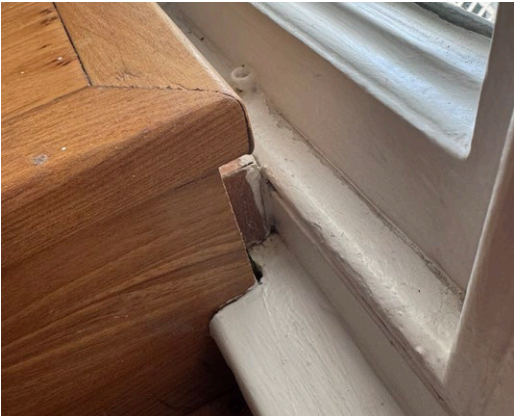
Stair overlaps and cuts into sill and frame

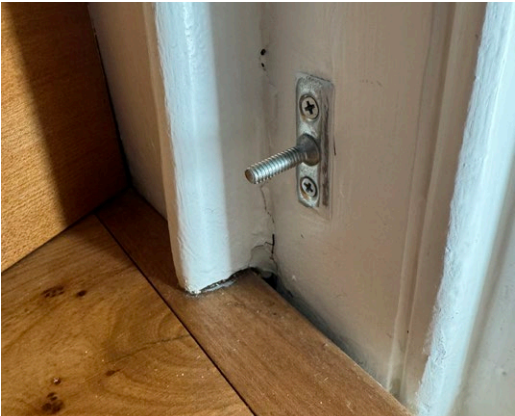
Previous blind or security fixings left in frame

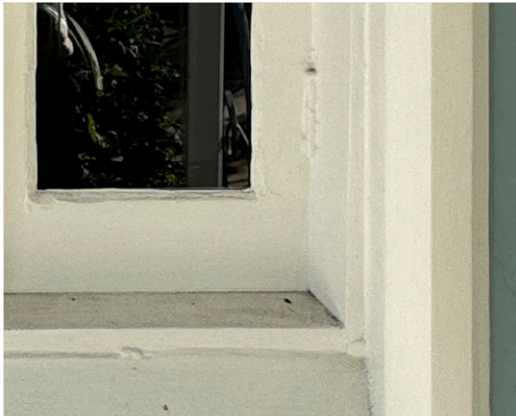
Hinges on previously operable casement painted over and sealed

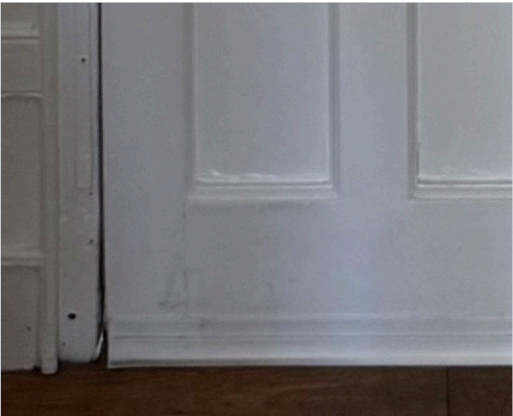
Scuff along bottom rail

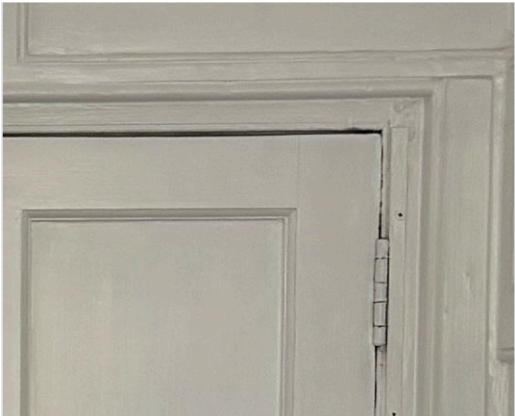
Visible gaps between door and frame

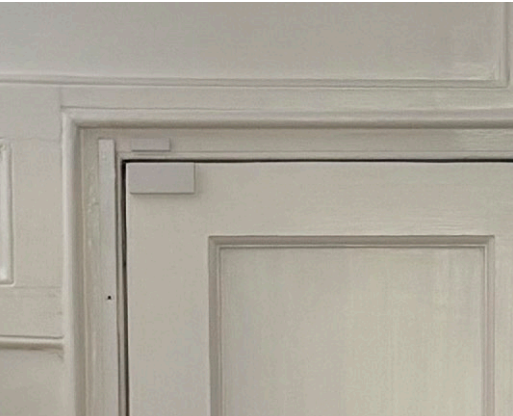
Security systems in place

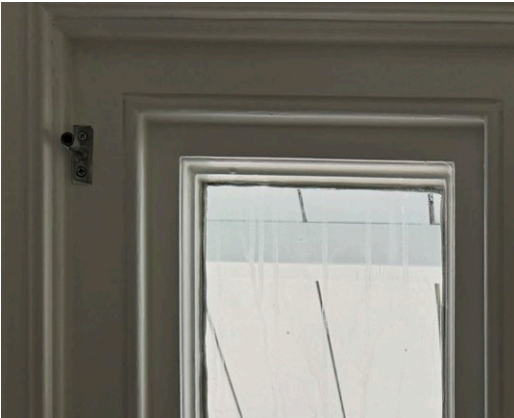
Previous blind fixings left in frame

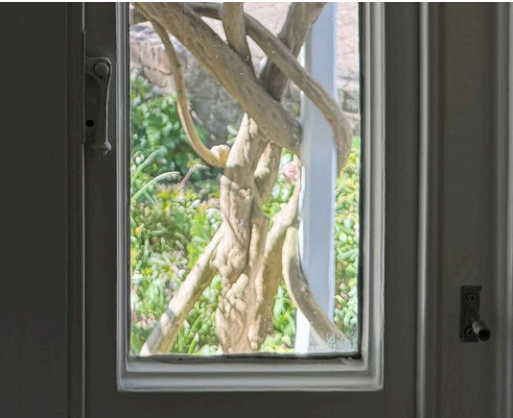
Hand and latch not fully sealing window casement

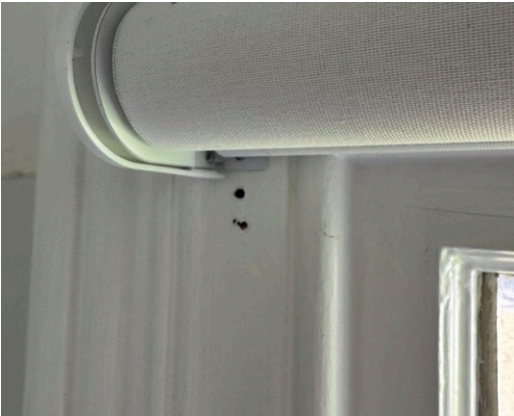
Screw holes/marks left by previous security or blind system

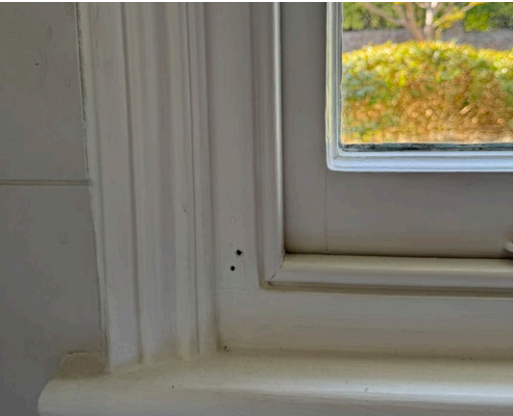
Screw holes/marks left by previous security or blind system, some splits in paintwork

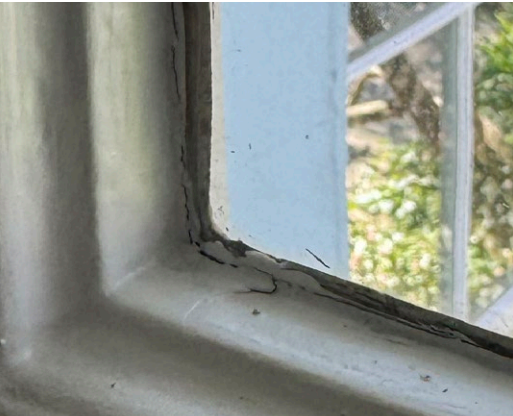
Early signs of rotting and splitting directly around glass pane

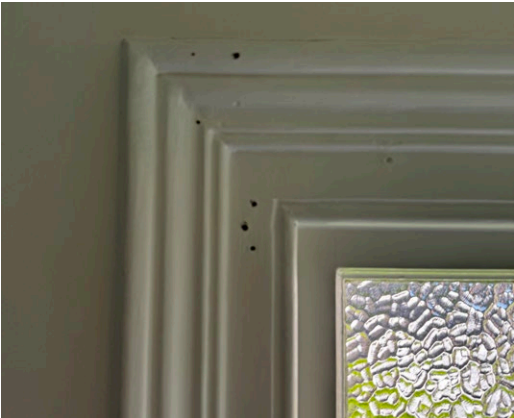
Screw marks/holes in frame and outer moulding

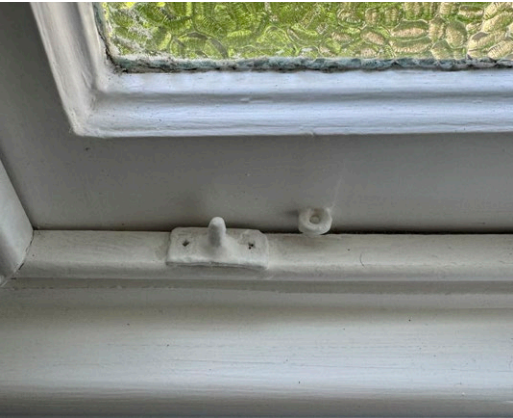
Missing window stay - window unable to be opened in fixed location

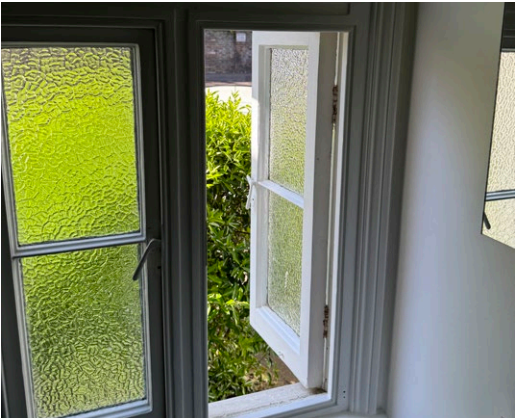
Window unable to be opened in fixed location

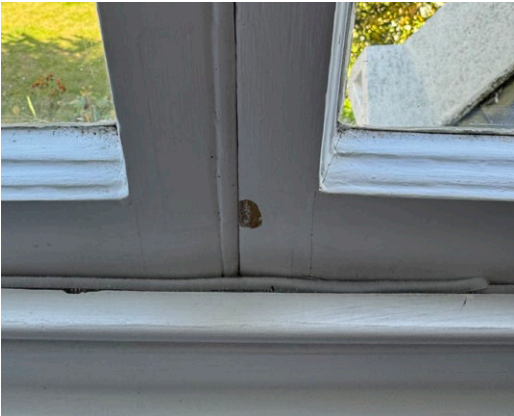
Chipped paintwork in frame, window not fully sealed when closed

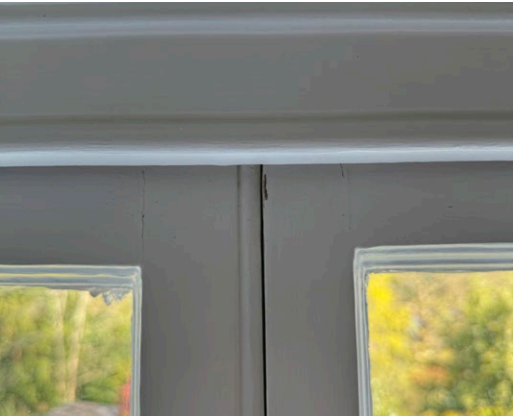
Splitting and chips in wood/paint work

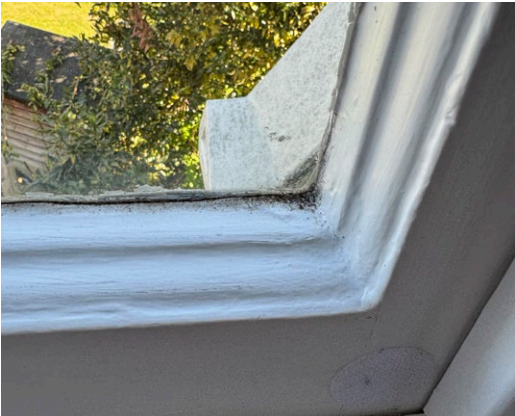
Early signs of black mould in corner of bottom rails, Velcro stickers placed in corners of frame

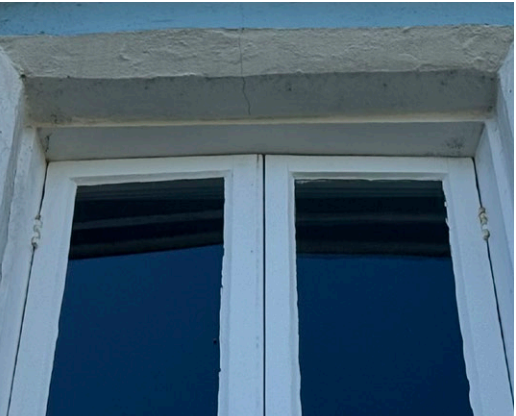
Poor airtightness-clear that window is not fully closable

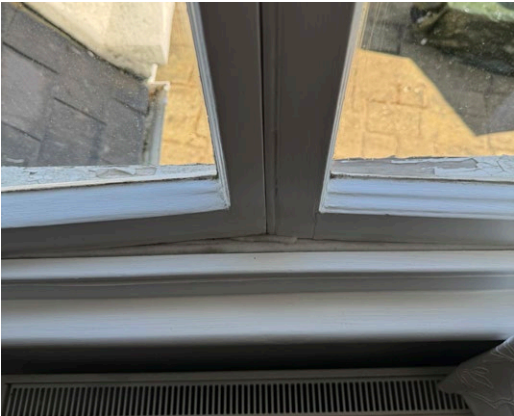
Significant gaps to exterior. Large brush seal placed around frame to reduce draft

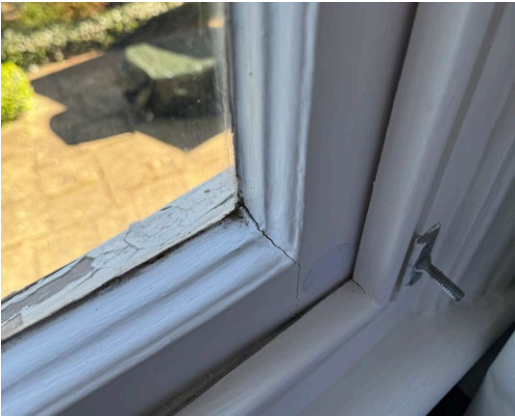
Splits and cracks in woodwork -condition of external sill is visible

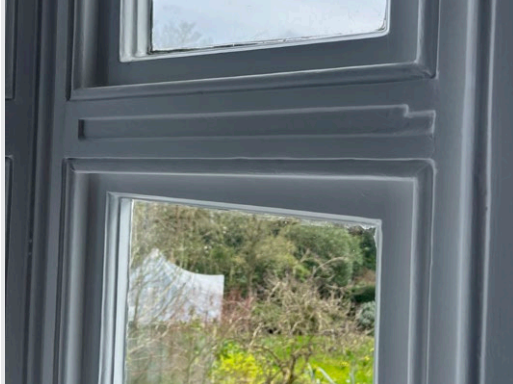
Evidence casement has been replaced - reshaped to accomodate skewed frame

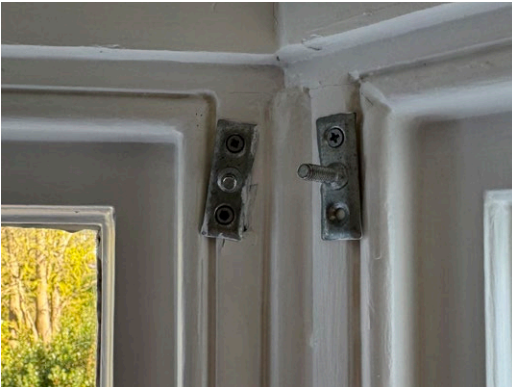
Previous blind fixings left in frame

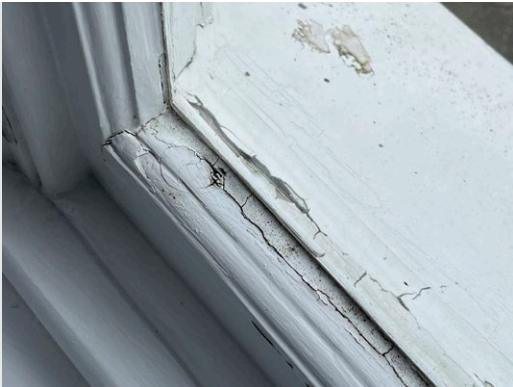
Evidence of cracking and rotting in timber frames

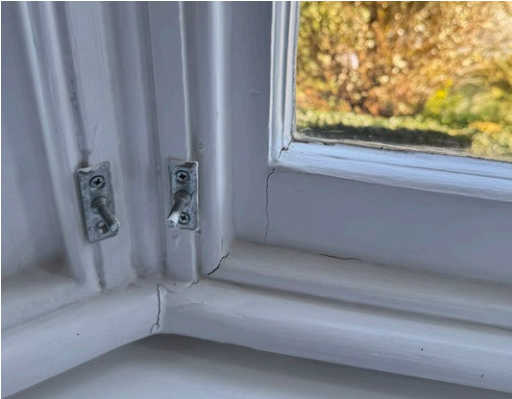
Previous blind fixings left in frame and evidence of cracking and rotting in timber frames

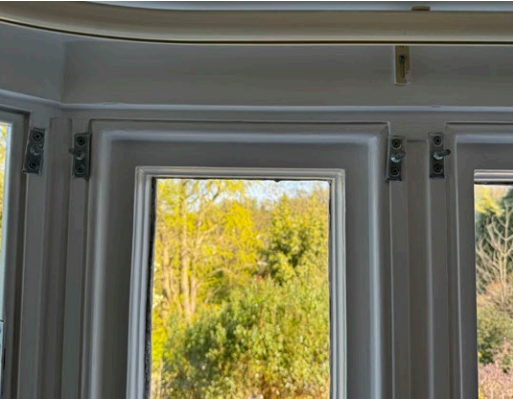
Previous blind fixings left in frame and previous curtain railed present

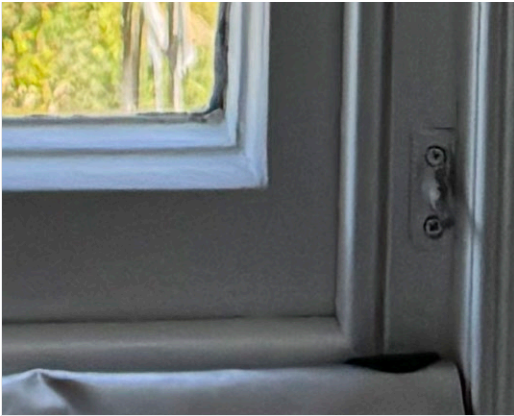
Previous blind fixings left in frame

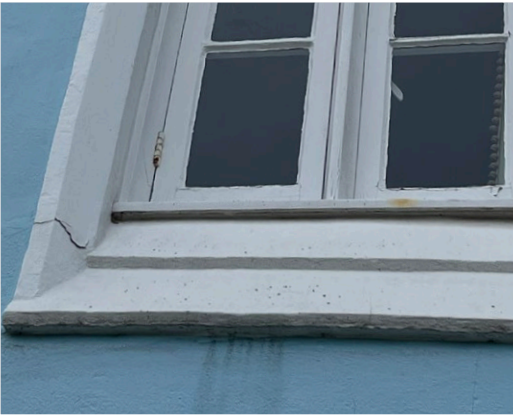
Cill in poor condition

| Element | Description | Condition |
|---|---|---|
| External | -Timber casement window with 6-pane configuration<br>-Casement window frames painted white<br>-Angled recess into masonry wall painted white | Cill in poor condition and needs replacement |

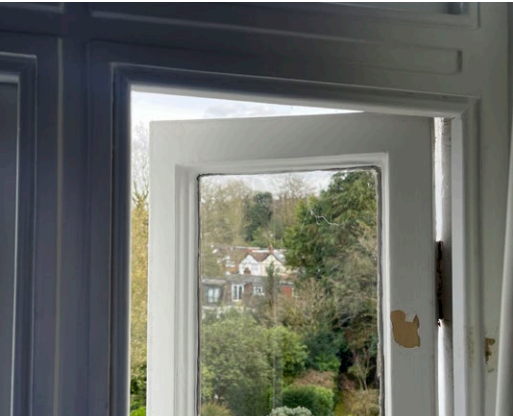
Evidence casement has been replaced to fit within skewed transom

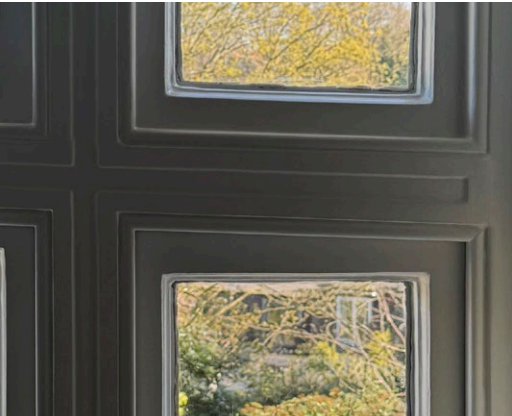
Not level transom

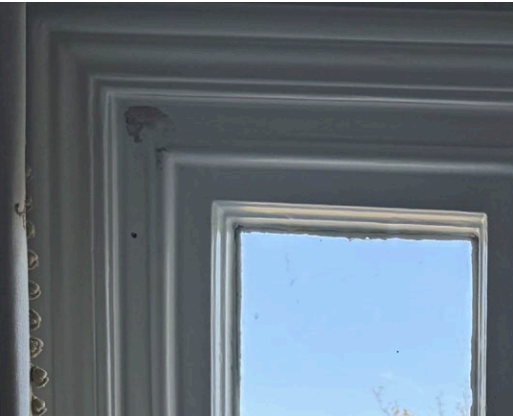
Paint flaking from frame and screw marks/holes present in frame

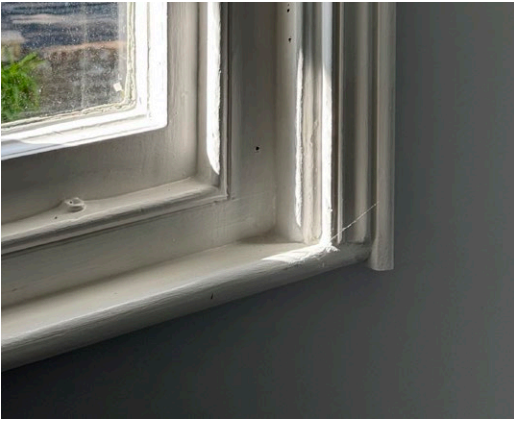
Screw marks/holes in frame

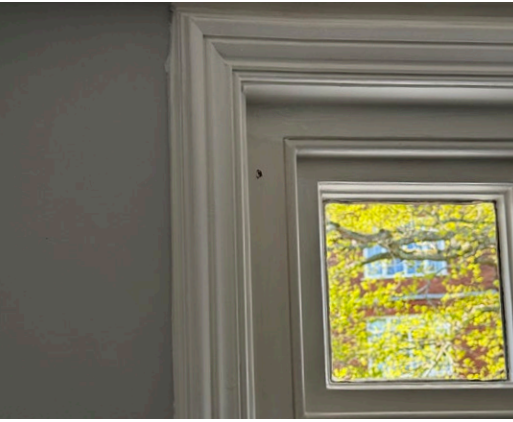
Screw marks/holes in frame

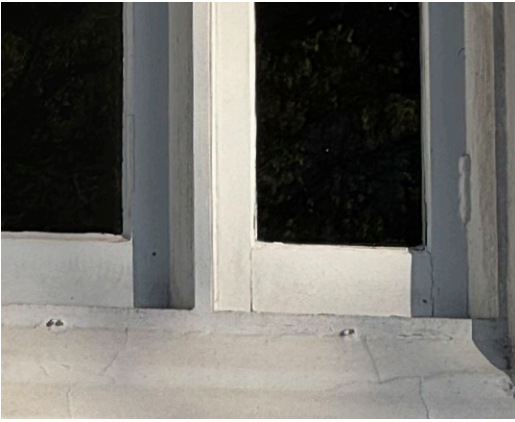
Splits in paintwork, painted over hinges and  
previous external latch fixings painted over

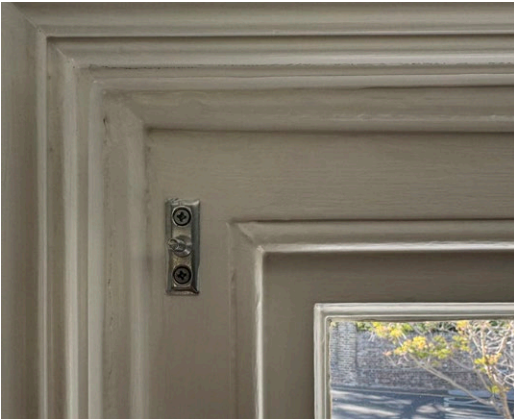
Previous fixings from blinds evident

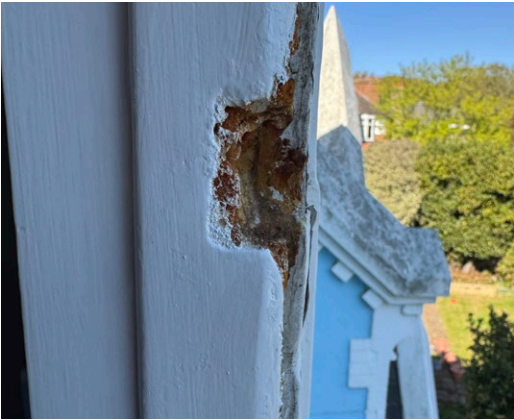
Advanced stages of rotting around lock/handle

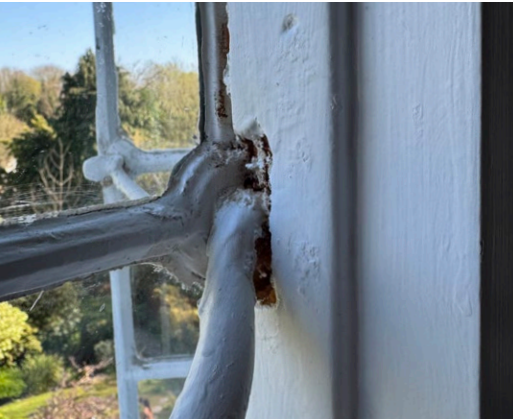
Casement not fully sealed when closed

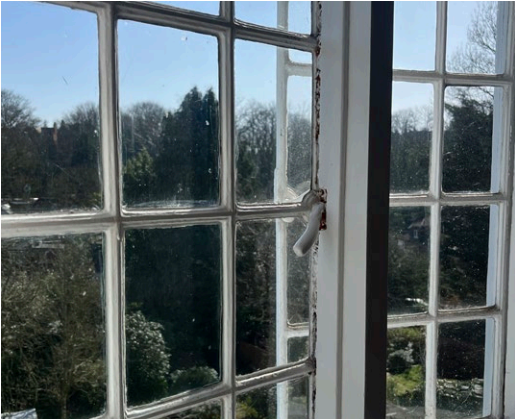
Advanced rotting and signs of black mould on rails
