## 28 Wood Lane, N6 5UB Proposed Window Upgrades - Cover Letter 23.03.2025

# 1. Introduction

This supplementary document has been prepared in support of a planning application for works to 28 Wood Lane (ref: PP-14585948, it specifically provides further detail on the repair, restoration and upgrading of the windows in response to dialogue with Haringey Conservation during application stage. This should be read alongside the accompanying window condition report, which sets out in detail the findings of specialist surveys carried out by two independent heritage window contractors in March 2025. As well as, the proposed window schedule.

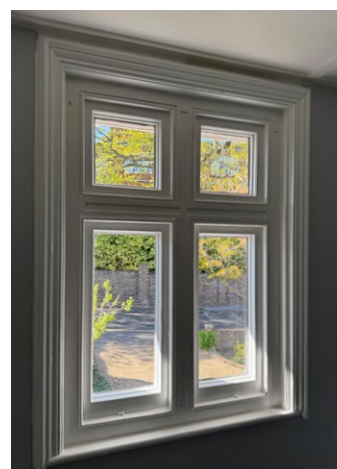
WFF.01 (FRONT)  
Stair  
Good internal and external condition

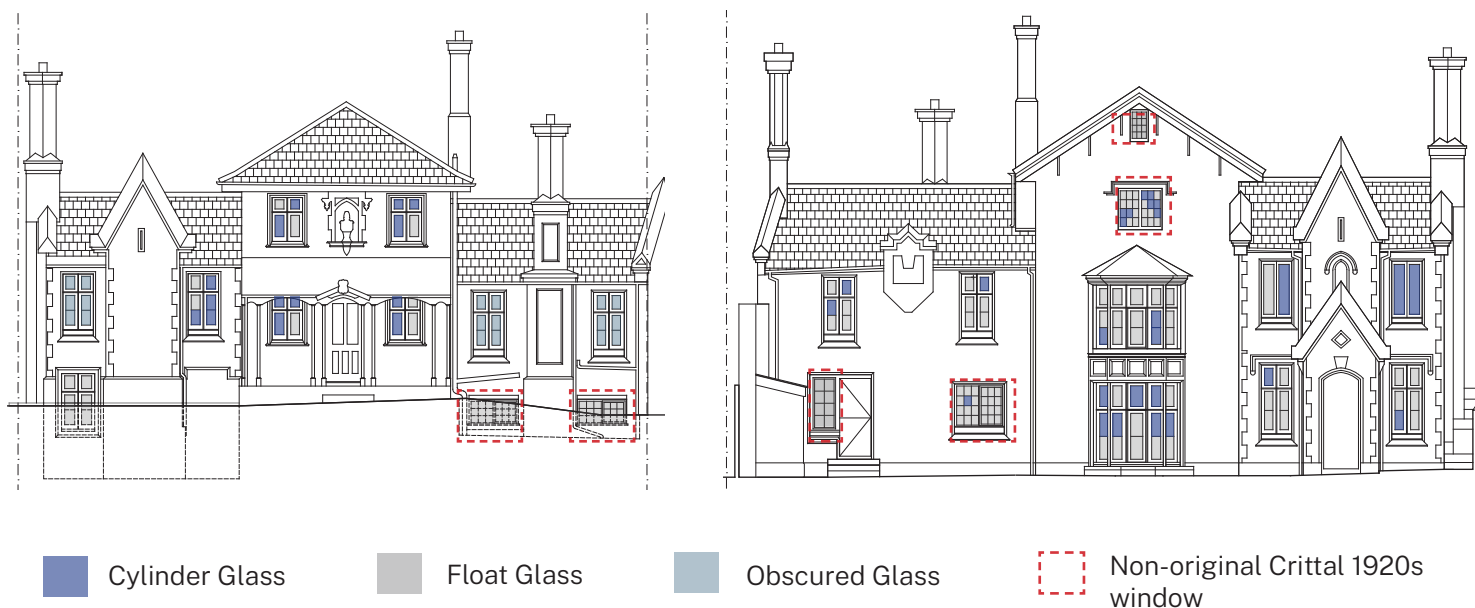
The principal findings in this regard relate to the adaptations and replacements of casements described above, and to a detailed discussion around the glazing itself. Across the window stock, there is a notable inconsistency in the age of glazing present: it is not uncommon to find individual windows retaining a mix of original and replacement glass within the same frame, or windows where all panes have been replaced entirely. The surveyors have highlighted the opportunity to restore greater consistency as part of the proposed works, noting that heritage glass can be retained and re-set and new heritage glass can be incorporate, reinstating the authentic appearance of the windows whilst improving thermal performance.

The colour coded elevation drawings below illustrate the distribution of original and replacement glazing across the property as assessed on site. This assessment was made visually, using the characteristic indicators of historic glass-most notably the wavy appearance of hand-blown cylinder glass and the presence of tiny air bubbles-as explained by the attending surveyors.

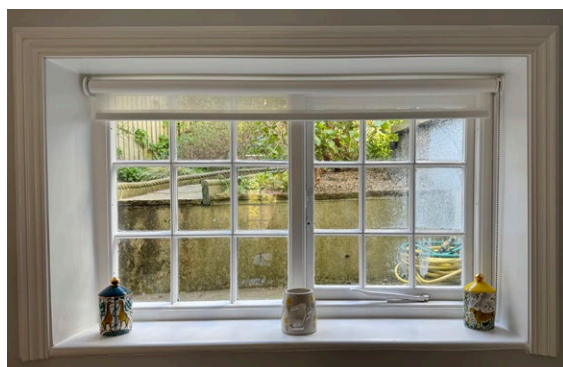
WLG.02  
Kitchen

The kitchen windows, which are proposed to be removed were subject of careful and detailed discussion on site. The surveyor noted that there is strong evidence that they are timber-framed replacements of what were originally Crittal windows. This is evidenced by the presence of infill holes in the surrounding frame, a frame moulding profile inconsistent with the period of the original timber windows elsewhere in the property, and the addition of supplementary framing to accommodate the dimensions of the existing opening. The fact that they were steel crittal indicates that these windows were already replacements or installed later.

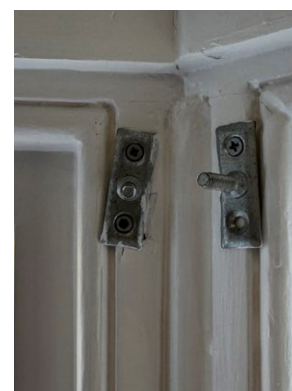
The condition surveys identified evidence of fixings added by previous owners across a number of windows, either left prominently in place, as with the upper ground floor bay window, painted over as with the lower ground floor bay, or removed but leaving unfilled screw holes in the frame. These accretions detract from the character and appearance of the windows. Addressing and reinstating the frames formed part of the discussion with the window surveyors and will be incorporated into the scope of works as part of the broader effort to reinstate the heritage character of the windows.

WUG.10 (REAR)  
Upper Ground Floor Bay Window  
Previous fixings left behind
