# Defect Advisory Report

93 Mountview Road  
London N4 4JA

28 July 2022

EKA220563

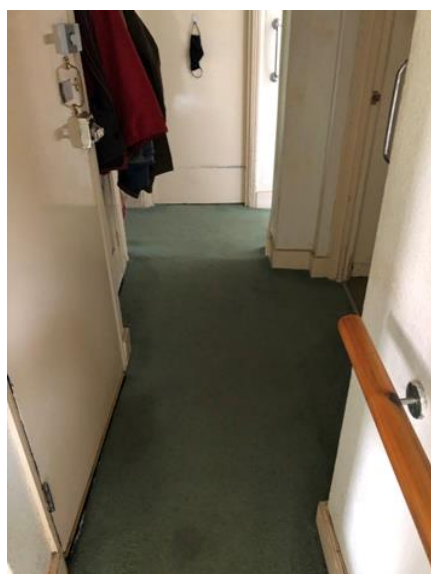
Photo 1: Overview of entrance hall

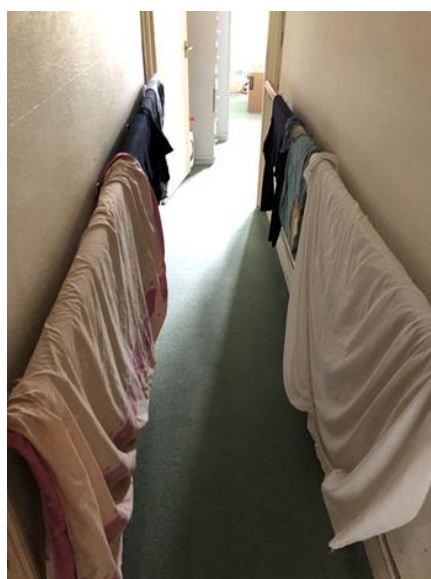
Photo 3: Overview of hallway leading to front bedroom

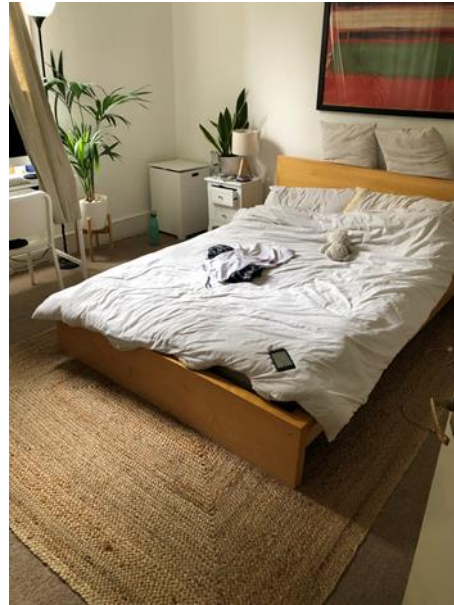
Photo 25: Overview of rear bedroom

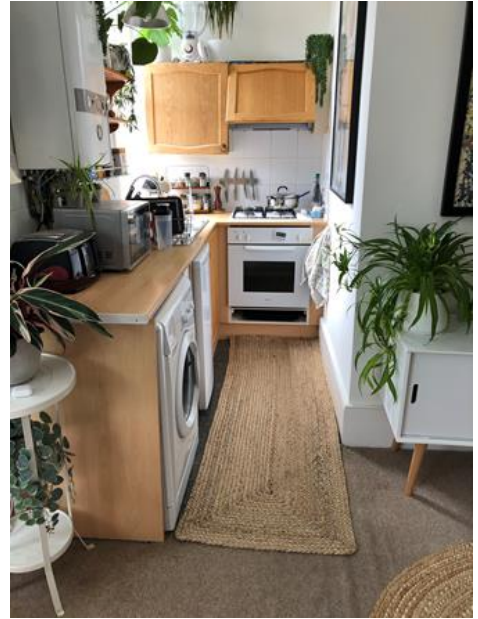
Photo 29: Overview of kitchen area

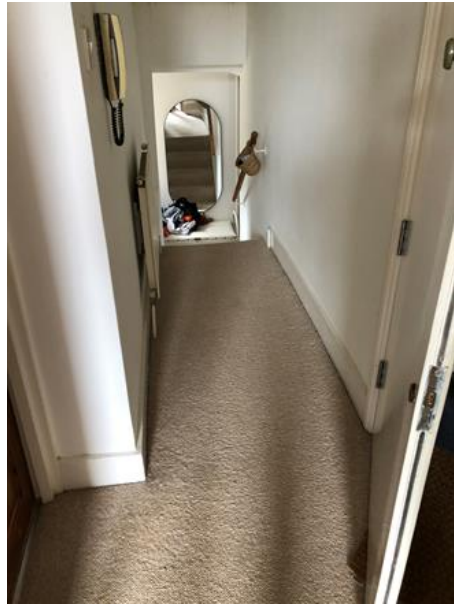
Photo 32: Overview of entrance hall

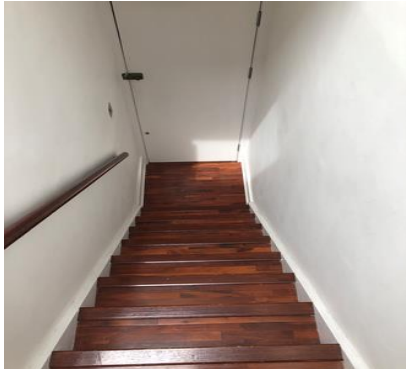
Photo 44: Overview of entrance stairs

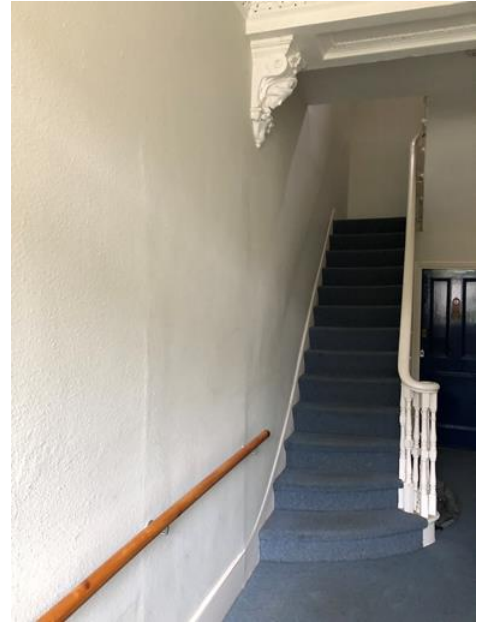
Photo 57: Communal stairs leading to 1<sup>st</sup> floor

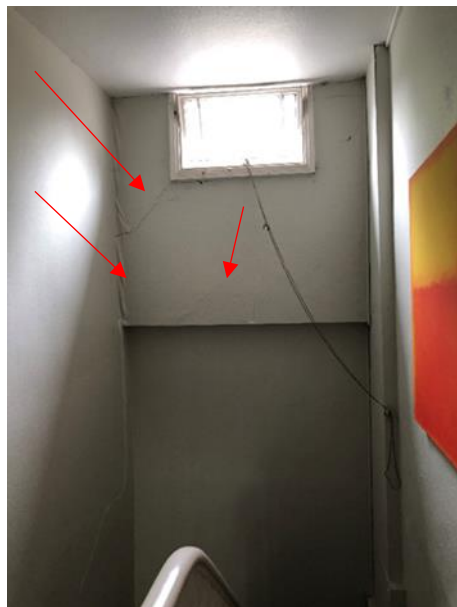
Walls and ceilings have been lined with a woodchip paper. Rippling and tears to paper, with wide cracks noted to the walls and ceiling in the landing area. Historic patch repair to cracks in this area.

Photo 58: Overview of top of stairs/landing

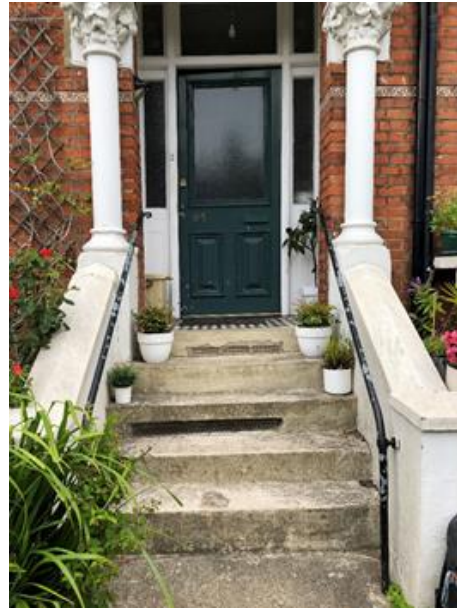
The front external steps and porch appear to have visibly shifted, with cracks appearing over the years. A local builder rebuilt the steps, installing wooden props in the cellar area beneath the steps, in order to provide temporary support. However, we were advised these have been in situ for some years.

Photo 60: Overview of front steps

Front external steps and porch have visibly shifted, with cracks to porch and stair areas. Temporary wooden props are keeping the stairs stable, with front external concrete pathway and garden significant cracked.

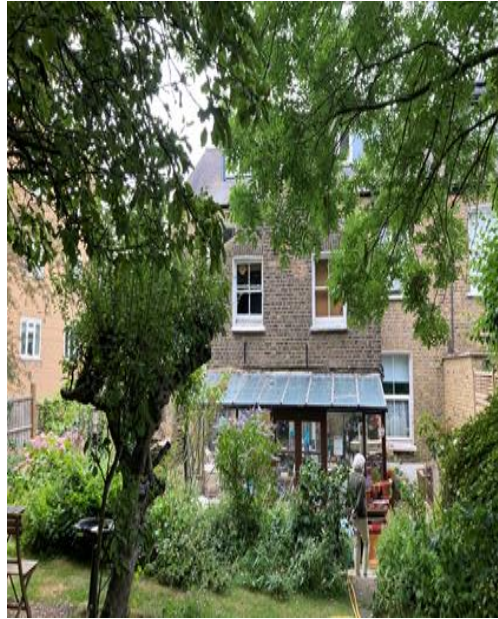
Photo 72: Overview of rear elevation

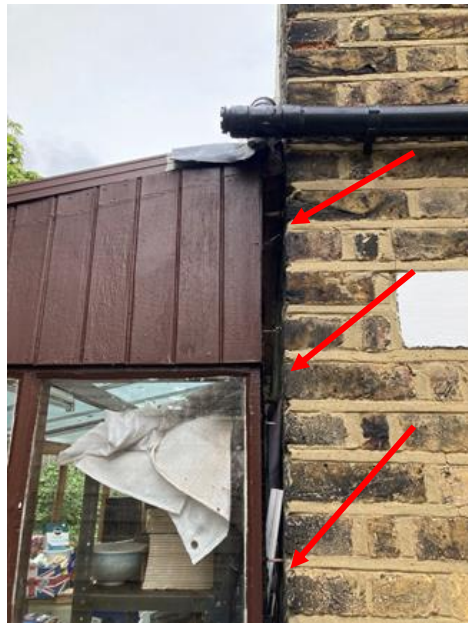
Photo 78: Lean-to / deached areas
