# GeoShield Verification Report 1

GEO105182

Cranford House,  
100 Woodside Avenue,  
Haringey,  
LONDON  
N10 3JA

Block C - Slab, gridlines 13-15/Q-T

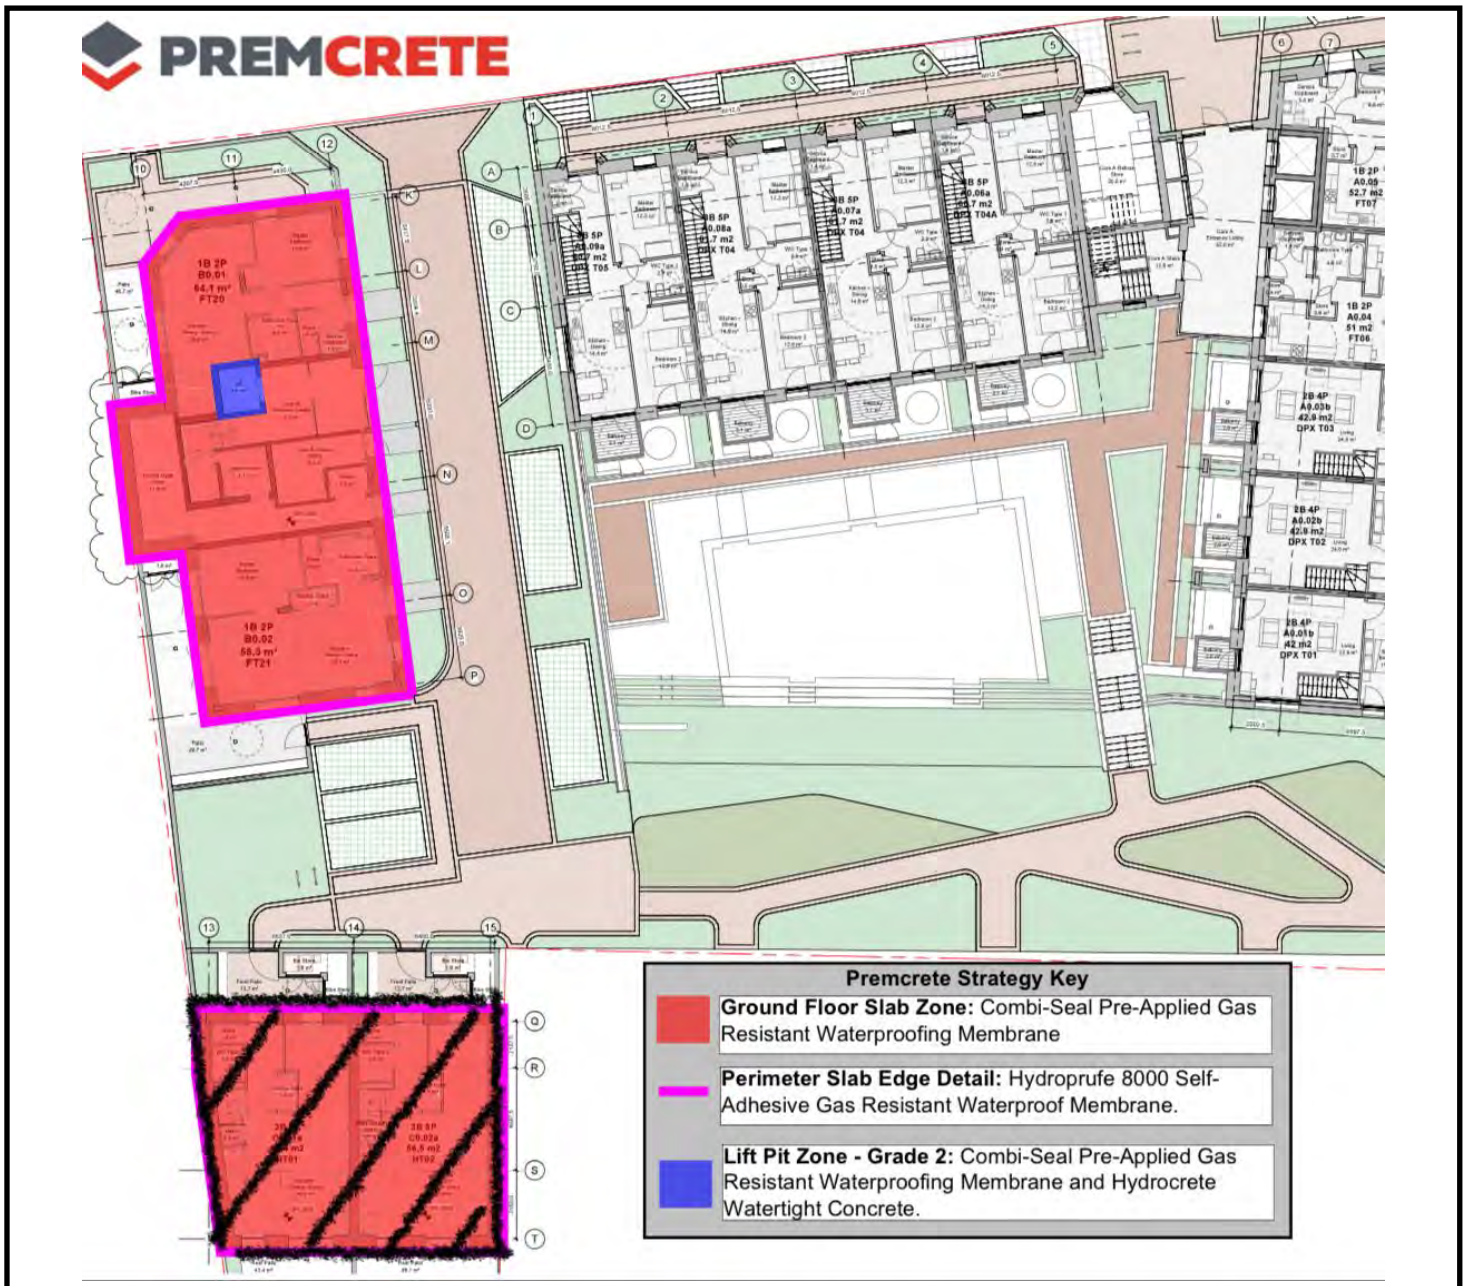
The photograph above shows a plan layout of the site. The area highlighted in black shows the slab section in Block C where the verification inspection took place on site today.

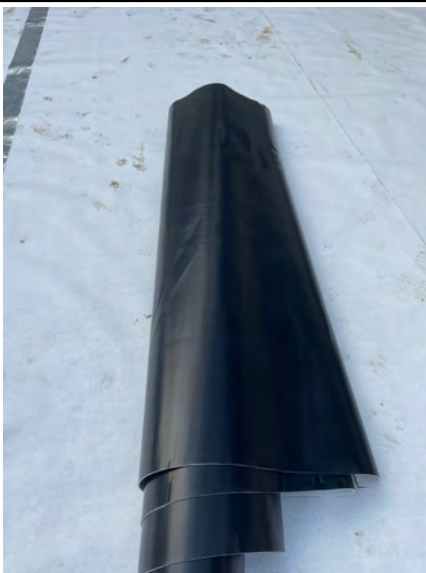
A bundle of Premcrete CombiSeal Plus Gas Barrier.
