# GeoShield Verification Report 5

GEO105182

Cranford House,  
100 Woodside Avenue,  
Haringey,  
LONDON  
N10 3JA

Block A, Slab Section - Full Line Out

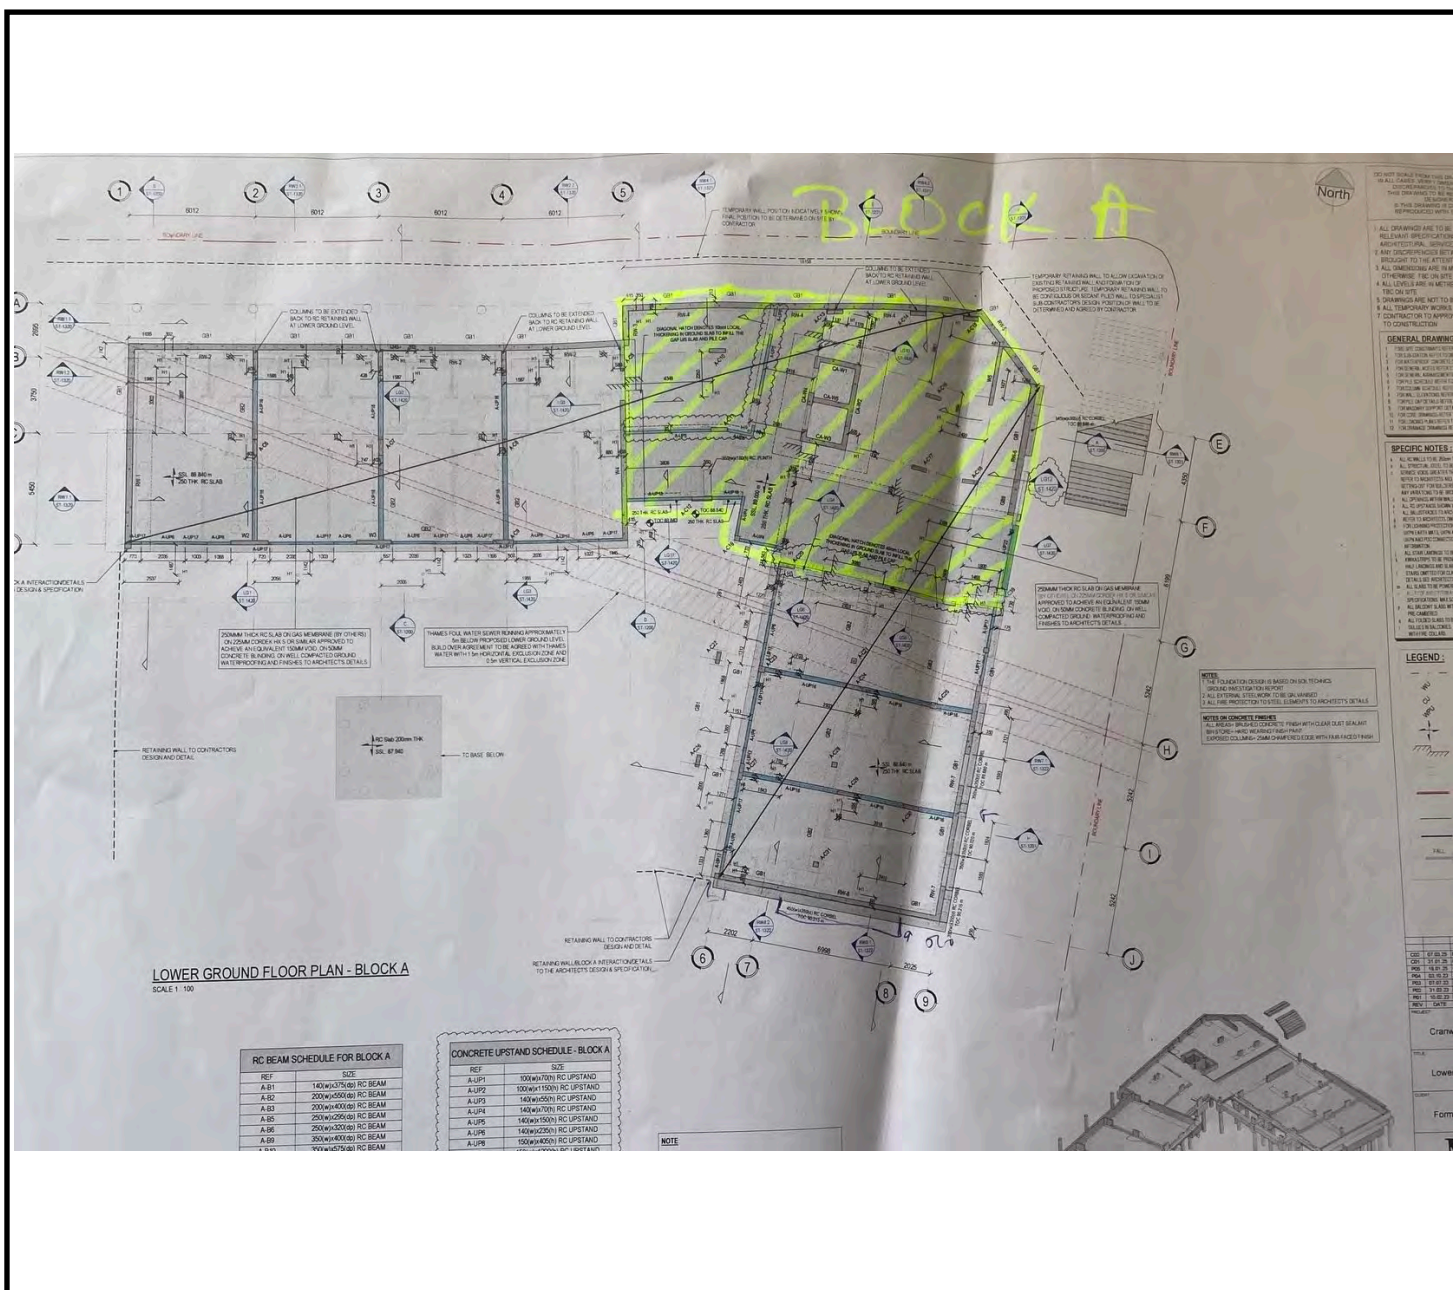
The photograph above shows a plan layout of the site. The areas highlighted in yellow show the slab section within Block A where the verification inspection took place on site today.

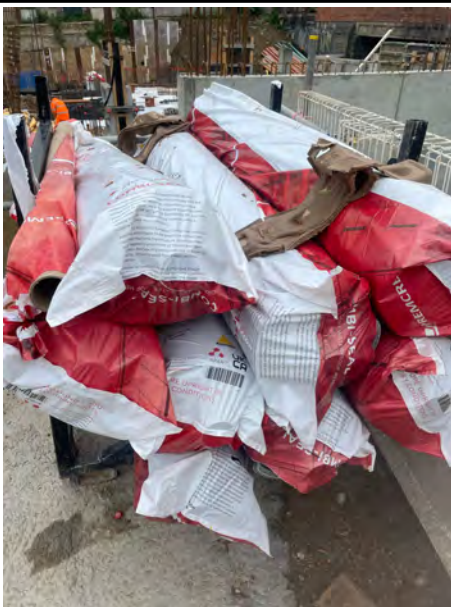
Bundles of Premcrete CombiSeal Plus Gas Barrier used during the installation.
