LOWER GROUND FLOOR PLAN

GROUND FLOOR PLAN

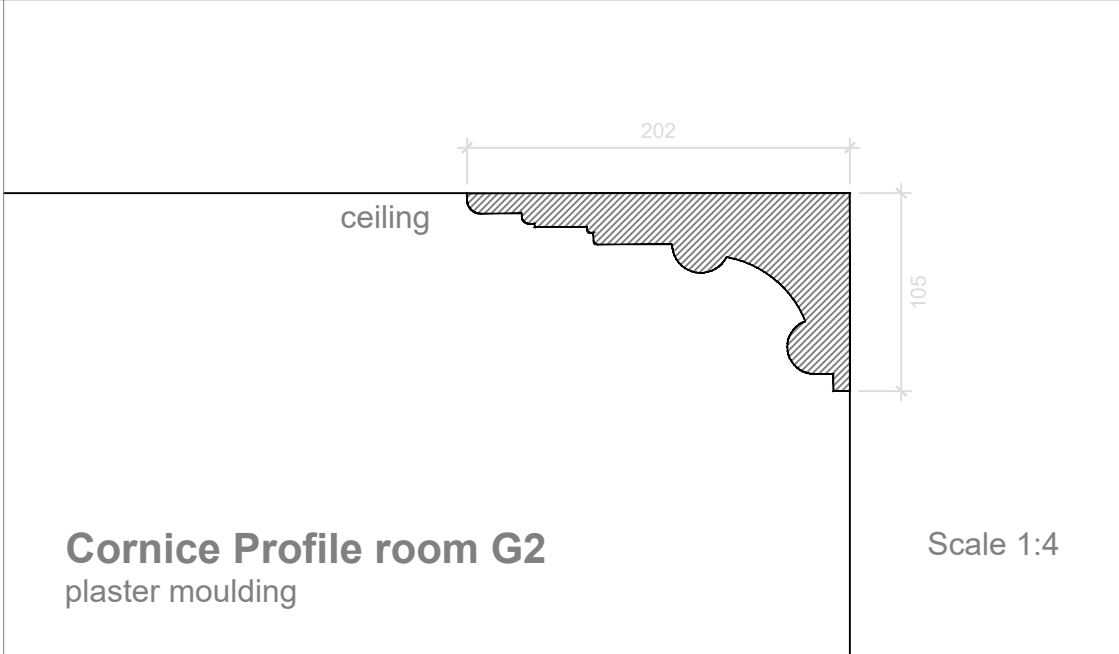
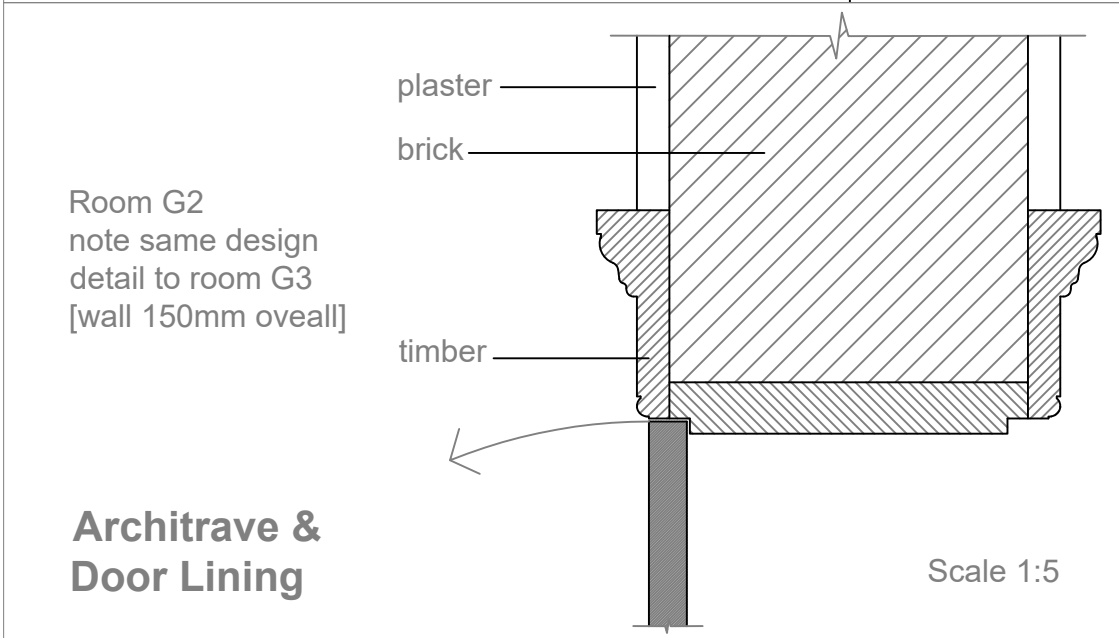
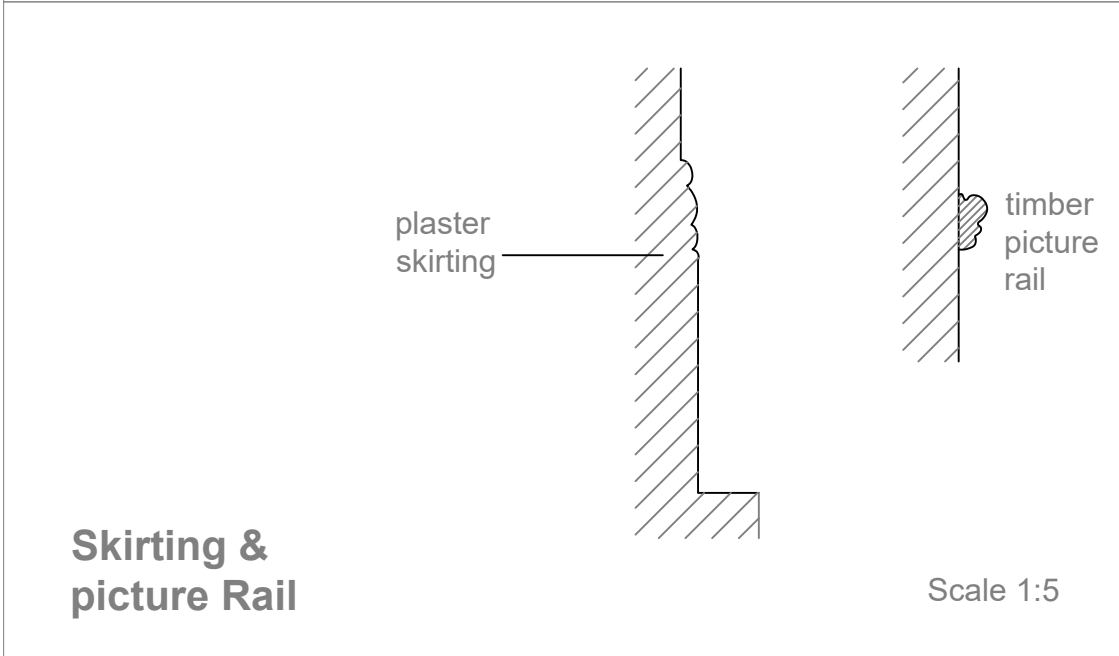
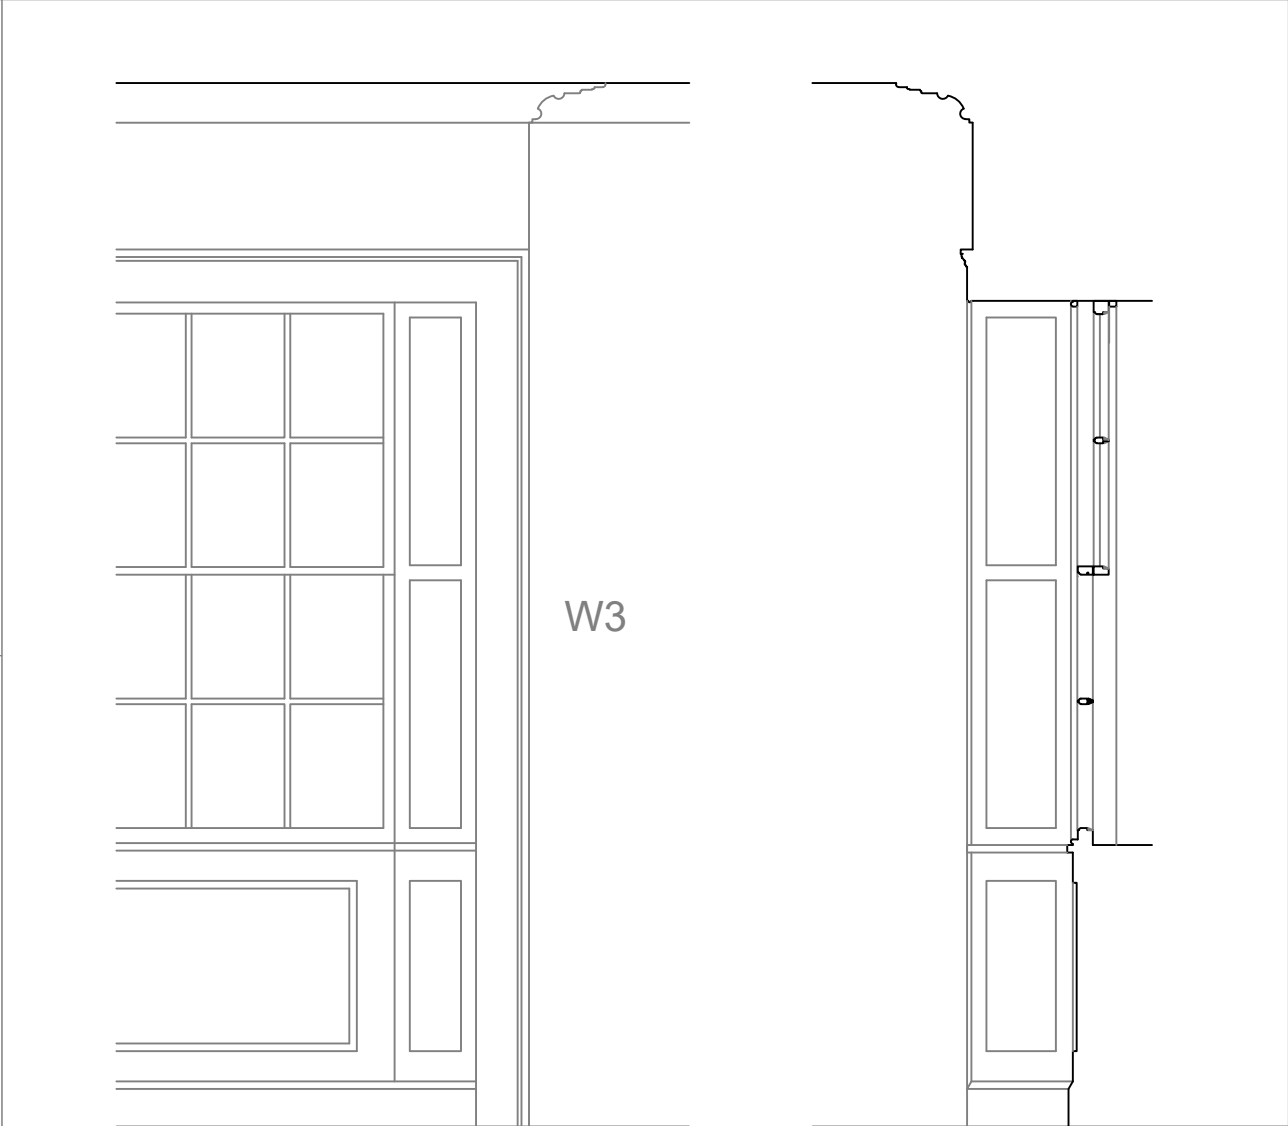
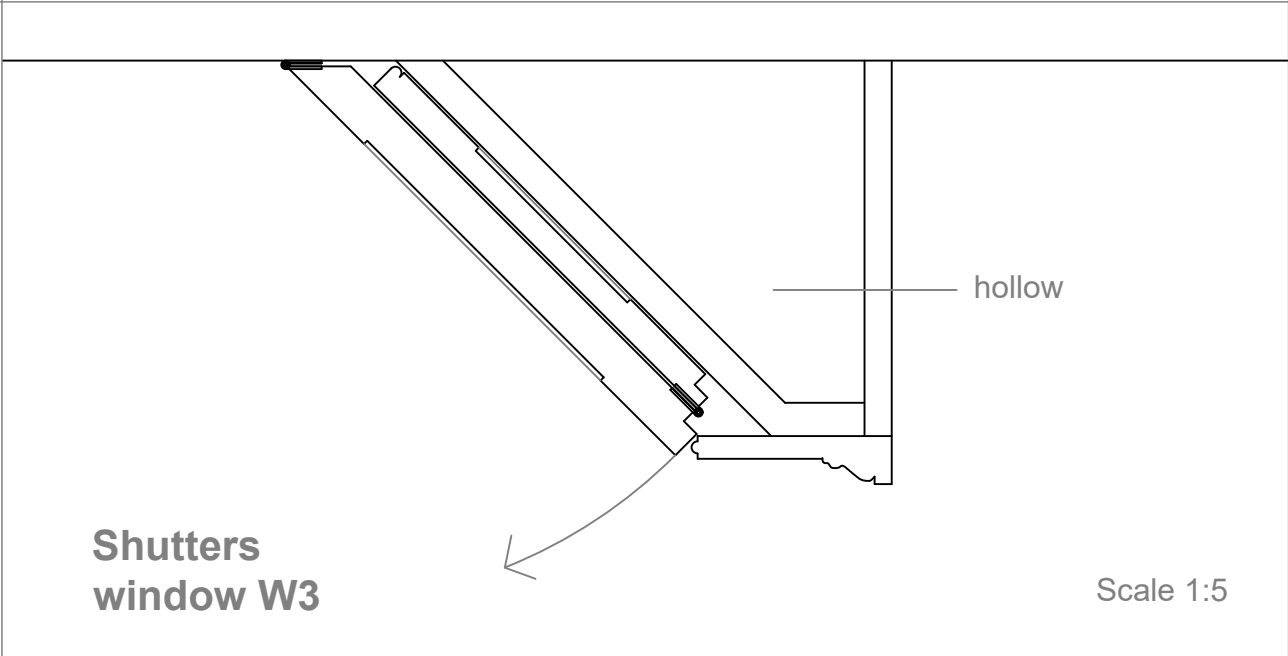
**Cornice  
Profile**

See Structural Engineer's  
[Mistry Design]  
Detail dwg 2505/06

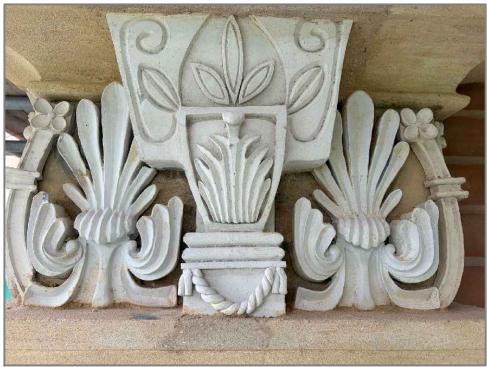
**Anthemion Image**

**M2** **Anthemion**  
Completely decayed. Clear loose render to establish secure base. Replace like-for-like in reconstituted stone to match neighbour [no 39NR] see PKS detail 15
