## SITE INVESTIGATION FACTUAL REPORT

Report No: 007770

Client: Sedgwick International UK

Site Address: 14a Sheldon Avenue, N6 4JT

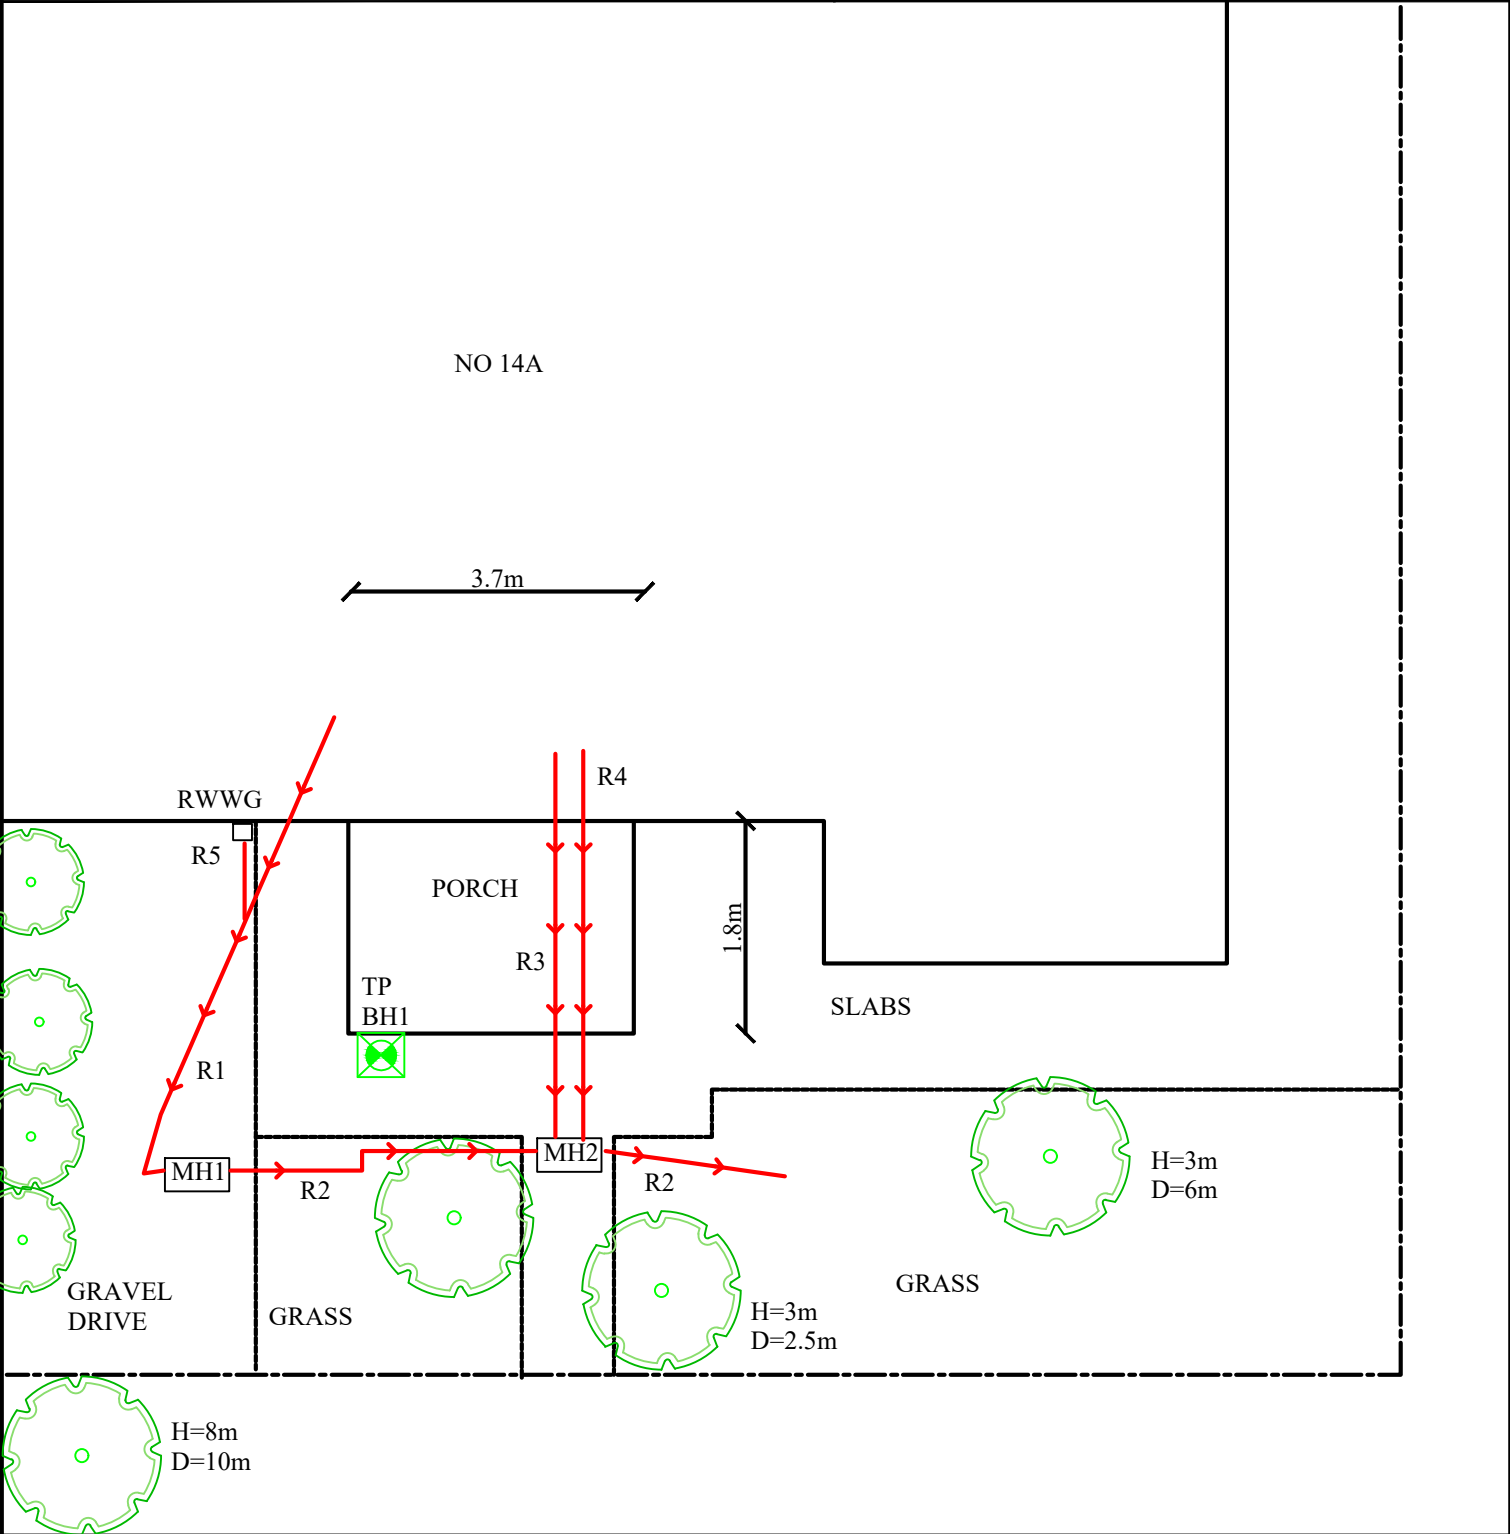
REPORT NUMBER: C5018022 / 389968.1.1.1  
TRIAL PIT REF: TP1  
CLIENT: Sedgwick International UK  
JOB NO: SI-007770  
EXCAVATION METHOD: Hand tools

For Strata below 1300mm see Bore Hole log
