# **PROTECTED TREE REPORT (TREE WORKS)**

| <b>Application number</b> | HGY/2026/1717 |
| <b>Site Address:</b> | 1A Dukes Avenue Hornsey London N10 2PS |

| <b>Tree Inspector</b> | DM | <b>Date:</b> 22 <sup>nd</sup> July 2026 |

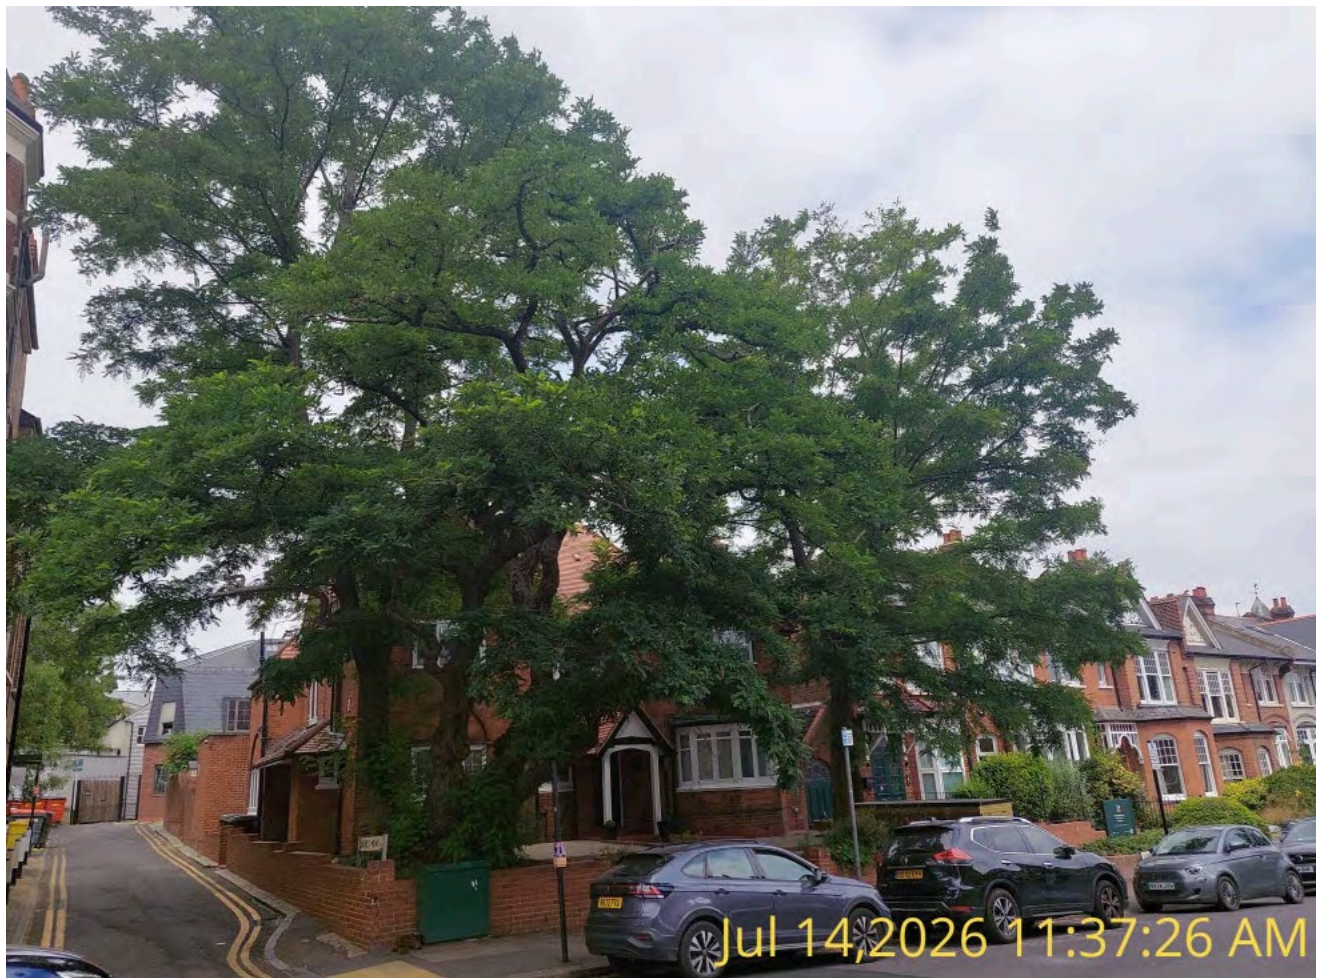
**T1 (right) & T2 (left)**

The acute lean is at a 45° angle with perpendicular corrective growth within the crown. There is no recent lifting of the root bole, but direct damage has been caused over time to the surrounding area on the tension north side of the trunk.

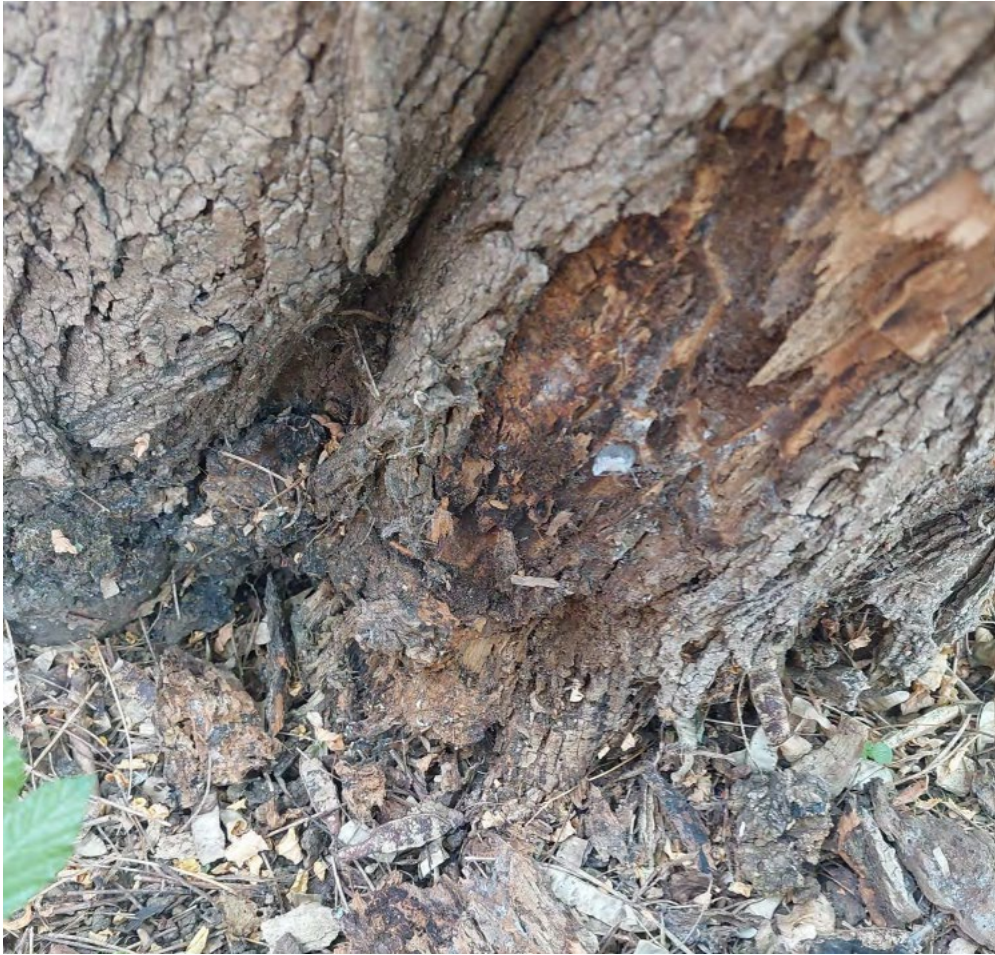
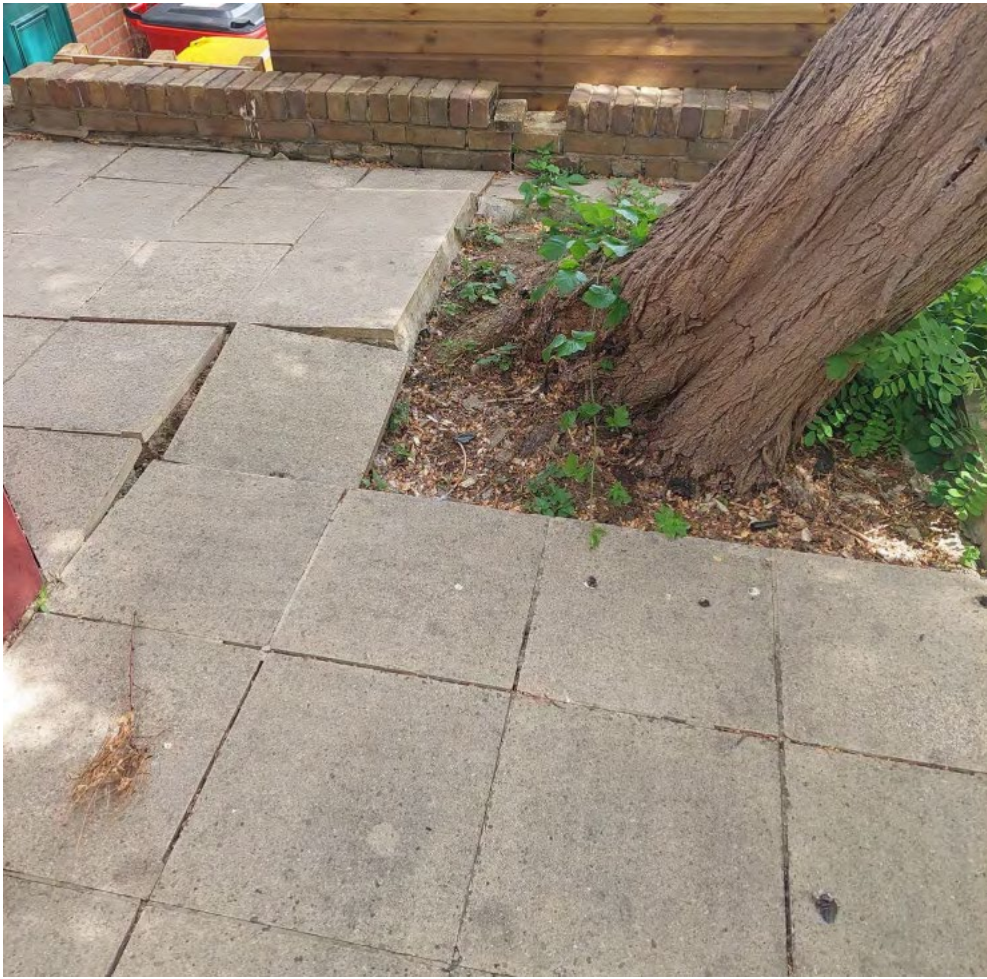
Old fungus fruiting bodies were found at the base of the tree which were hard to identify. However, I am certain the fungus was the *Inonotus hispidus* (white/ soft rot mode of decay). There is mycelium activity under the bark and dead cambium.

When probed with a 450mm probe, the decay was found to be extensive, with the probe lost within the trunk in all directions including down into the buttresses of the roots.

450mm Probe on south side of trunk and possible *Inonotus hispidus* fungus fruit
