# Assunnah Islamic Centre, Bruce Grove

## Structural Engineering Condition Report

19th Century Barn

April 2026

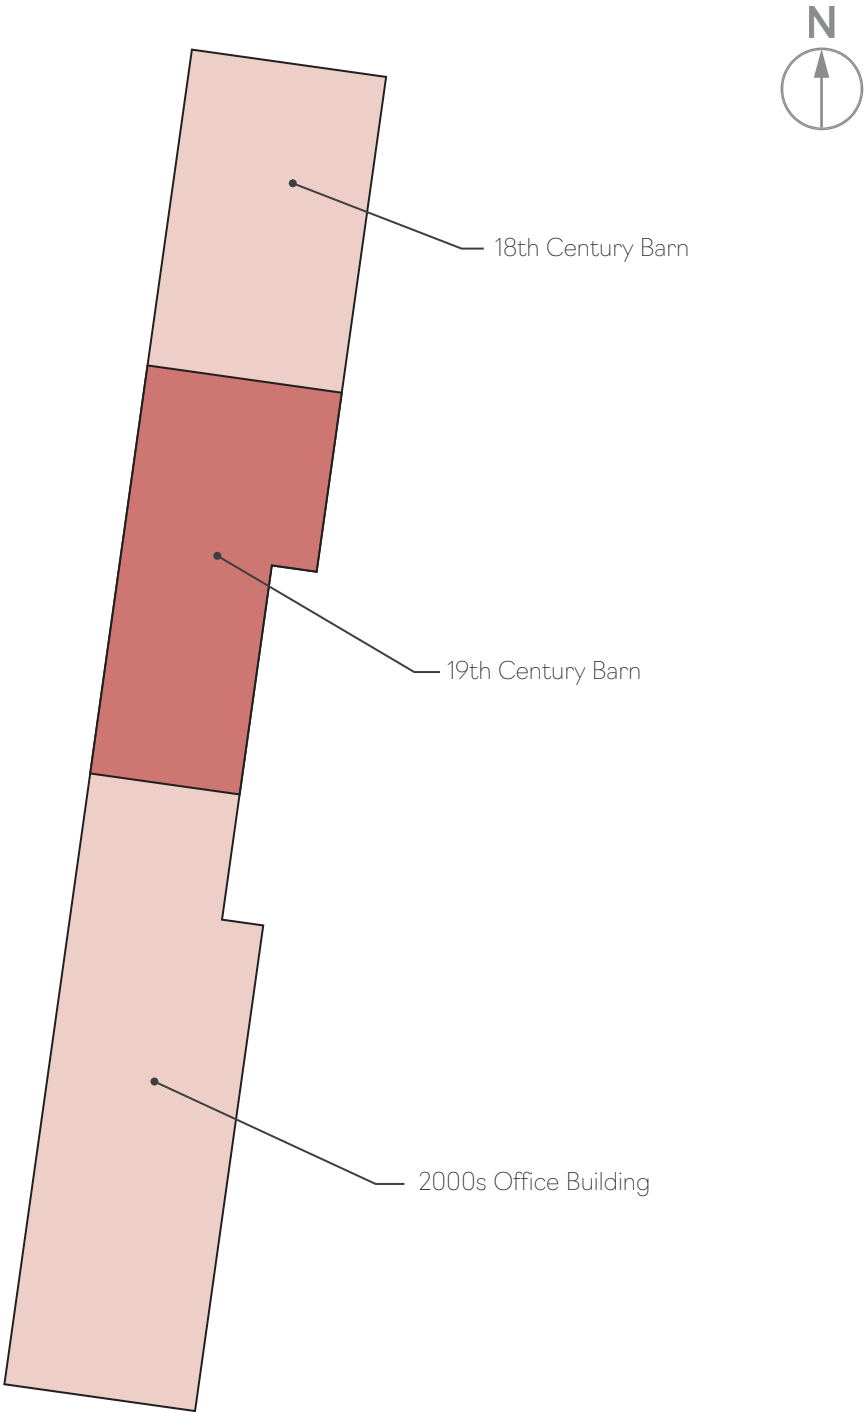
Figure 01 - Block Plan of Assunnah Islamic Centre

The 19th century portion is roughly L-shaped on plan and comprises two storeys above ground level. Refer to Figure 01 for a diagram of the Assunnah Islamic Centre buildings and the indicative extent of each phase.
