## ARBORICULTURAL REPORT

*Mechanical Decay Detection — Sonic Tomography & Resistograph Drilling  
Quantitative Tree Risk Assessment (QTRA) | BS 5837:2012*

### **108 CROUCH HILL**

| <b>Report Title</b> | <i>TCR/1107 — 108 Crouch Hill Mechanical Decay Detection Report<br/>2026</i> |

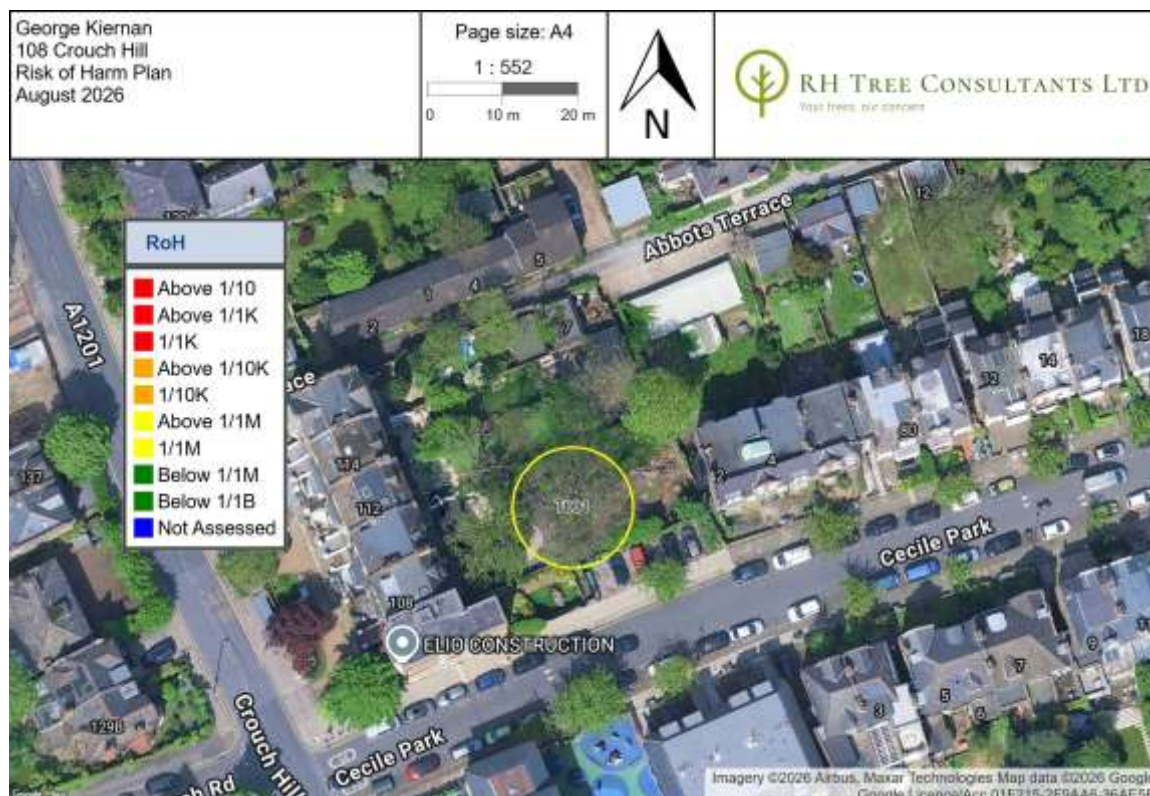
Figure 1: Site Location and Risk of Harm (RoH) Plan — 108 Crouch Hill. Scale 1:552 at A4. © 2026 Airbus, Maxar Technologies; Map data © 2026 Google.

While the calculated numeric RoH value of 1/30K sits within the 'Above 1/1M' banding shown on the Risk of Harm Plan at Figure 1 (a moderate QTRA band), it should be noted that QTRA calculates probability of harm over a standard one-year reference period and is not, of itself, designed to capture an actively and rapidly deteriorating condition of the kind identified in this report. In the surveyor's professional judgement, and consistent with BS 5837:2012 guidance that QTRA outputs should always be considered alongside professional judgement, the rate of decline evidenced by the crown dieback, the corroborating Resistograph data, and the known association with *Ganoderma* spp. and *Armillaria* together justify an urgent priority for management action, notwithstanding the calculated RoH banding. This is reflected in the recommendations at Section 4.

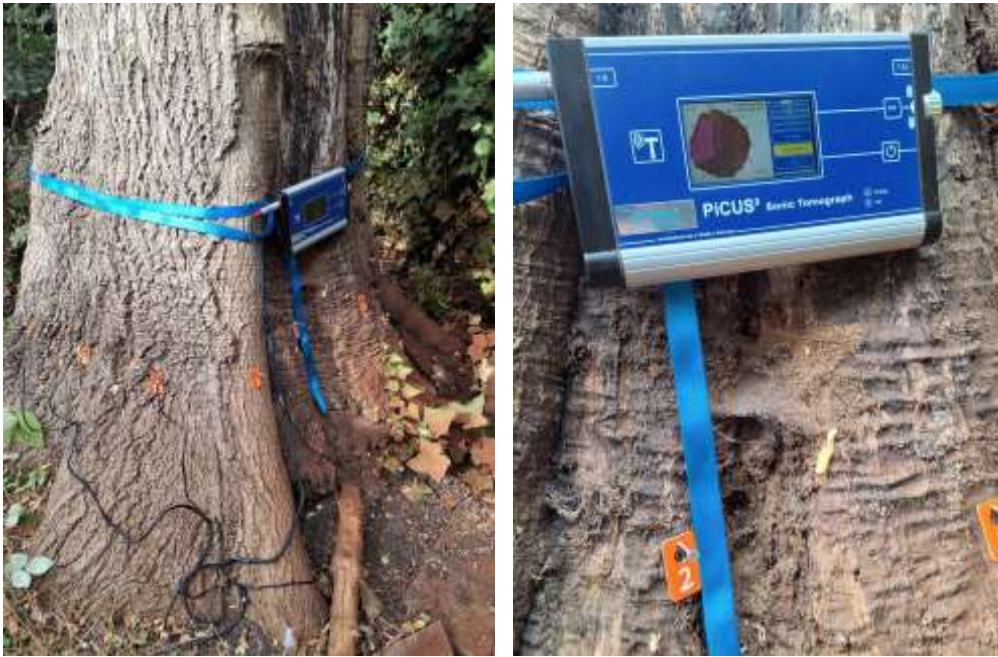
*Figure 6: PiCUS 3 sensor array installed on T001 prior to sonic tomography (left), and the PiCUS 3 display showing the tomogram being captured in real time on site (right), 16 August 2026. Numbered sensor pins correspond to the positions shown in Figure 5.*

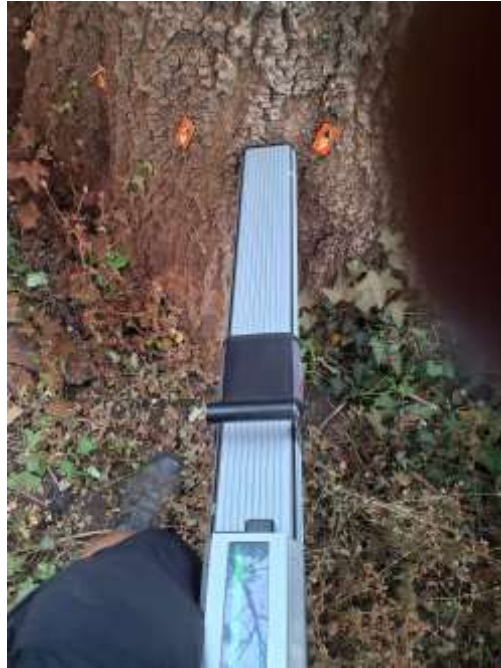
**MP1 — Stem, 0.5 m, SW aspect**

| Species | Location | Drilling depth | Assessment (bark to full depth) |
|---|---|---|---|
| Common ash | Stem, 0.5 m, SW aspect | 50.00 cm | 0.00–2.00 cm: Decay 2.00–6.50 cm: Reaction wood 6.50–50.00 cm: Decay |

*Figure 7: T001 Resistograph Trace — MP1 (Stem, 0.5 m, SW aspect). Data corroborates the tomography data, suggesting significant dysfunction in association with *Ganoderma* spp. This is the only measuring point at which the Resistograph and tomography data are in agreement.*

*Figure 8: Resistograph drilling in progress in the vicinity of sonic tomography sensor pins 5–9, adjacent to the MP1 test location. (16 August 2026).*

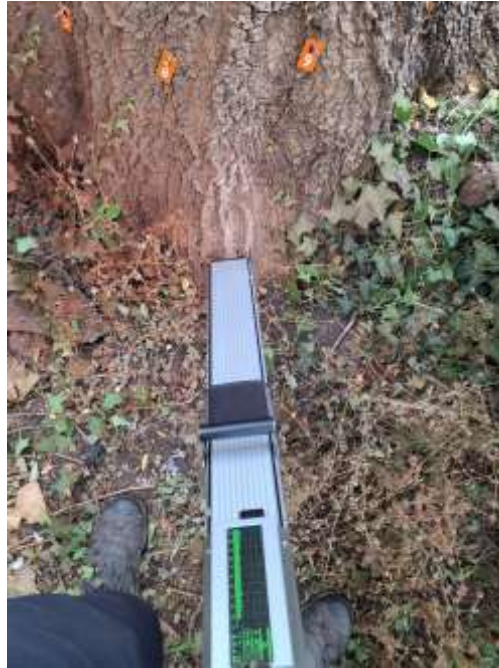
**MP2 — Root collar, 0.1 m, SE aspect (45°)**

| Species | Location | Drilling depth | Assessment (bark to full depth) |
|---|---|---|---|
| Common ash | Root collar, 0.1 m, SE aspect (45°) | 46.77 cm | 0.00–1.70 cm: Bark 1.70–15.00 cm: Sound wood 15.00–24.00 cm: Reaction wood 24.00–44.00 cm: Decay 44.00–44.50 cm: Needle exit |

Figure 9: T001 Resistograph Trace — MP2 (Root collar, 0.1 m, SE aspect (45°)). Reading suggests a historic association with decay at the root collar. The extent of decay recorded (a 20 cm zone from 24–44 cm depth) is greater than would be inferred from the tomography data alone.

*Figure 10: Resistograph drilling in progress in the vicinity of sonic tomography sensor pins 7–9, adjacent to the MP2/MP3 (SE aspect) test locations. (16 August 2026).*

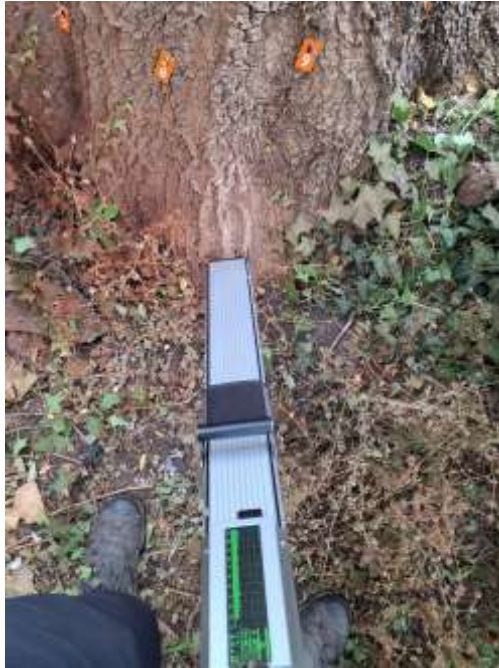
**MP3 — Stem, 0.5 m, SE aspect**

| Species | Location | Drilling depth | Assessment (bark to full depth) |
|---|---|---|---|
| Common ash | Stem, 0.5 m, SE aspect | 50.00 cm | 0.00–1.00 cm: Bark 1.00–12.00 cm: Sound wood 12.00–14.00 cm: Cavity 14.00–50.00 cm: Decay |

Figure 11: T001 Resistograph Trace — MP3 (Stem, 0.5 m, SE aspect). Reading suggests a higher level of dysfunction than indicated by the tomography, with a sound wood shell of only approximately 12 cm before a cavity and extensive decay are encountered.

*Figure 12: Resistograph drilling in progress in the vicinity of sonic tomography sensor pins 7–9, adjacent to the MP2/MP3 (SE aspect) test locations (same photograph as MP2, above). (16 August 2026).*

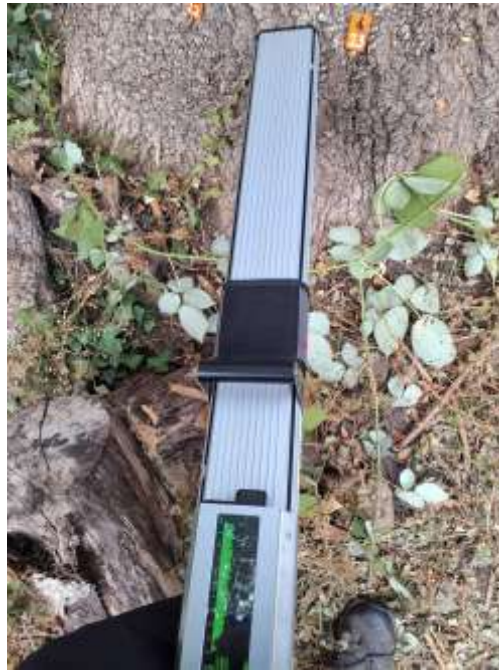
**MP4 — Stem, 0.5 m, NE aspect**

*Figure 13: T001 Resistograph Trace — MP4 (Stem, 0.5 m, NE aspect). Data suggests a higher level of dysfunction than shown by the tomography data at this location.*

*Figure 14: Resistograph drilling in progress in the vicinity of sonic tomography sensor pins 12–13, adjacent to the MP4 (NE aspect) test location. (16 August 2026).*

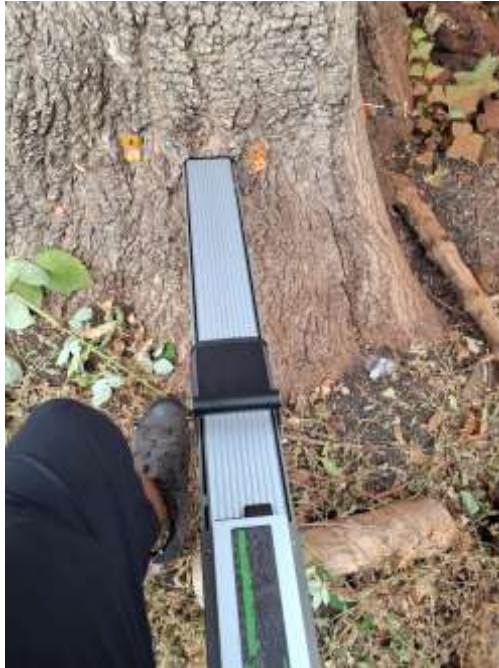
**MP5 — Stem, 0.5 m, NW aspect**

Figure 15: T001 Resistograph Trace — MP5 (Stem, 0.5 m, NW aspect). Data suggests significantly more advanced decay than shown in the tomography at this location — the NW aspect corresponds with the area of the crown that has died back.

*Figure 16: Resistograph drilling in progress in the vicinity of sonic tomography sensor pins 14–15, adjacent to the MP5 (NW aspect) test location. (16 August 2026).*

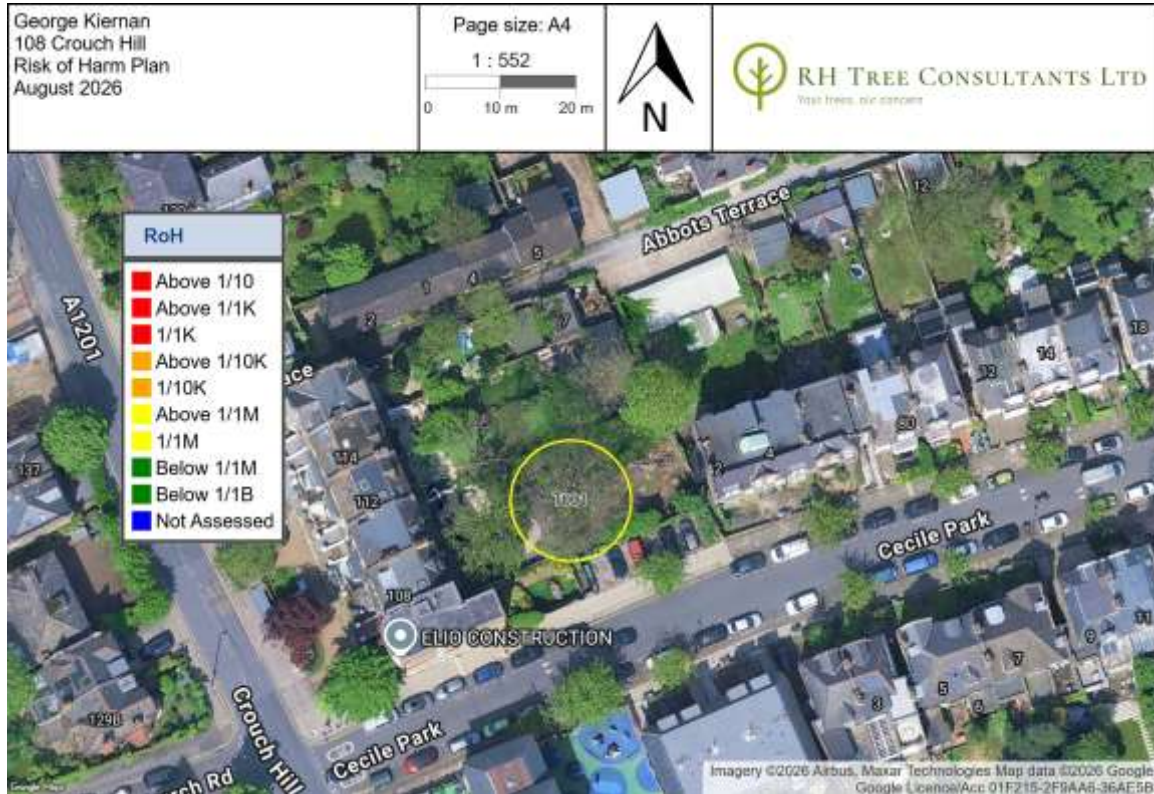
Figure 12: 108 Crouch Hill — Risk of Harm (RoH) Plan showing T001 position. Scale 1:552 at A4.
