# Arboricultural Consultancy for Lloyds Bank

| Insured | Ms Sarah Gibbs | Address | 29 Orchard Road, London, N6 5TR | | |
| ES Ref | SA-258021 | Consultant | Keith Burgess | Contact No. | 0330 380 1036 |
| Report Date | 09/02/2026 | | | | |

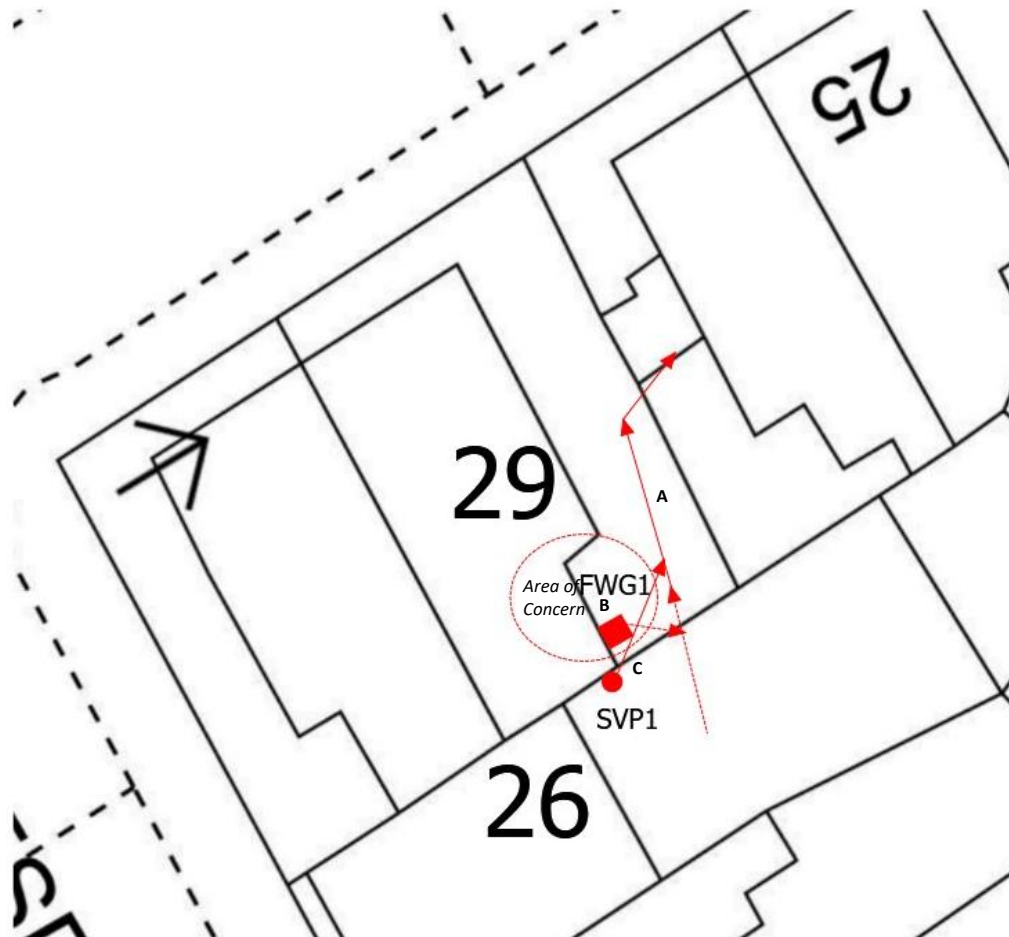
**CCTV Survey Result:** Structural damage. Drain is at depth of roughly 4m due to No29 rear garden being raised in comparison to neighbouring properties. Drain is assumed to be shared due to the depth and diameter.

**CCTV Survey Result:** Structural damage

No repairs have been recommended as the drain line is shared and is therefore a transferred asset. The responsibility and maintenance of this drain falls with the Local Water Authority.

To excavate and replace existing gully including 1m of adjacent pipework  
Carry out further CCTV survey and report findings  
Bed new pipe, compact, back fill and reinstate flag paving

Require permission to access No26 as the downpipe is located in the garden next door  
Cut a section of above ground pipework  
Prepare the drain and install 3x resin patch liners to seal defects  
Prepare the drain and install 1x radial resin patch liners to seal defects
