Structural Survey Report

# 182-184 St Ann's

CF2 Studio Project Reference  
0021

Issuing Date  
07/10/2026

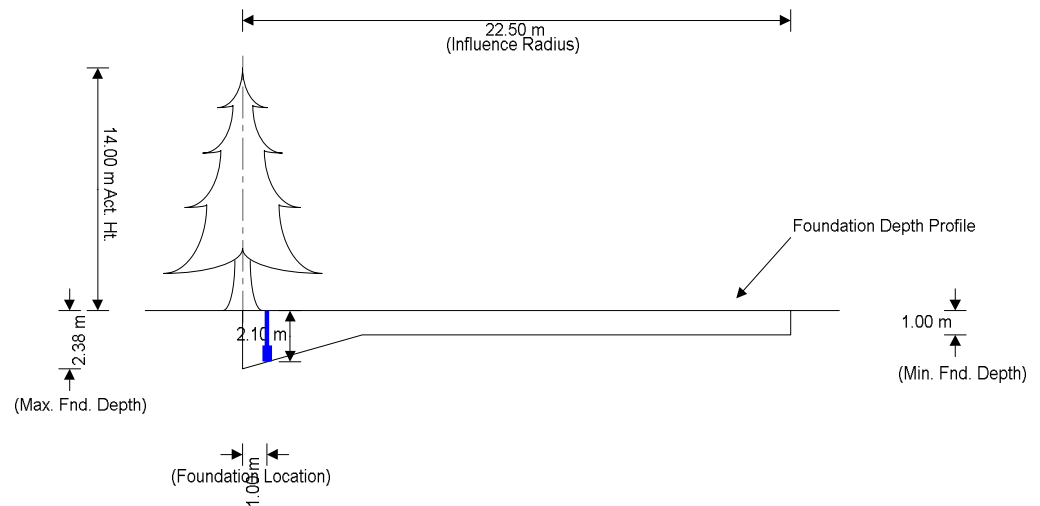
Species of tree; Redwood  
tree is to be removed from the site, and  $H_{act}$  is less than 50% of  $H_m$ , with no further planting allowed.  
Water demand of tree - Table 3; Moderate  
Mature height of tree - Table 3;  $H_{m1} = 30.00$  m  
Influence radius - Table 3b;  $r_{inf1} = 0.75 \times H_{m1} = 22.50$  m  
Measured height of tree;  $H_{act1} = 14.00$  m  
Distance from centre of tree to face of foundations;  $D_1 = 1.00$  m  
Effective height of tree - Table 3a;  $H_{eff1} = 14.00$  m

Minimum foundation depth - Table 4B;  $Z_{min} = 1.00$  m  
Look up value for foundation depth -; Chart 1 Soils with HIGH volume change potential;  
 $Z_{LookUp1} = 2.10$  m  
Required foundation depth;  $Z_{req1} = Z_{LookUp1} - Z_c = 2.10$  m

To avoid any movement in the existing building in the long term, we believe the best course of action would be to remove the existing tree and remediate the existing foundation to be in line with the requirements outlined above.
