**CCTV REPORT FOR: 8 HASLEMERE ROAD  
LONDON  
N8 9QX**

**Site Visit:** 28-Feb-25  
**Report Date:** 01-Apr-25

Address: **8 HASLEMERE ROAD, LONDON, N8 9QX**

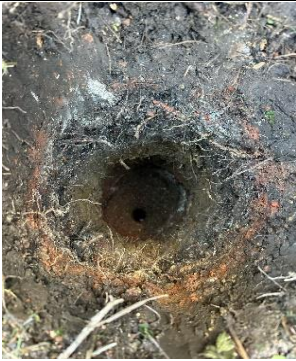
| Location: <b>Front Garden</b> | B/H No. <b>2</b> |

| <b><u>Borehole Only</u></b> | Roots Depth & Diameter:<br>From 0.85m<br>Down to 1.5m<br>up to 1mm diameter<br><br>Water Depth Hit & Rise:<br>Hit at 3.0m<br><br>Reason for Termination:<br>Hole at instructed depth |
