**ADDENDUM TECHNICAL REPORT**  
Retained

| OUR REFERENCE NO: | 72230964 |

| POLICYHOLDER DETAILS | |
|---|---|
| Supposed cause: | Subsidence |

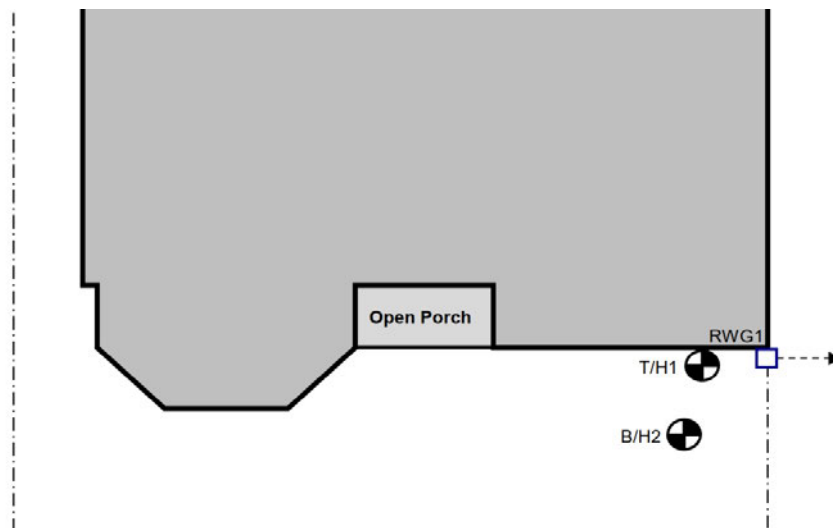
Drainage Repair Company (DRC) were commissioned to carry out the site investigation which took place 16/10/2024.

They were asked to carry out a trial pit and borehole to the front bay window, close to the area of concern and also the Third-Party vegetation located to the right of the property at number 10 Haslemere Road, which may be implicated in the ground movement.

DRC successfully exposed the foundations and performed the bore hole as requested. At 0.7 m down, they came to a hard stop due to the cellar structure beneath the property.
