**Structural Appraisal Report for****Ivy House, 128 Highgate Hill, London N6 5HD**

Ref: 231165/H Hawker

23 Nov 2023

Version 1

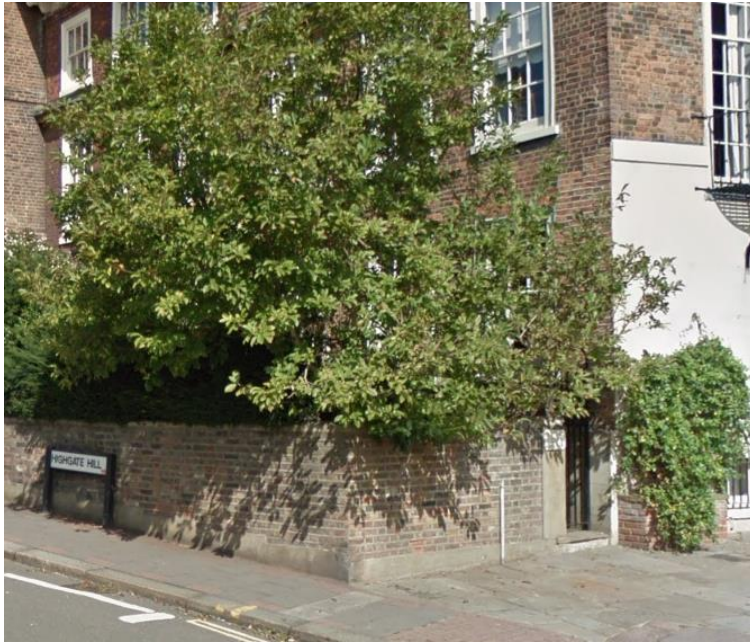
1 Google maps August 2017

- 4.1 There is a mature magnolia tree just inside the return of the wall, planted in the retained soil. It has a thick multi-stemmed trunk, which is within 100mm of the wall. It is clear looking at historic images available on google-maps street that the tree has matured considerably over the past few years, and rather than gaining height has been gained girth, with branches over hanging the wall increasing in size.

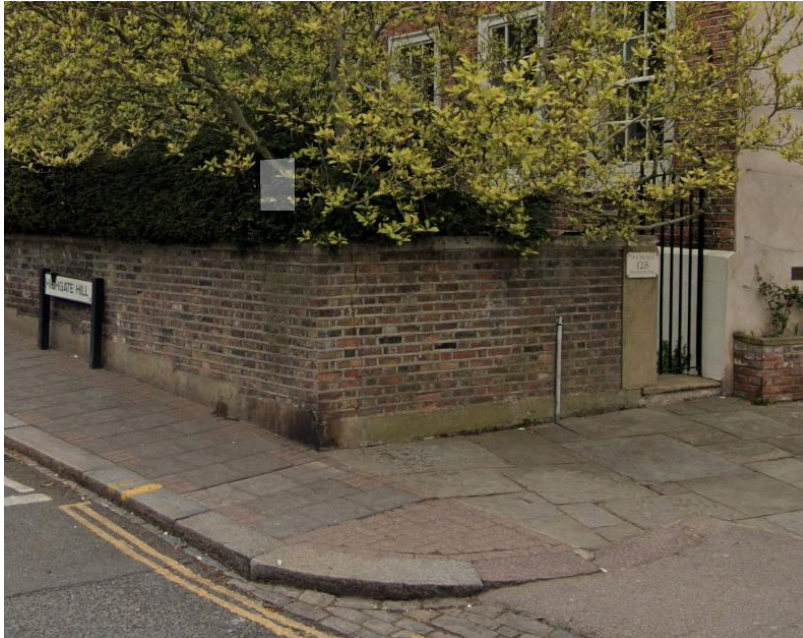
3 Google maps April 2021

- 3.1 There is a vertical crack to the return of the wall, 10mm wide at the top and 4mm close to the bottom.

- 4.2 On google maps street view, the crack can first be clearly identified in 2019, and in many of the images a darker patch is visible on the base of the wall on the return on Highgate Hill side, this is most likely damp penetrating the wall from the retained soil.
