# Basement Impact Assessment

**69 Grove Avenue, N10 2AL**

**8 December 2023**

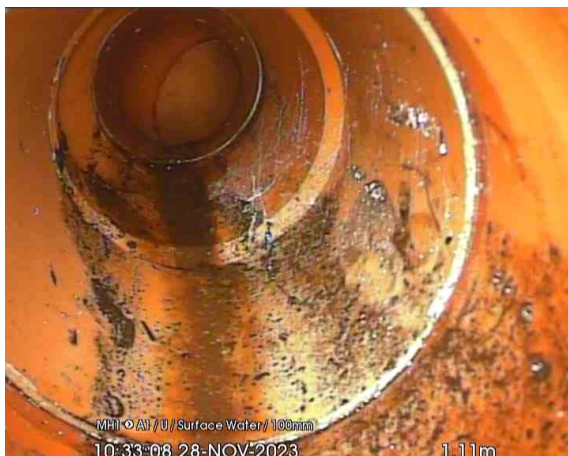
| Comments: | Displaced and open joint at 0.87m might cause leakage | | | | |

1-1-6A, 00:00:17, 0.87 m  
Open joint, medium

| Recommendations: | CIPP patch line open joint | | | | |

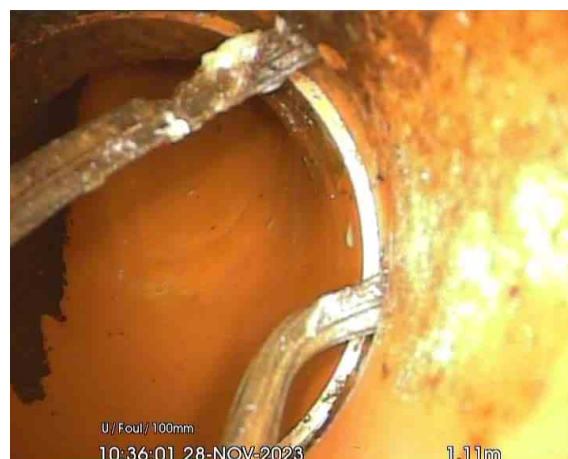
2-1-8A, 00:00:39, 1.11 m  
Sealing ring intruding from 12 o'clock to 12 o'clock

| Recommendations: | Possible renew rest bend, but line appears to be unaffected by protruding seals at rest bend | | | | |

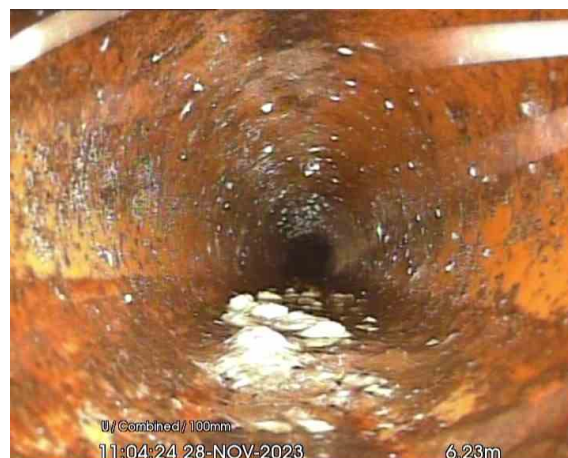
4-1-8A, 00:01:13, 6.23 m  
Settled deposits, other, 10% cross-sectional area loss, start, Debris/waste

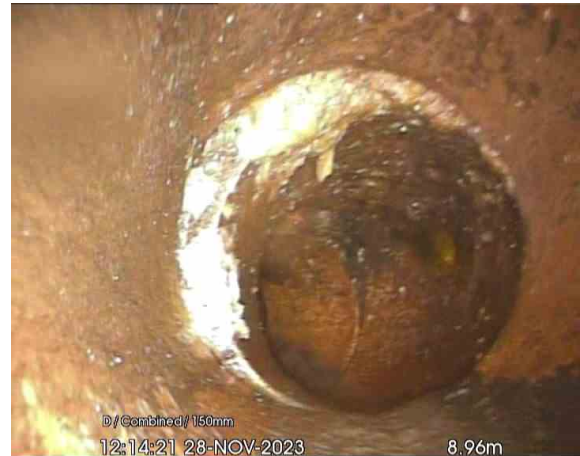
6-1-11A, 00:00:52, 8.96 m  
Joint displaced, medium

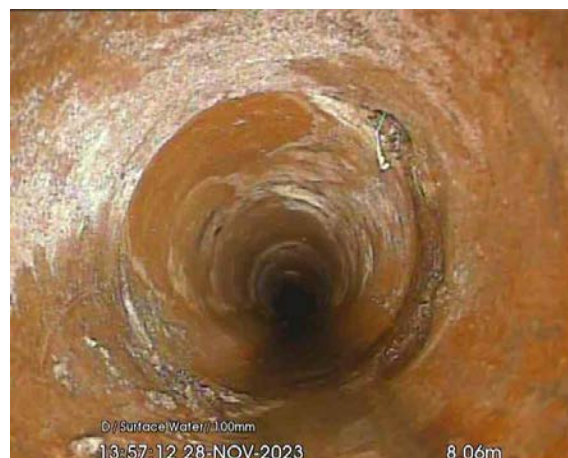
7-1-8A, 00:01:33, 8.06 m  
Joint displaced, medium

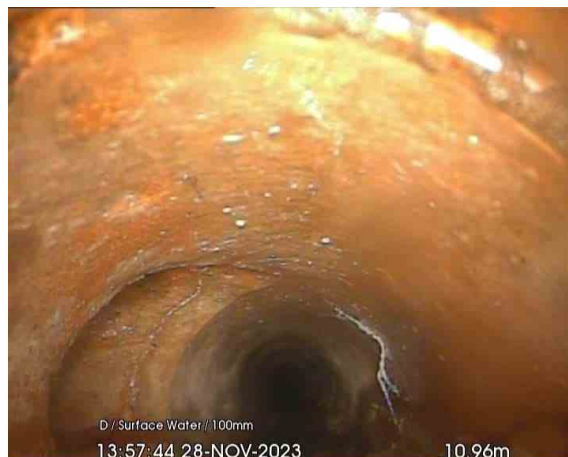
7-1-11A, 00:02:04, 10.96 m  
Junction at 10 o'clock, 100mm dia, F - not sourced/possible from No.71

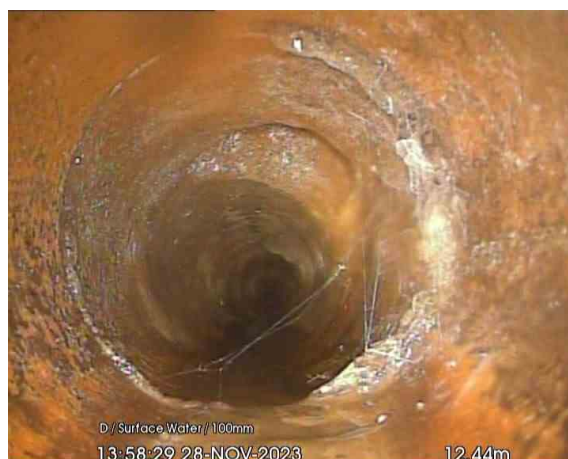
7-1-14A, 00:02:36, 12.44 m  
Attached deposits, other at joint from 12 o'clock to 6 o'clock, 5% cross-sectional area loss, Jointing intrusions

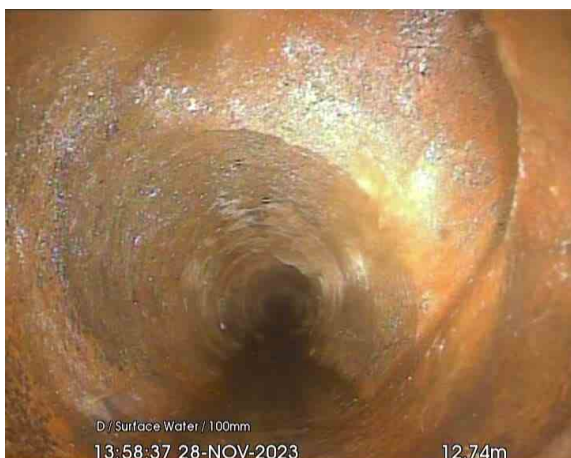
7-1-15A, 00:02:45, 12.74 m  
Junction at 1 o'clock, 100mm dia, G - not sourced / assumed original RWG2 junction

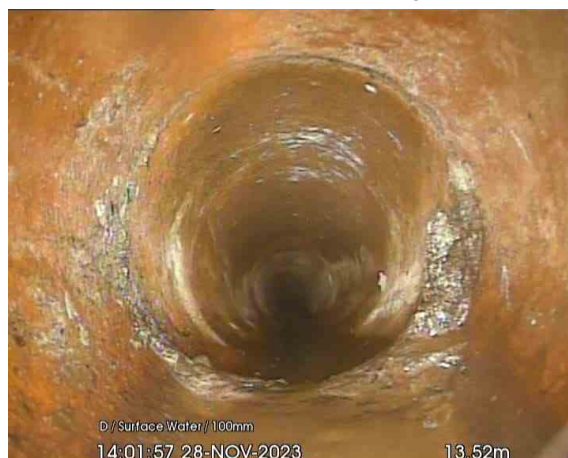
7-1-16A, 00:02:57, 13.52 m  
Attached deposits, other at joint from 3 o'clock to 8 o'clock, 10% cross-sectional area loss, Jointing intrusions

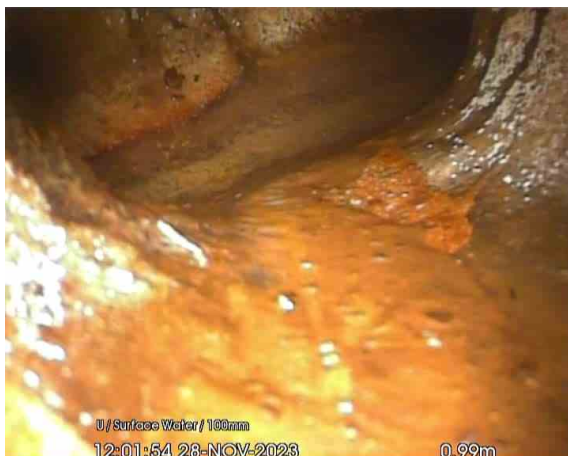
8-1-5A, 00:00:17, 0.99 m  
General remark, At junction to line from SWG1 downstream  
(point A1)

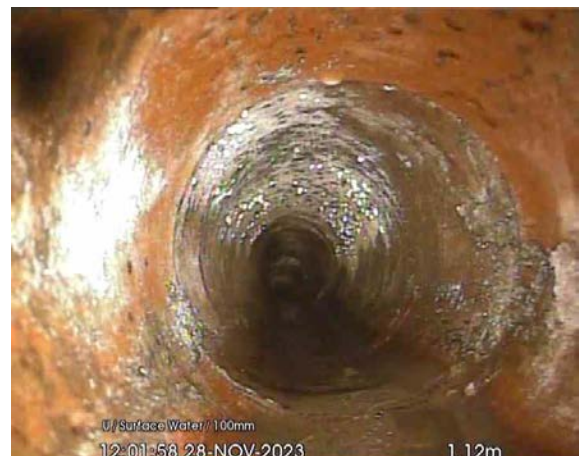
8-1-7A, 00:00:21, 1.12 m  
General remark, Camera enters line from SWG1 downstream

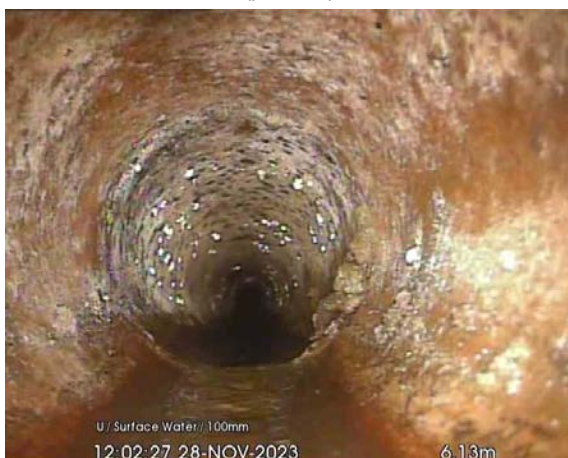
8-1-8A, 00:00:49, 6.13 m  
Attached deposits, other at joint from 3 o'clock to 5 o'clock,  
10% cross-sectional area loss, Jointing intrusions/scale

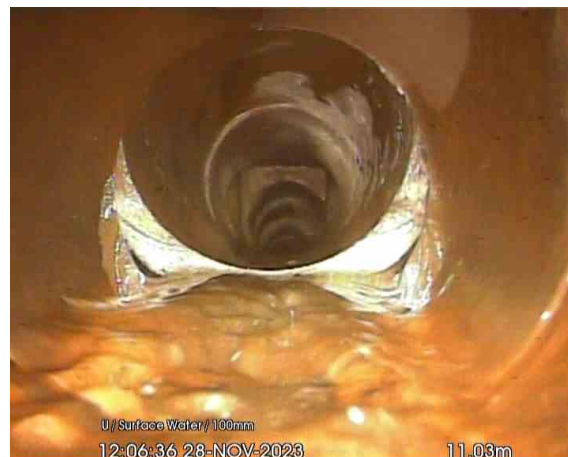
8-1-15A, 00:01:46, 11.03 m  
Joint displaced, large

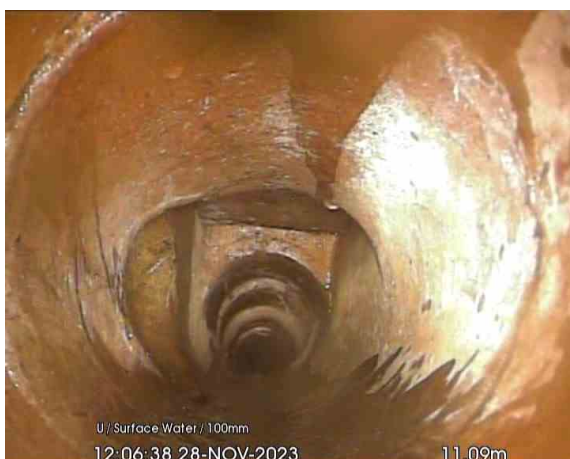
8-1-17A, 00:01:48, 11.09 m  
General remark, Approaching entry into manhole MH2

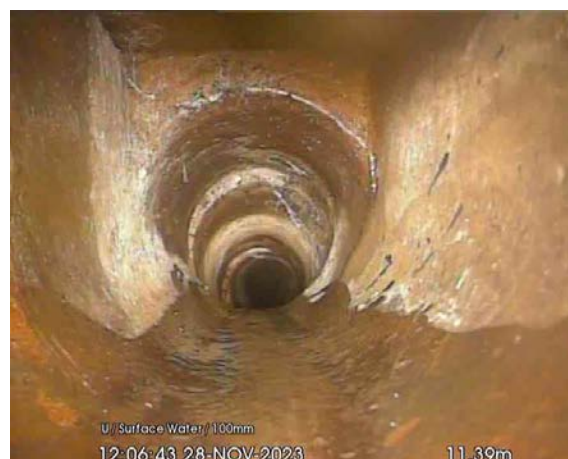
8-1-19A, 00:01:53, 11.39 m  
General remark, At access point in MH2 benching

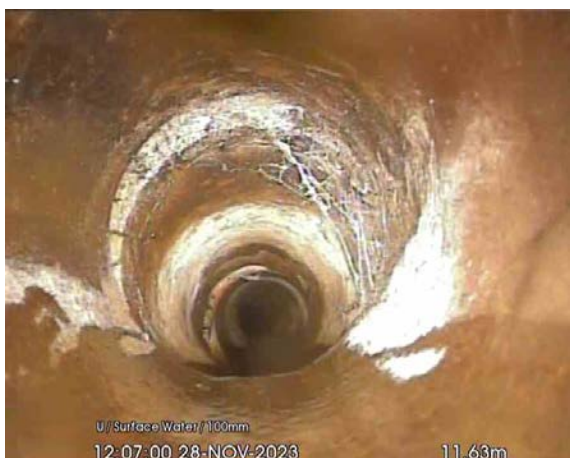
8-1-22A, 00:02:00, 11.63 m  
Joint displaced, medium

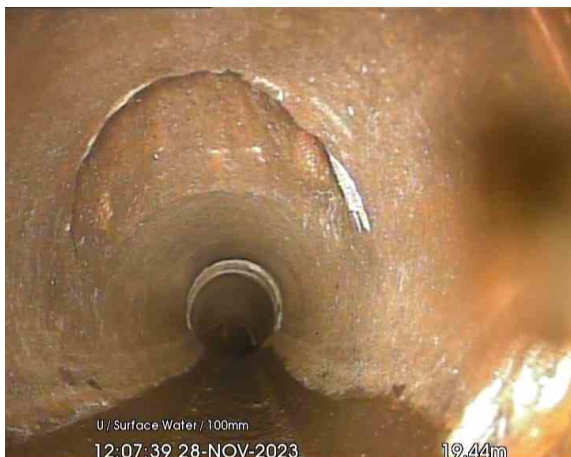
8-1-25A, 00:02:39, 19.44 m  
Junction at 11 o'clock, 100mm dia, H - not sourced / assumed lamphole

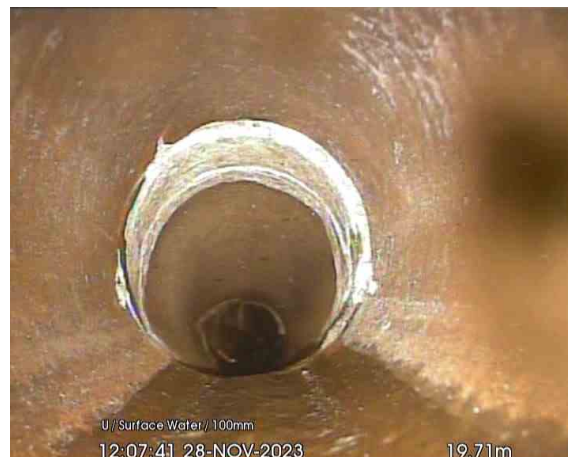
8-1-26A, 00:02:41, 19.71 m  
Joint displaced, medium

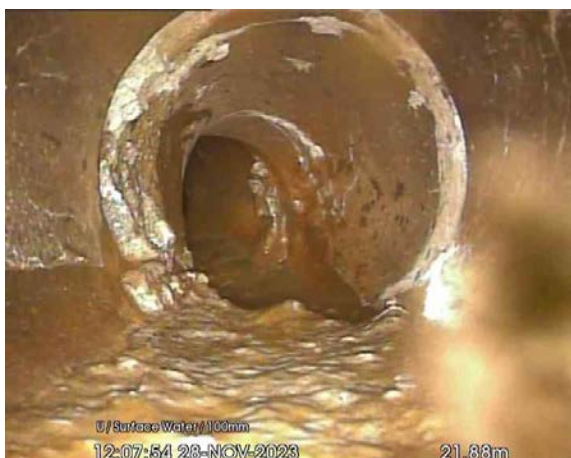
8-1-32A, 00:02:54, 21.88 m  
Attached deposits, encrustation at joint from 12 o'clock to 12 o'clock, 10% cross-sectional area loss, Jointing

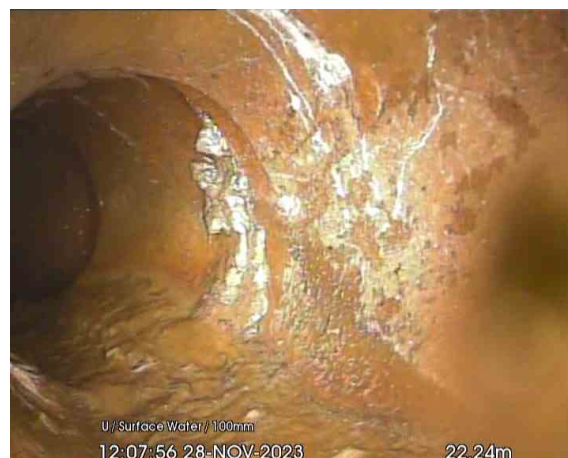
8-1-34A, 00:02:56, 22.24 m  
General remark, Approaching junction to Main SW Sewer in Grove Avenue
