# GEOSHIELD Verification Report

PROJECT REFERENCE: GEO102491

REPORT NUMBER: 006

PROJECT: Blocks D3 & D4. Clarendon Road.

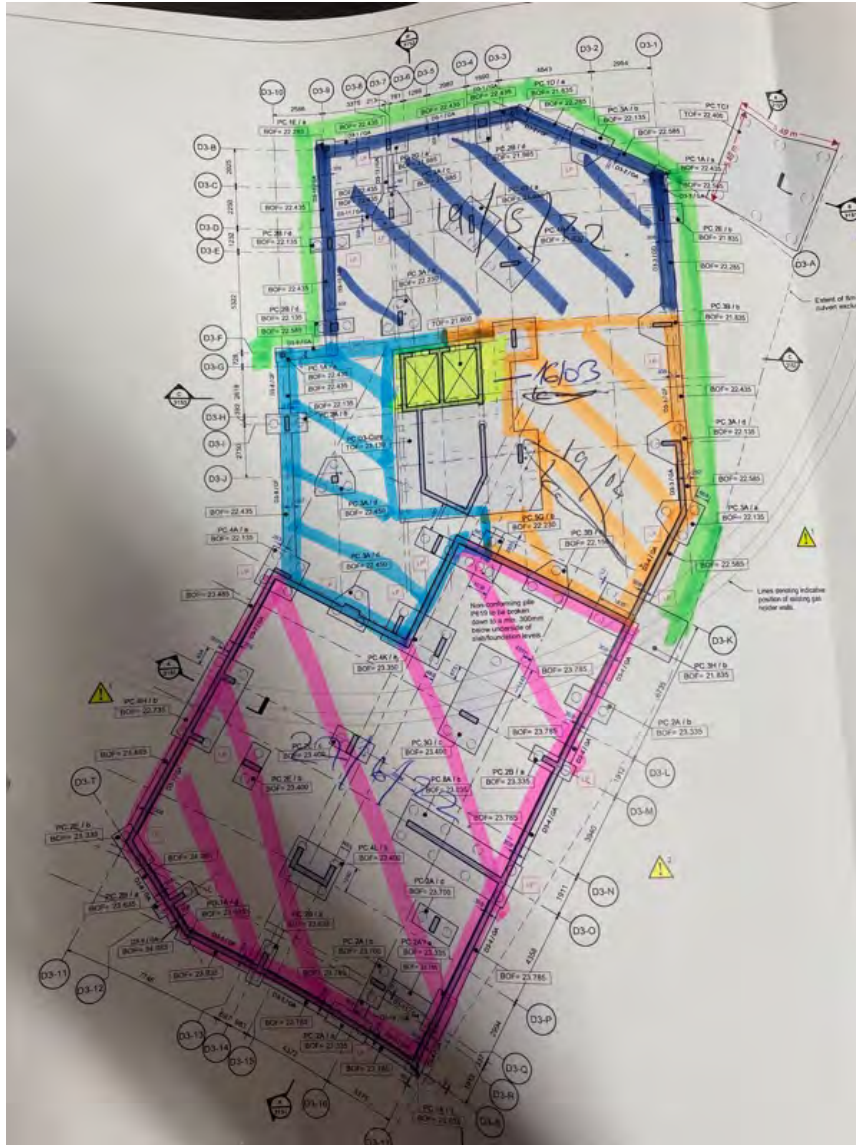
## VERIFICATION LAYOUT

The above photograph displays a layout plan of block D3.

The area highlighted pink&green above is where verification took place in this visit.
