# Site Investigation Report

144332.1.USI

Auger were commissioned by Crawford & Co to undertake a site investigation and CCTV inspection of the underground drainage within the area of concern (AOC) at the property.

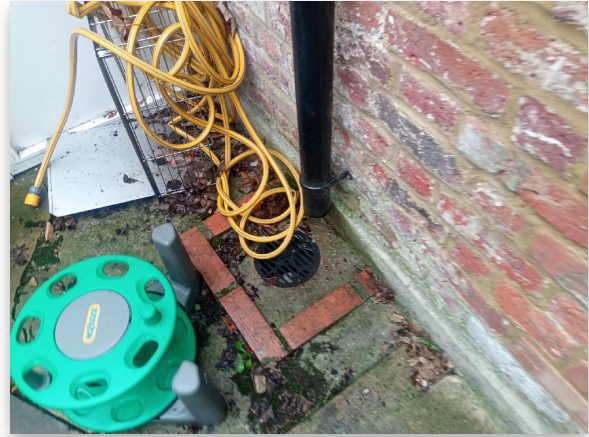
Fig 4.2: RWG

There is a cracked above ground pipe that is expelling into the WG. This is leading to an escape of water down the side of the property wall. We would recommend that a plumber is appointed to resolve this issue. These works will need to be carried out on a private basis

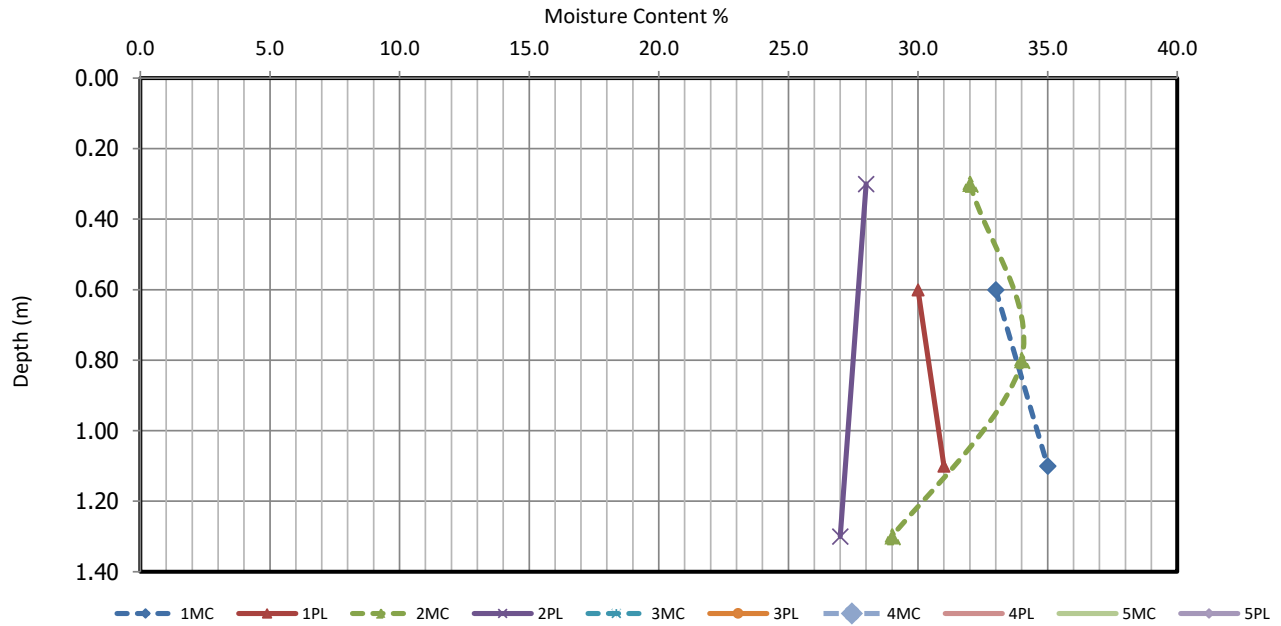
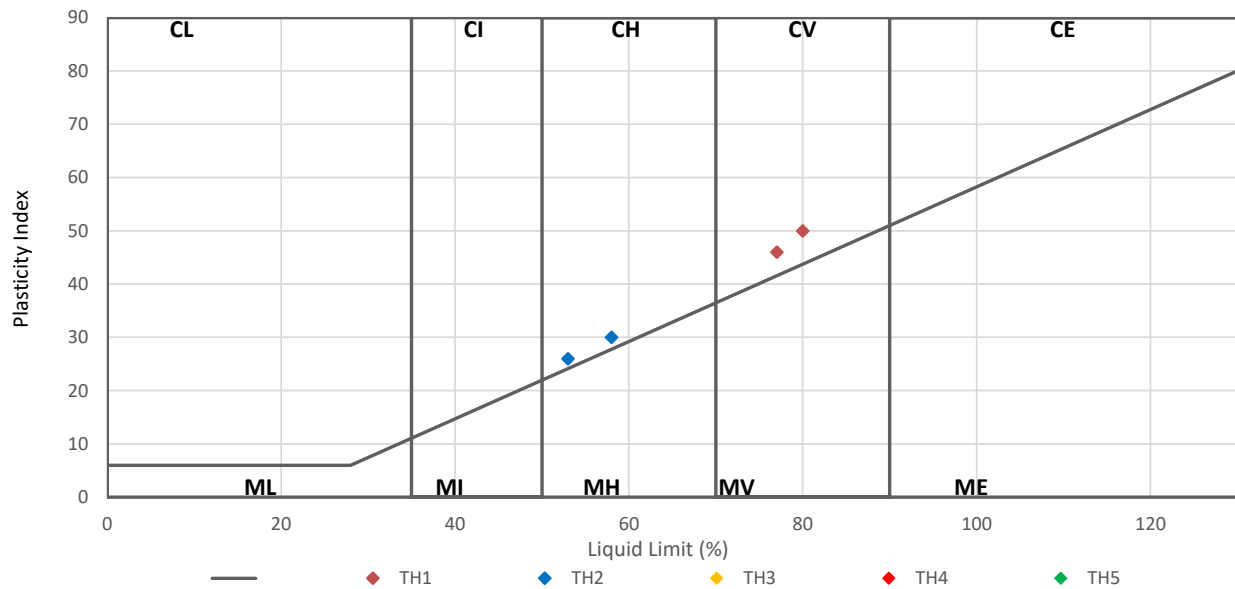
PLASTICITY CHART FOR CASAGRANDE CLASSIFICATION  
BS 5930:1999+A2:2010

Modified Plasticity Index (PI) <10 : Non Classified  
 Modified PI = 10 to <20 : Low volume change potential (LOW VCP)  
 Modified PI = 20 to <40 : Medium volume change potential (Med VCP)  
 Modified PI = 40 or greater : High volume change potential (HIGH VCP)
