# Site Investigation Report

144332.1.USI

Auger were commissioned by Crawford & Co to undertake a site investigation and CCTV inspection of the underground drainage within the area of concern (AOC) at the property.

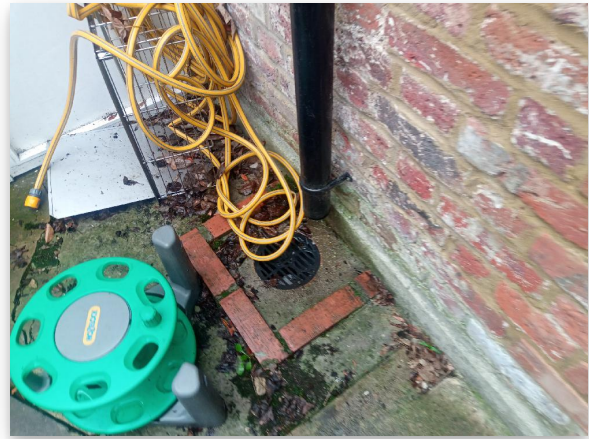
Fig 4.2: RWG

There is a cracked above ground pipe that is expelling into the WG. This is leading to an escape of water down the side of the property wall. We would recommend that a plumber is appointed to resolve this issue. These works will need to be carried out on a private basis
