Section Pictures - 17/10/2023 - RE

TSA-23-2537 Channing School for Girls CCTV Report\_303\_Issue01

Section Inspection - 17/10/2023 - MH21 X

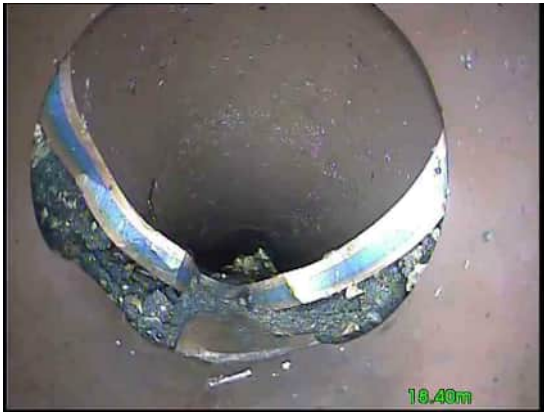
6, 00:01:09, 18.40 m  
Joint displaced, large

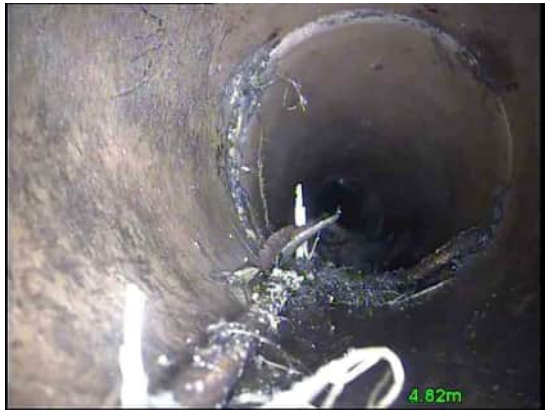
7, 00:00:45, 4.82 m  
Roots, tap at joint

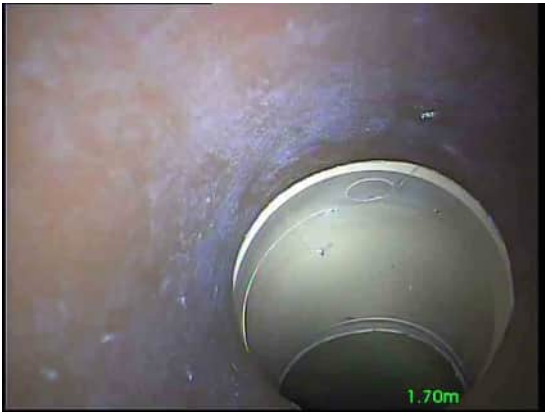
2, 00:00:11, 1.70 m  
General remark, Sewer levels out at this point

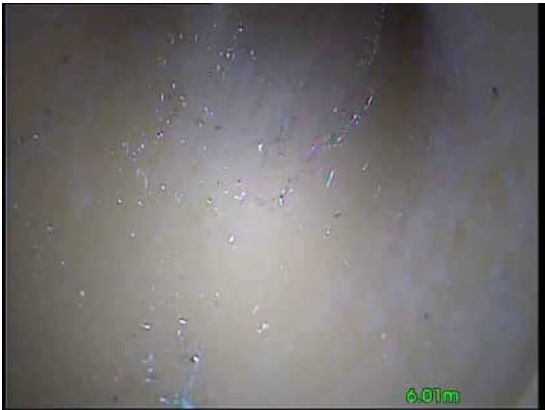
4, 00:00:26, 6.01 m  
Line deviates up

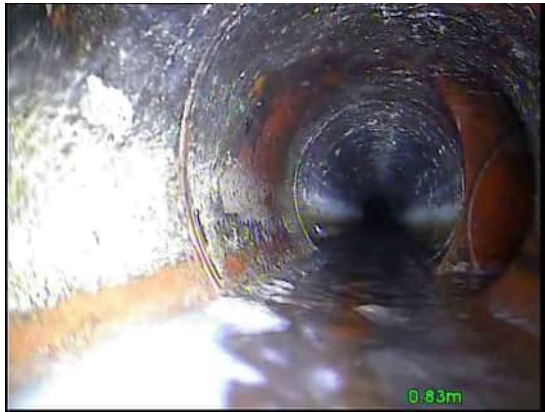
1, 00:00:10, 0.83 m  
Junction at 3 o'clock, 100mm dia

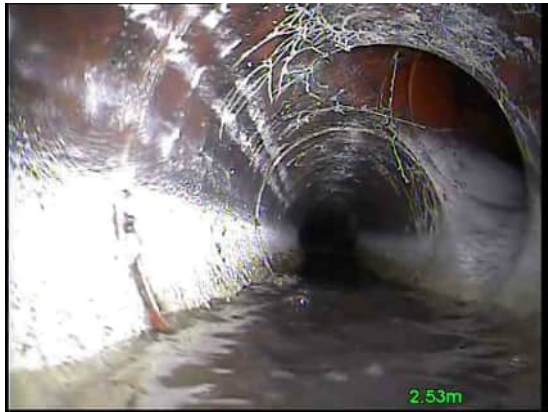
2, 00:00:17, 2.53 m  
Junction at 2 o'clock, 100mm dia

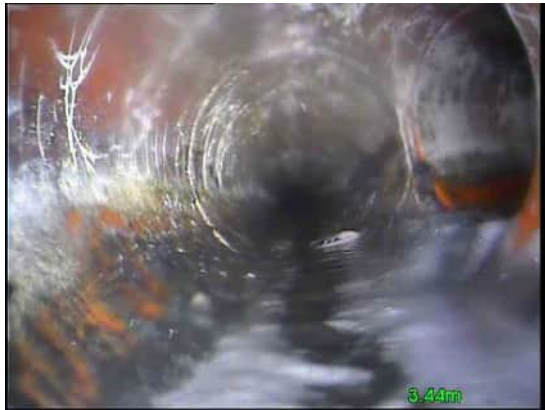
3, 00:01:53, 3.44 m  
Junction at 3 o'clock, 100mm dia

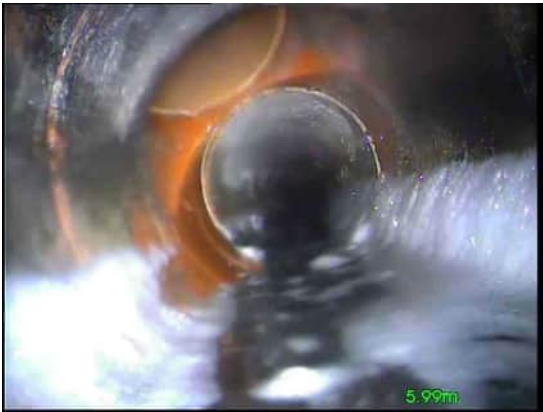
5, 00:01:37, 5.99 m  
Junction at 10 o'clock, 100mm dia

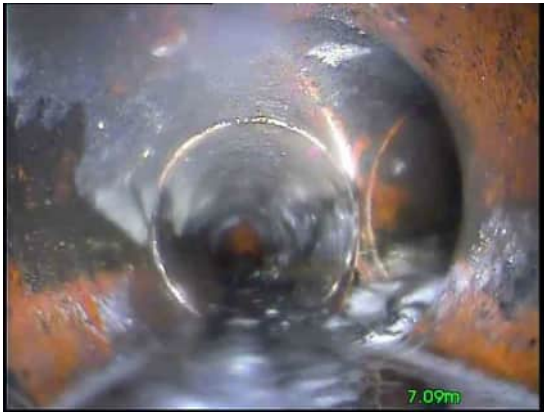
6, 00:01:31, 7.09 m  
Junction at 9 o'clock, 100mm dia

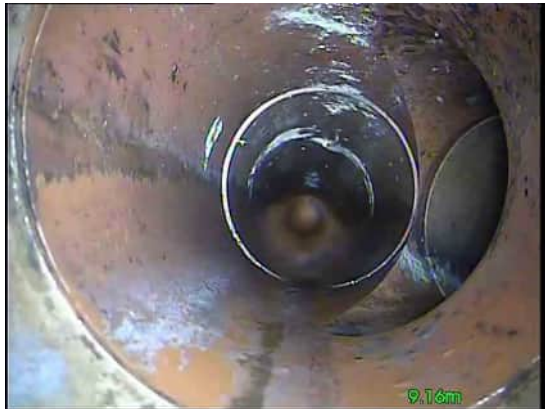
5, 00:00:41, 9.16 m  
Junction at 3 o'clock, 100mm dia

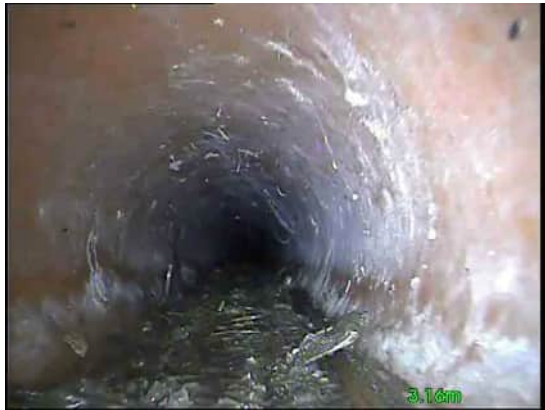
3, 00:00:14, 3.16 m  
Settled deposits, coarse, 10% cross-sectional area loss, start

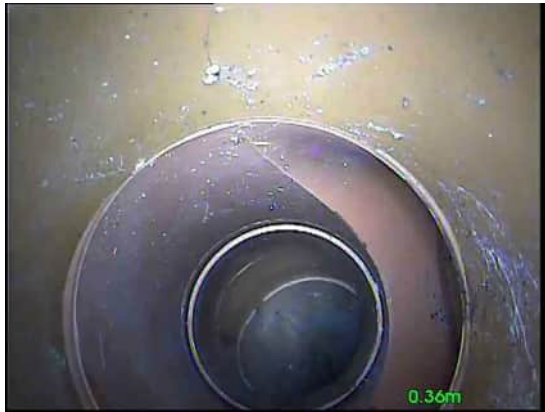
1, 00:00:09, 0.36 m  
Junction at 3 o'clock, 100mm dia

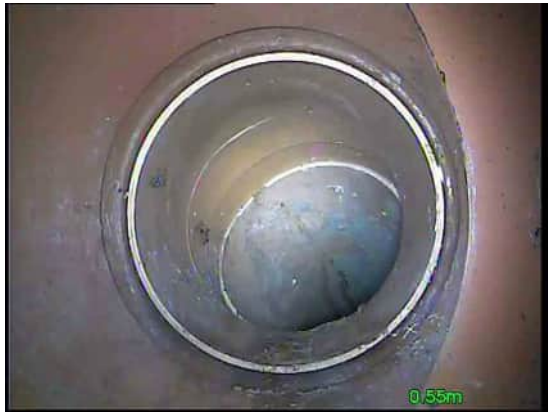
2, 00:00:11, 0.55 m  
Line deviates up

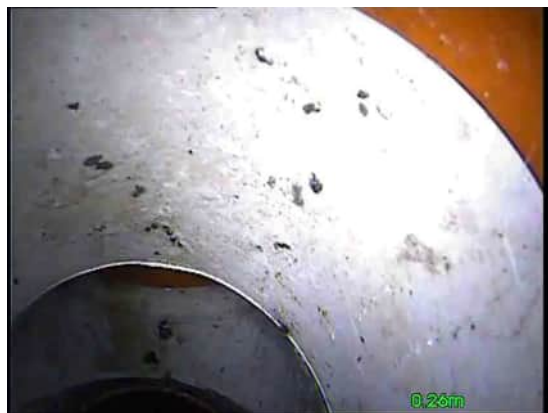
2, 00:00:05, 0.26 m  
Junction at 12 o'clock, 100mm dia

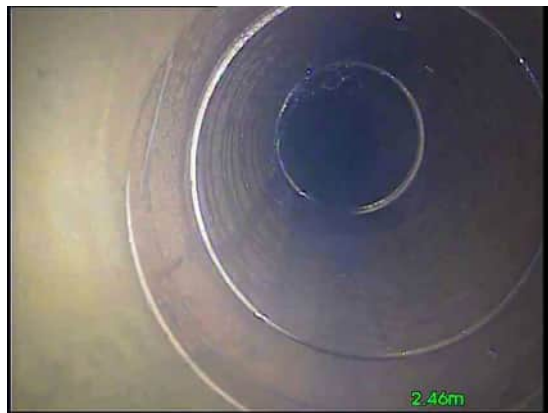
4, 00:00:18, 2.46 m  
General remark, Sewer levels out at this point

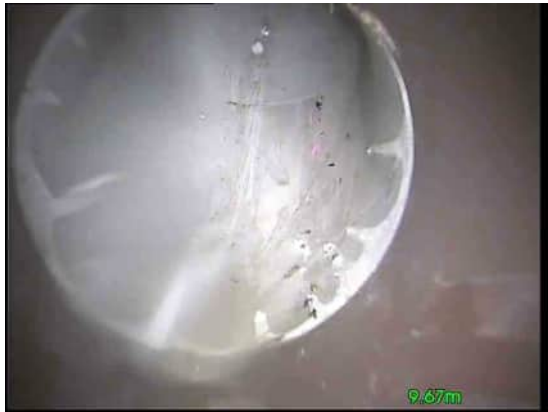
9, 00:01:23, 9.67 m  
Finish node, other special chamber, reference: RWP, Internal RWP reached

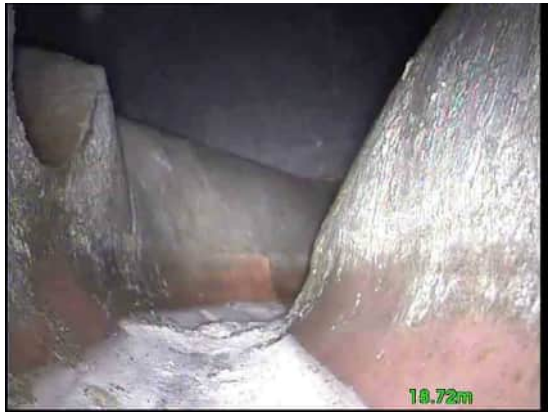
9, 00:01:01, 18.72 m  
Finish node, manhole, reference: MH31 UTL reached

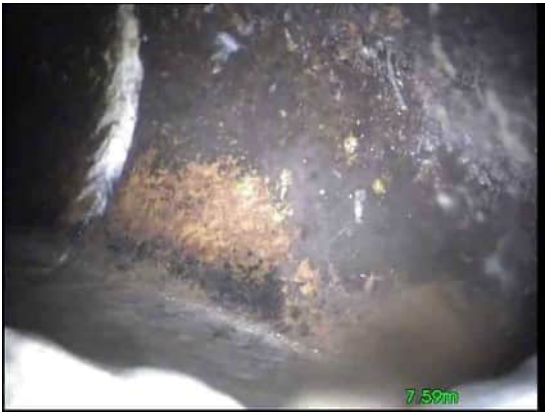
9, 00:00:50, 7.59 m  
Finish node, major connection without manhole, reference:  
Main public sewer reached

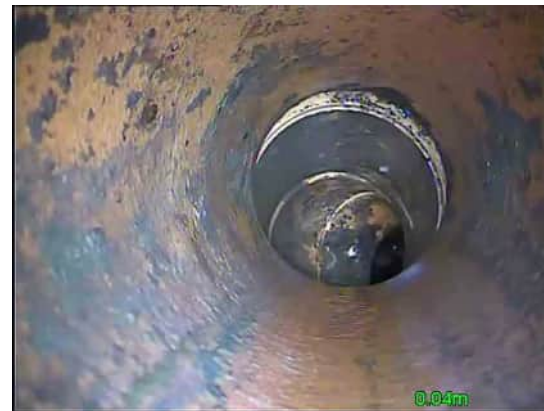
1, 00:00:03, 0.04 m  
Line deviates up

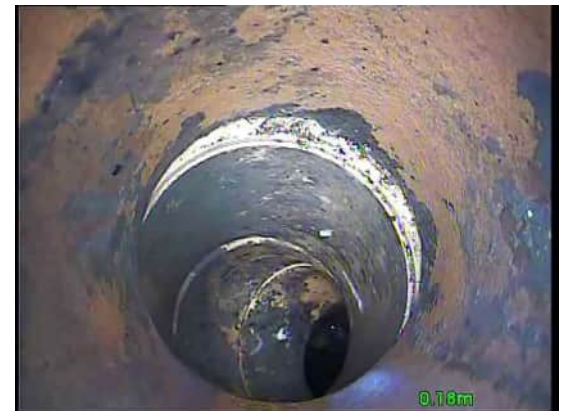
2, 00:00:06, 0.18 m  
Pipe material changes to polyvinyl chloride at this point

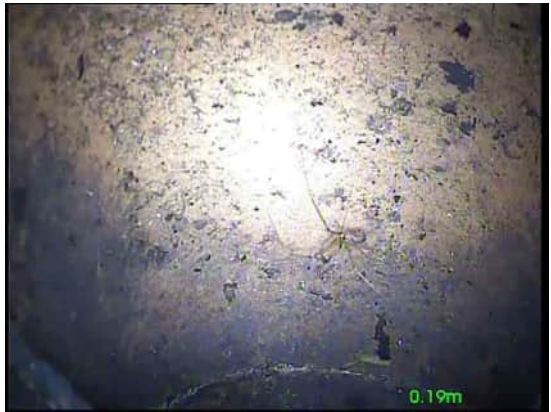
2, 00:00:08, 0.19 m  
Finish node, gully, reference: Buried Gly reached

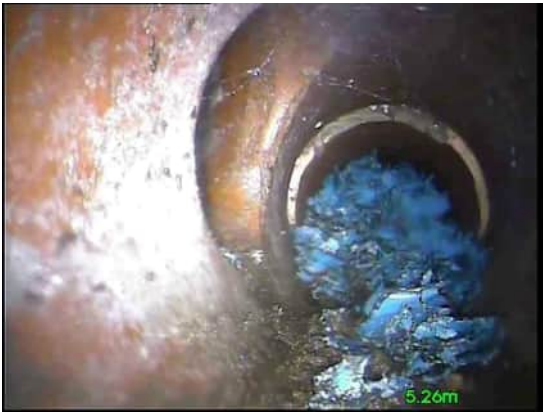
5, 00:00:30, 5.26 m  
Junction at 10 o'clock, 100mm dia
