Project ref: **383**

Site address: **139 Fortis Green Road, London, N10 3LX**

# HERITAGE STATEMENT & ASSESSMENT

Revision: **A 09.11.2023 (first issue)**  
**B 22.01.2024**

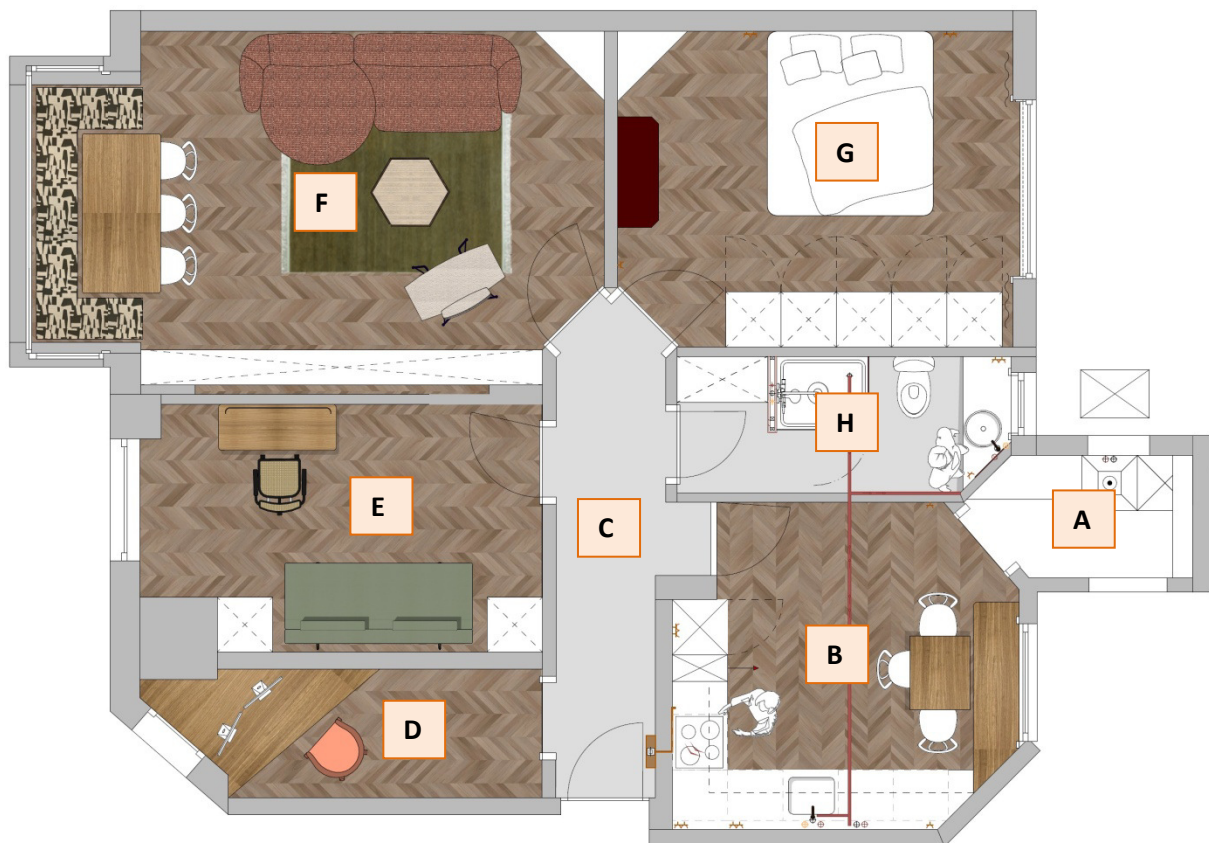
Latest revision of the proposed floor plan layout – note room labels.

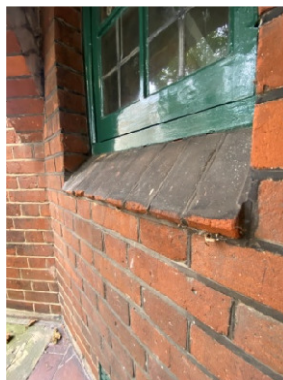
Window cill detail

- 2.6 The exterior of the building is largely in good condition, however there are small select areas of brickwork that have been re-pointed in mortar offering a poor match. There is also evidence of some window cill tiles having been replaced offering a poor match with existing.
- 2.7 Internally, over the years it would appear from publically available data that many of the flats have been modernised and have been altered. There is evidence showing that bathrooms and kitchens have been modernised to meet current living standards which is to be expected. There is also evidence of internal doors being changed. Some rooms in flats appear to have retained key details such as plaster cornices, picture rails and dado rails. We are unable to confirm whether or not any of these alterations have been granted Listed Building Consent.

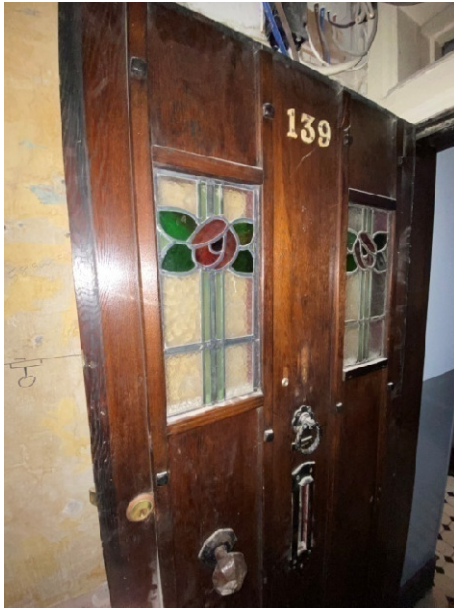
Original flat front door with lead framed glass

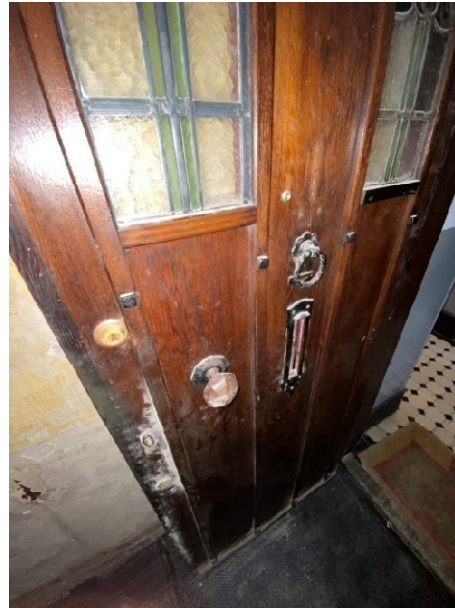
Original ironmongery of historic interest:

- knocker
- letter box
- square fixings

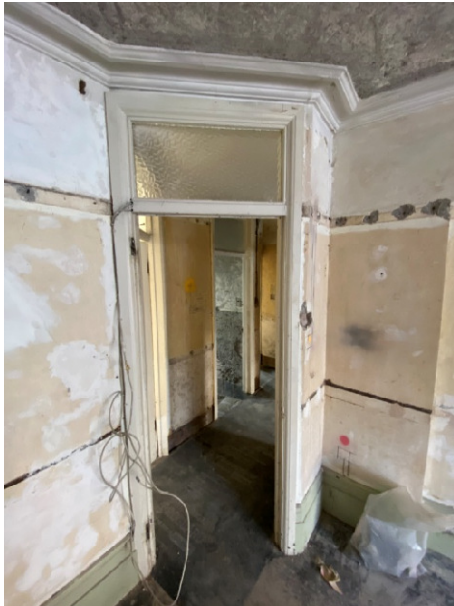
- 4.9 Our assessment of the hallway is that the key aspects that are of considerable historic and architectural interest are the partition walls that denote the circulation space and separate the front (road facing) and the back (garden facing) rooms ending with the two internal oblique doors positioned at around 45 degrees. The original floor tiles also feature a simple decorative boarder that aligns with the original wall partitions. Internal clear storey panes of glass above the doors also allow for natural light to enter the otherwise windowless hallway and while the glass in these openings does not appear to be original the opening itself and design feature is an aspect that we would deem of interest and worth preserving. Original door openings, doors and architraves all remain in situ and we understand are to be preserved.

Oblique doorways with clear storey window integrated into door opening

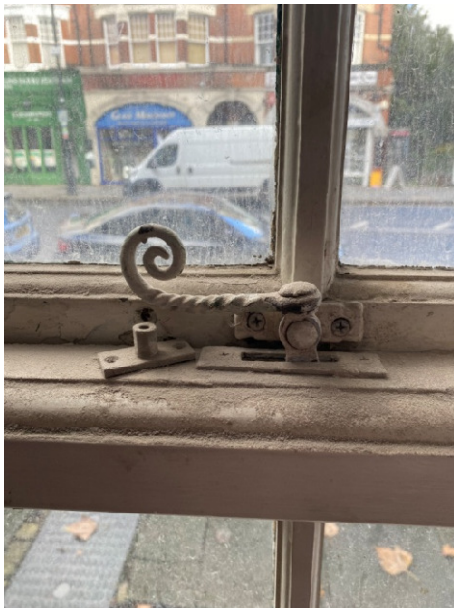
- 4.21 Finally there are a number of other small detailed observations. Not all, but some of the original crafted monkey-tail window handles and stays remain in situ. These should be preserved. We understand that the owners are looking to reinstate matching window handles and stays were required. No original door handles or hinges were observed on site. As expected, given the mechanical nature of these fittings it is not uncommon for these to have been replaced over time. We understand the owners are looking to reinstate new Arts & Crafts style door ironmongery.

Original monkey-tail window lock
